REHABILITATION

Expect the Unexpected

Lenox Hotel Façade Repairs

Restoration of Fraser Field Stadium

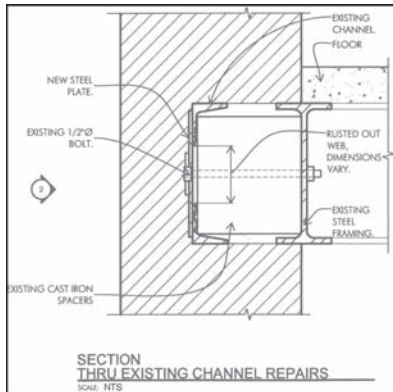
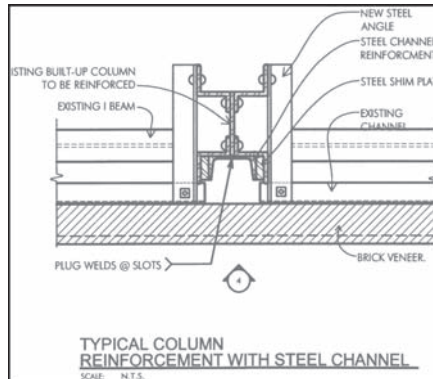
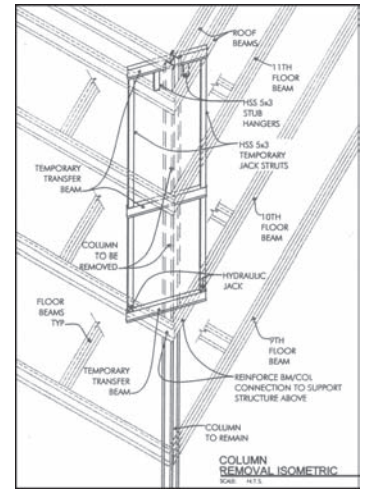
One hundred years of this process resulted in significant parts of the steel structure rusting away, especially at the corner columns. When CBI accessed the exterior of the building and cut test holes to observe the steel, they found many locations where the steel no longer existed. Examples of rusting and missing steel were so numerous, it was recommended that all the steel on the exterior of the building be exposed for review and repair for life safety reasons.

Steel lintel angles riveted to channel sections at each floor line were extremely corroded. In many locations, holes were discovered through the channel webs. In two cases, column deterioration was so severe that the steel cross section had completely disintegrated, and the masonry substrate and veneer was carrying vertical loads. The bid package contained details for reinforcement and full replacement of each type of element. Construction documents also provided many detail variations, to accommodate varying field conditions and budget.

All existing steel was evaluated. When it was determined that the column cross section could be rehabilitated, a series of supplemental steel pieces were added to the existing cleaned cross section as reinforcement.

During the investigation phase, it was decided to test the process of removing a column and replacing it with a new cross section. The purpose was to test which procedures would be most user-friendly to a contractor, and to establish budget costing while documenting the procedure for subsequent construction and use of bidders. (These sketches demonstrated the types of reinforcements that were added to address a variety of deficiencies).

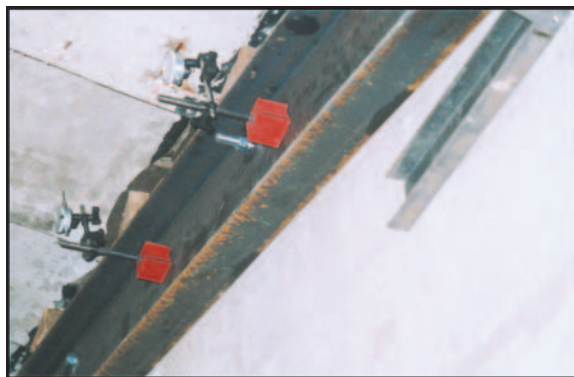
Deflection Measurement During Load Test

During each of the tests, loads were applied in four increments with deflection measurements taken at midspan and adjacent to supporting beams after each load increment. The deflections were then measured after the load had been in place for a twenty-four hour period. The test load was subsequently removed after completion of the twenty-four hour load period, and in both loading arrangements the structure recovered more than seventy-five percent of the maximum deflection. The load tests results successfully demonstrated that the existing grandstands could safely support a uniform live load of 100 psf. These results eliminated the need for installation of permanent supplemental framing, allowing more of the budget to be expended for other necessary stadium repairs and improvements.
