A Tale of Two Bridges

By F. E. Griggs, Jr. FASCE

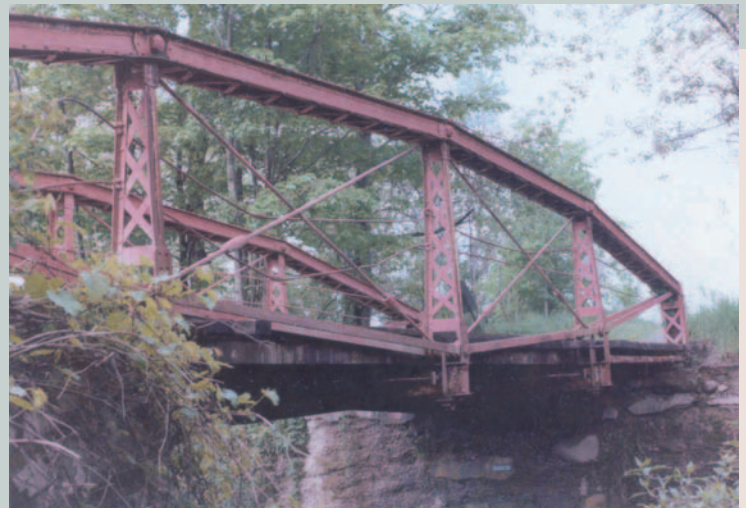
Berlin Iron Bridge, Salem, Washington County, NY

Due to the low volume of traffic, the Salem bridge served well for over 100 years, only requiring wood deck replacement periodically. The State Historic Preservation Officer (SHPO) determined the bridge was eligible for future placement on the National Register of Historic Places. State inspections in the 1980s indicated section losses on the steel stringers of up to 30% and on some of the truss elements up to 20%. The abutment stonework was also collapsing in places. The bridge was flagged at the time and its load rating reduced. In 1990, the county decided to remove the bridge with the intention of restoring and re-erecting it at another location. The bridge was moved to the County Park near Cambridge, where it was cleaned and painted by inmates from Mt. McGregor Correctional Facility. In the spring of 1998, the County was still planning to use the bridge, but by early 1999 the Supervisors instructed the County Engineer to find a new home for it. At this time, the writer was asked to assist in finding a town, county or individual interested in a bridge of this span.

2. Inspect main truss members, looking for members with section loss. The top chord of the truss was built up of wrought iron plates, angle irons and lattice bars riveted together. Rust bulge is common on these members, frequently resulting in rivet failure or tearing of wrought iron plates. Minor amounts of rust bulge existed. Hammer blows removed it. Separation of the plates due to rust bulge was closed by additional hammer blows and some heat. Lattice bars were frequently bent, but not cracked or broken. The verticals were built up with angle iron and lattice bars. They had been impacted and plates were welded to the iron members. Tension links connected by pins, being outside the deck area, are generally not subject to impact or corrosion and were in

good condition. The diagonal bars in the two middle panels were connected by pins and generally were free from corrosion. The vertical end posts were built up with plates, angles and lattice bars similar to the top chord. These members were bent in places resulting in tearing of the wrought iron. The inspection revealed that welding could repair them. All rivets were inspected visually and by hammer impact. They were found to be tight and as originally installed. The members connecting the end base plate to the first lower chord panel point frequently are bent or corroded. This was the case in the Washington County structure. Of the four members, one was entirely replaced and the others rehabilitated.

The welding of wrought iron requires a technician with experience, and the use of a low hydrogen-welding rod such as E7018. All cracks are grooved and welded, and the weld ground smooth. One cast iron junction block needed minor repair, and this was done with a high nickel content welding rod Cronocast 211.

Painting the bridge was necessary due to the welding required on the members. A three coat paint system was required using Dupont Imron 333, Dupont Imron 610P and Corlar 25P. Since the bridge was sandblasted and primed earlier, the three-coat system was applied directly over the prime coat.
