San Simeon Earthquake

December 22, 2003

By: Ronald O. Hamburger and Joshua M. Marrow

Ronald O. Hamburger, Vice President of NCSEA and Principal at Simpson, Gumpertz and Heger, Inc. (SGH), along with Joshua M. Marrow, Senior Engineer at SGH, prepared the following report for NCSEA News on the San Simeon Earthquake of December 22, 2003.

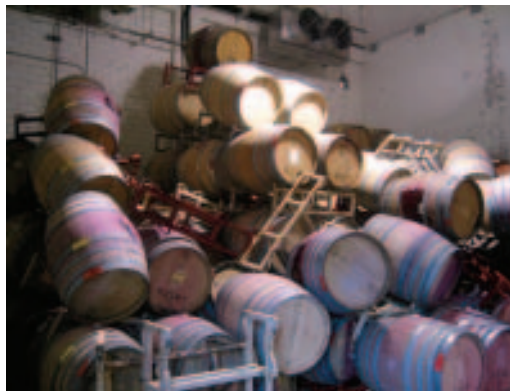
The central coast is an active vineyard region with many wineries present. Several of these wineries reported significant losses to their inventory, with ageing barrels toppling over and in some cases spilling contents (Figure 6). Several million dollars of losses are reported.

Figure 6 Toppling of wine ageing barrels

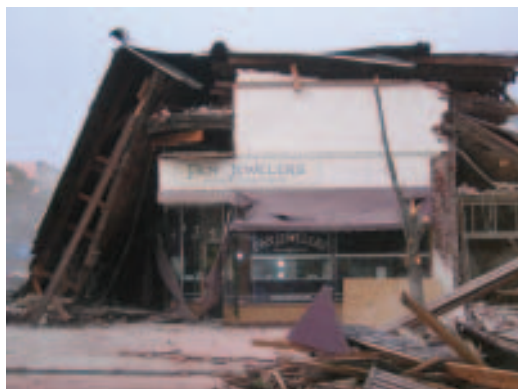
The most severe damage to buildings occurred in Paso Robles, where one historic unreinforced masonry structure experienced a complete collapse of its second story (Figure 4) resulting in the two fatalities. It was reported that a seismic upgrade of the building had been

planned and that the building's owners were attempting to obtain funding for this project, the cost of which had been considerably increased by requirements to add a passenger elevator for disabled access to the second floor. In the past, California structural engineers had argued for legislation that would exempt seismic upgrade projects from mandated collateral disabled access and fire/life safety upgrades. However, these efforts have not been successful. As a result, seismic upgrade of many buildings remains outside the financial resources of building owners.

Figure 4 Collapse of the Acorn Building in Paso Robles

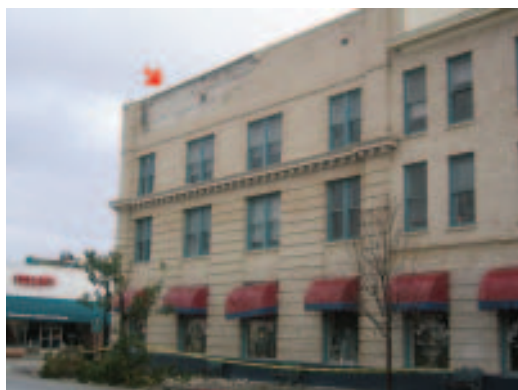
Many of the other unreinforced masonry buildings in Paso Robles had previously been upgraded and performed much better. Still, potentially life-threatening failure of masonry veneers did occur in a few cases (Figure 5). In addition, several homes experienced severe damage or collapse of their brick chimneys. Concrete roof tiles were loosened and in some cases fell off buildings. Fortunately, these additional failures did not result in further human loss. Buildings throughout the region experienced cracking of stucco and dry wall. One school building, originally

Figure 5 Masonry veneer peeled off the parapet of this building in Paso Robles
