# Lessons Learned

## Structural Upgrade of Sutro Tower San Francisco, California

By: Ronald O. Hamburger, S.E.

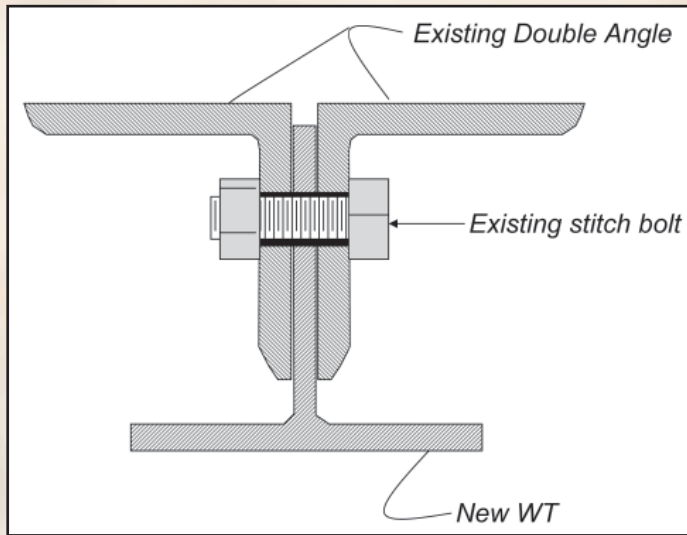
Figure 5: Cross section of retrofitted double angles.

cabling, wave guides and other equipment related to the broadcast transmission use of the tower, it was not possible in all cases. For these cases, the double angle braces were upgraded with the insertion of new WT members between the back-to-back legs. New WT reinforcement was connected to the double angles, using the bolts originally provided in the double angles for intermediate attachment, but using slotted holes in the new WT members, so that the stiffness of the reinforced section matched that of the original member. As illustrated in *Figure 5*, this resulted in a cross section that had the approximate appearance and slenderness properties of a wide-flange section, but the axial stiffness and tensile strength of the original double angles.

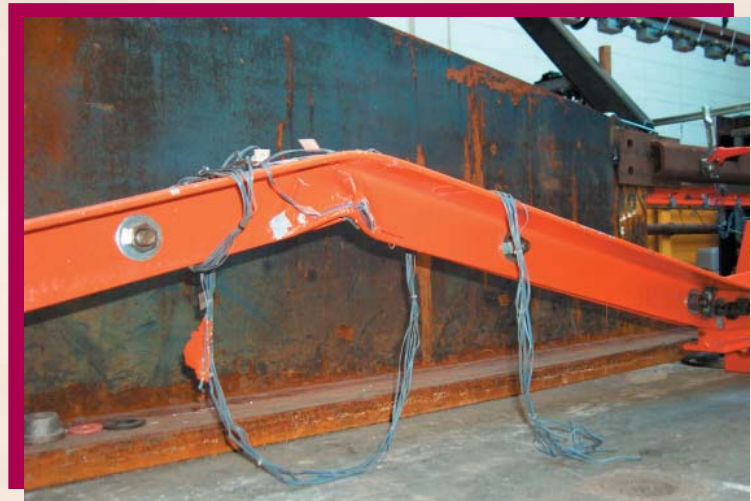
Unstrengthened specimens exhibited poor inelastic behavior with local buckling initiating at points of plastic hinging at mid-span (*Figure 6*), followed by fracturing. Fracture also occurred at plastic hinge locations at the ends of the braces (*Figure 7*). Strengthened braces, however, performed much better, avoiding local buckling (*Figure 8*) and displaying remarkably stable hysteretic behavior, both in tension and compression, validating the design approach.

Figure 6: Local buckling at mid-span of double angle brace in compression

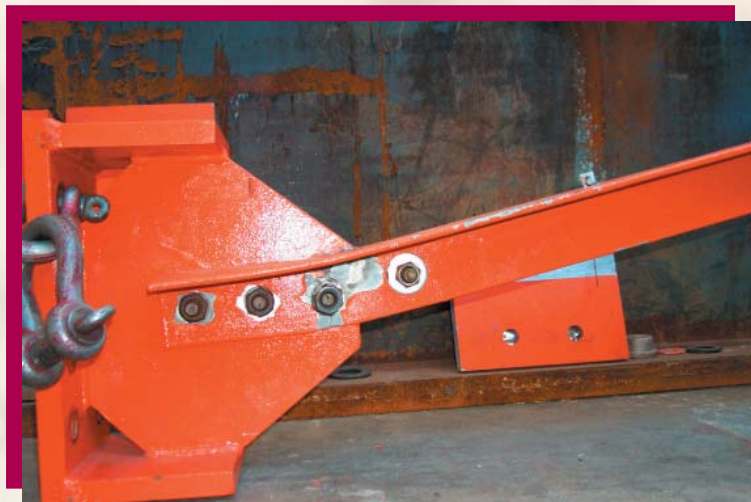
Figure 7: Fracturing of angle at point of plastic hinge development at brace end connection

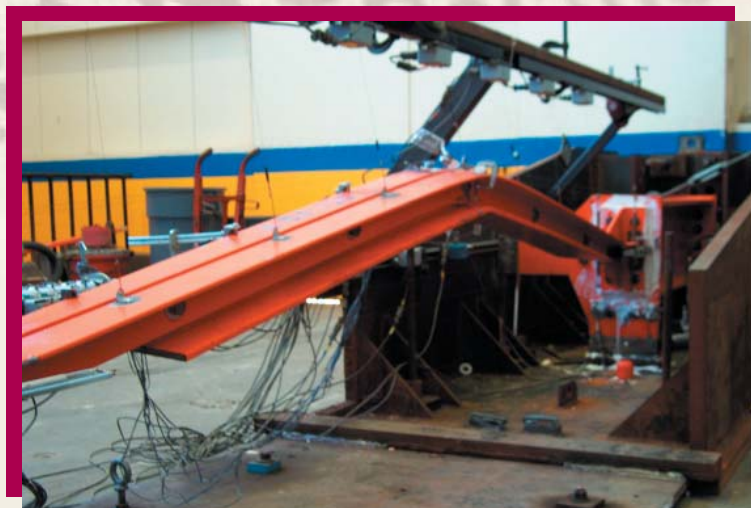
Figure 8: Buckling behavior of reinforced brace specimen
