Evaluating Historic Structures for Adaptive Re-Use

By Dominick R. Pilla, P.E., C.E., S.E., R.A. and Xiaoli Tong, P.E.

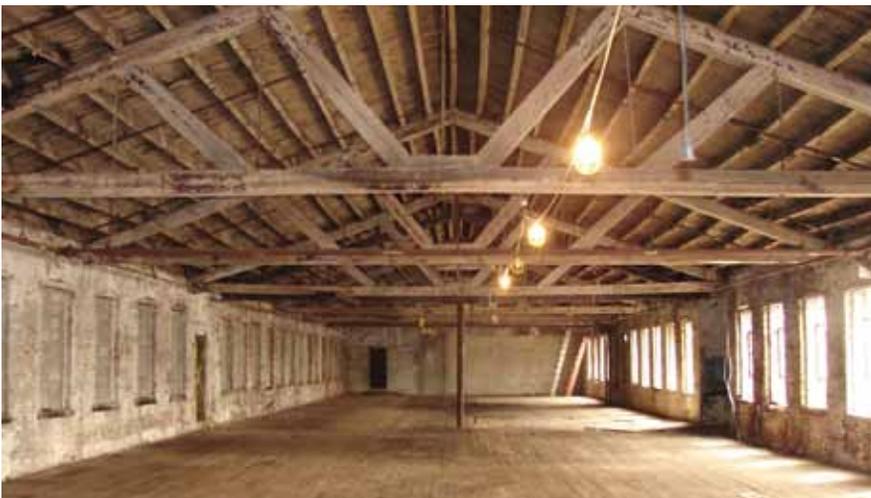
Lacking construction documents, visual inspection and detailed field measurements were the primary means used to assess the buildings (Figure 2). The buildings were examined, and areas of spalling and cracking were noted.

Figure 2: Lacking construction documents, visual inspection and detail field measurement were the primary means used to assess the buildings.

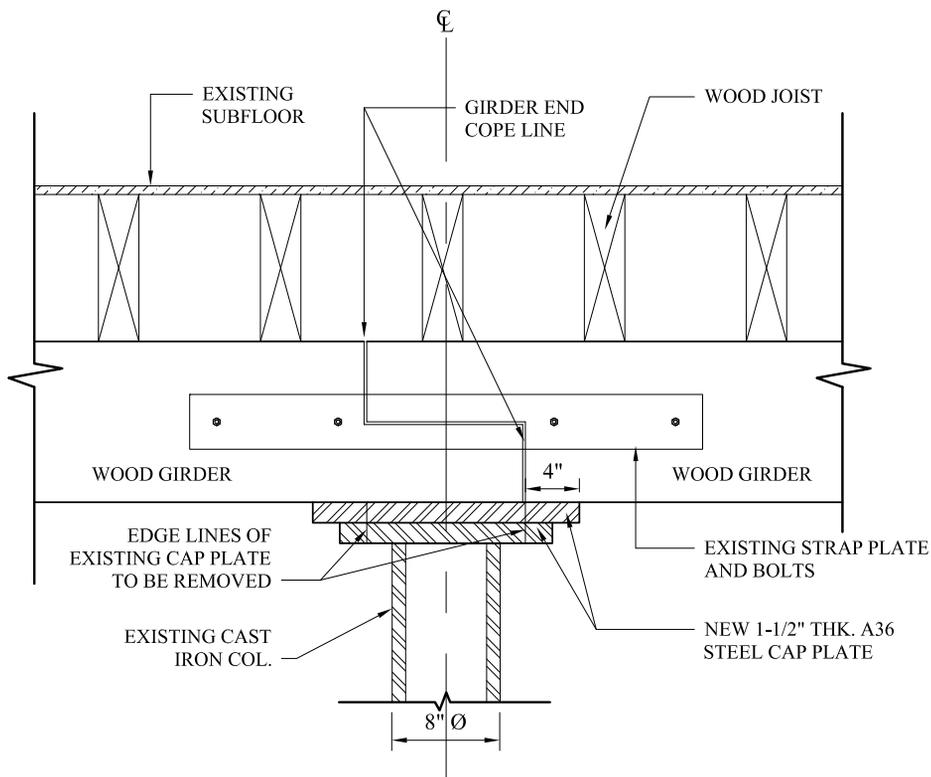
Figure 3: Retrofit of cast-iron column top plate connection.

Some of the existing girders were discovered to be coped with half depth to overlap each other. This connection detail provided for more uniform stress bearing on the top plate because the end reaction forces vary largely due to widely varying adjacent spans.

While this top plate connection detail benefited the columns by reducing the possibility of eccentric loading at their tops, it impaired the coped girder because of a decrease to its shear capacity. An analysis showed the existing shear resistance at the coped section was only 70% of the required shear force. The existing top plate detail was replaced by a new design (Figure 3, page 15), which provided adequate bearing length from the cope line for the coped girder.

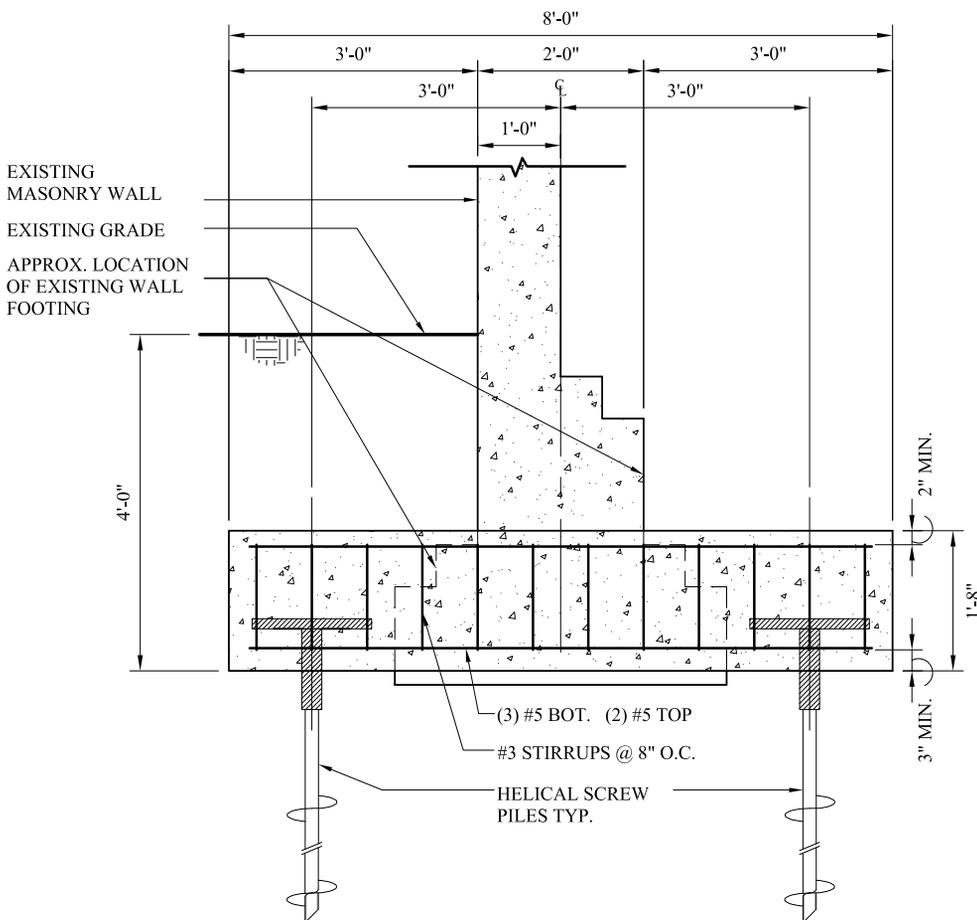
In addition to the anticipated deterioration due to time, large settlement cracks were observed on most of the one-story building exterior walls and at the south-west corner of the three-story building. Test pits and in-situ dynamic cone penetration tests were conducted adjacent to the existing wall footing. The testing revealed the bearing soil layer was mainly fill comprising sand with gravels, crushed concrete, etc. The sample fill had a low bearing capacity of less than 1.0 tsf.

Since the building had been bearing on the soil for at least 60 years, the 1.0 tsf capacity was not as much of a concern for soil below the footings as was whether the back-fill was fully and uniformly compacted during construction. Differential settlement from non-uniform bearing soil was likely the primary cause of the settlement cracks and leaning interior columns observed throughout. Excavation of the column footings proved the footings were dimensionally adequate. However the footings were rotating at the corners, a condition indicative of improper in-filling and soil compaction when the building complex was initially built.

Figure 4: Helical Pile Grade Beam Support.

The existing spread footings were determined to be adequate. However, helical piles incorporated with grade beams were designed to strengthen the wall footing at the cracking south-west corner of the three-story building (Figure 4). The advantage of helical piles is mainly its minor disturbance to the existing building and the subway structure adjacent to the building during installation. The piles prevent further cracking of the existing wall and increased the building's integrity.
