Avoiding Structural Failures During Construction

Part 2

By David B. Peraza, P.E. and Dennis M. McCann, Ph.D., P.E.

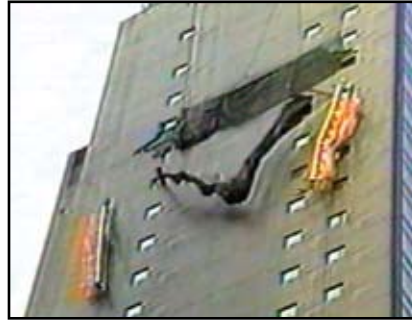
Figure 1: 540 Madison Avenue, partial facade collapse. Courtesy Channel 7 News.

On a Sunday afternoon, December 7, 1997, a portion of the south wall from the 35th floor collapsed, raining bricks down onto the low adjacent building and onto Madison Ave. The incident resulted in the closing of many stores during the holiday shopping season, and hobbling traffic along a major midtown artery.

Figure 1 shows an overall view of the façade after the failure.

This event has a number of lessons for us. One is that periodic façade inspections should include ALL sides of the building. Prior to this event, New York City required that only facades over sidewalks needed to be inspected. The façade that fell, therefore, was exempt from inspection. Within months, the law was modified to require that all sides of a building be periodically inspected. This incident also underscores the importance of inspection during construction. Even the most rudimentary spot check during construction would have detected the brick ties were not being installed. And, finally, this incident reinforces the fact that inspections of existing facades by qualified professionals can often detect problems before they occur. The bulging sealant and the spalling of the brick along the relieving angles were telltale signs to an engineer familiar with masonry facades that the brick might be under high compression, and that further investigation was needed on an expedited basis. Such an investigation would have probably resulted in the recommendation that new horizontal soft joints be installed prior to cutting the window openings, and it probably would have detected the missing brick ties.

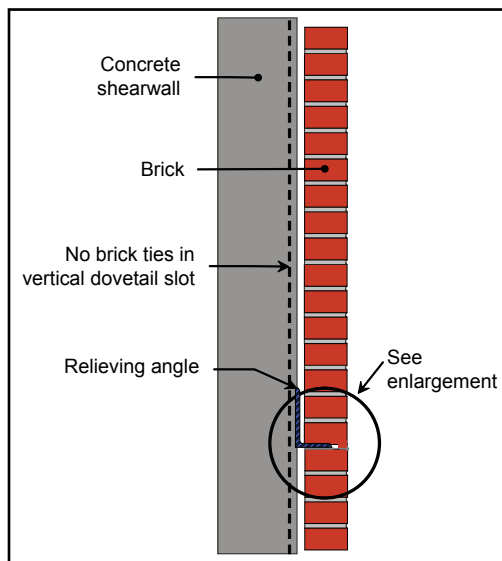
Figure 2a: 540 Madison Avenue wall section: The failure was caused by a combination of lack of brick ties and excessive compression in the brick due to non-functioning horizontal soft joints. The soft joints were not wide enough to accommodate shortening of the concrete frame and moisture expansion of the brick.

So, why did this failure occur? For two reasons, as illustrated in Figures 2a and 2b. First, the field investigation revealed that brick ties were completely missing over large expanses of the wall. The vertical dovetail slots in the concrete shearwall were filled with fiberglass insulation and concrete, clearly indicating that brick ties had never been installed. About 60% of the façade had this condition. In these areas, the 4-inch thick brick veneer was essentially balanced on its edge with no lateral support. This condition had existed since the day the wall was built.

The second reason was that the brick veneer was subjected to high compressive stresses. These high stresses were caused by the inability of the horizontal soft joints to accommodate the natural expansion and contraction of the building. These dimensional changes were produced by two cumulative effects: 1) creep and shrinkage of the concrete frame, a phenomenon that structural engineers learn about in undergraduate courses, and 2) the natural expansion of the brick due to moisture absorption, which structural engineers may not be familiar with. That the joints had been squeezed closed was clearly visible in portions of the façade that had not collapsed. Since the majority of creep, shrinkage, and moisture expansion occur early in the life of the structure, this condition also had probably existed for many years and went undetected.

So, what triggered this event to occur at the moment that it did? It was probably the making of the window openings. The introduction of openings reduced the net section of wall, thereby increasing the already high compressive stresses in the wall. Although this renovation work, in and of itself, should not have caused any problems...it was the straw that broke the camel's back.

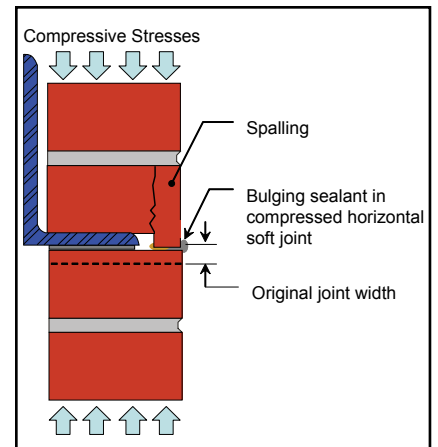
Figure 2b: Visual inspection can detect symptoms that a wall is being unduly compressed, such as brick spalling and bulging of sealant. With lip brick, as shown above, micro-probes are needed to determine the remaining width of the joint under the angle.

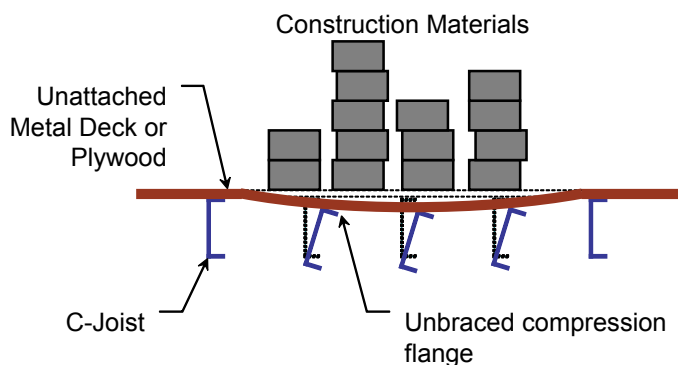
Figure 3: Light gage metal joists are vulnerable to lateral torsional buckling if their compression flange is not properly braced. Contractors may not be aware of the importance of attaching decking before loading a floor.

materials, with the intention of making the permanent attachments later. What the contractor doesn't realize is that the joists are dramatically weaker if the deck is not attached to them. If subjected to modest loads, the joists will fail due to lateral torsional buckling, as illustrated in Figure 3.

These cases highlight the need to communicate to contractors the importance of providing bracing for C-Joists. This can be done via notes on the design drawings and comments on the shop drawings, in a manner that does not negate the contractor's responsibility for means and methods. The light gage metal joist industry can reduce the likelihood of these types of failures by providing prominent warnings in its literature and on its packaging.

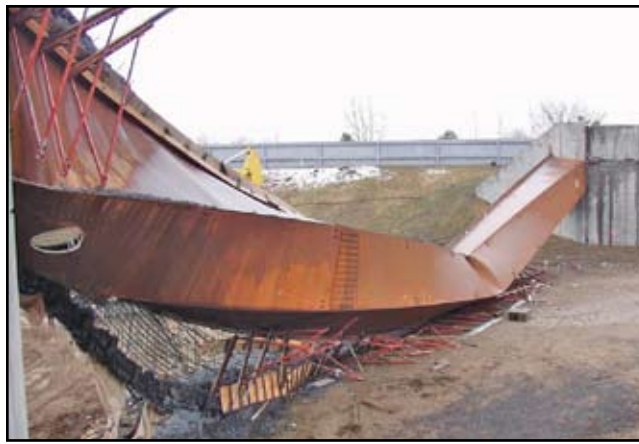
Figure 4: The Marcy Pedestrian Bridge following collapse during placement of the concrete deck.

The Marcy Bridge was a pedestrian bridge designed to span approximately 170 feet across an extension of the Utica-Rome expressway (NYS Route 49) in Marcy, New York. The design consisted of a single trapezoidal steel tub girder with a composite reinforced concrete deck. The bridge collapsed during casting of the deck, shortly after placement of the wet concrete had passed midspan, severely injuring nine workers and killing one. The failure mode was determined to be lateral-torsional buckling of the steel tub girder in which the entire girder cross-section participated, not simply the compression flanges. A photograph of the

Prior to and during placement of the concrete deck, the tub girder was an open section and was therefore relatively flexible torsionally. After curing, the concrete deck would have created a closed cross section, and the increased torsional stiffness would have prevented lateral-torsional buckling. Torsional stiffness can be increased

prior to placement of the slab by means of a top flange lateral bracing system to create a quasi-closed section. However, top flange lateral bracing was not prescribed in the design or included in the fabrication of the Marcy Bridge. Another means by which a closed cross section can be created is through adequately designed stay-in-place formwork. While the Marcy Bridge utilized stay-in-place forms, the connections between the individual panels were not engineered for this purpose and therefore could not prevent the lateral-torsional buckling from taking place.

The flexibility of the open cross section without lateral bracing, coupled with the vertical curve and long, slender geometry, made the Marcy Pedestrian Bridge susceptible to lateral-torsional buckling.

A lesson that can be learned from the Marcy Bridge collapse is that a thorough consideration of all possible limit states of a design should be made, in addition to those that may be addressed in codes. Limit states that affect constructability of the structure are particularly important. As an outcome of the collapse, New York State Department of Transportation issued an Engineering Bulletin in July 2003 requiring full length lateral bracing systems for all tub girders that rely upon a composite concrete deck to form a closed cross section.

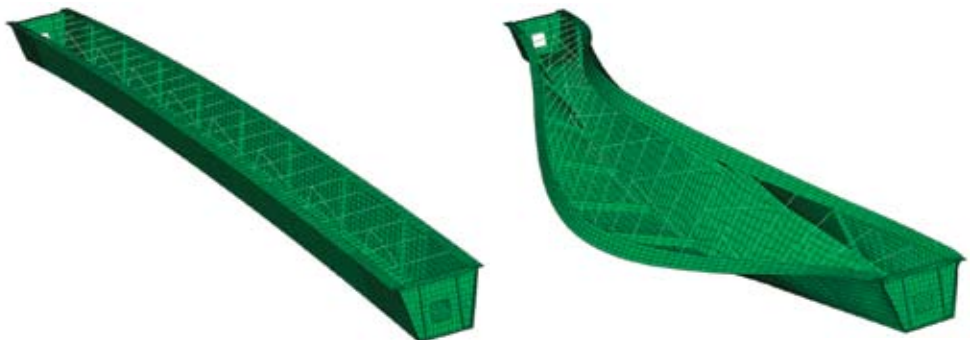
collapsed tub girder is shown in Figure 4 and the buckled shape computed by the structural analysis software, ABAQUS, is depicted in Figure 5.

Figure 5: Finite element model of the Marcy Pedestrian Bridge showing the undeformed shape and the global lateral-torsional buckling mode.
