Fire Damaged Post Tensioned Slabs

By Douglas Sarkkinen, P.E., S.E.

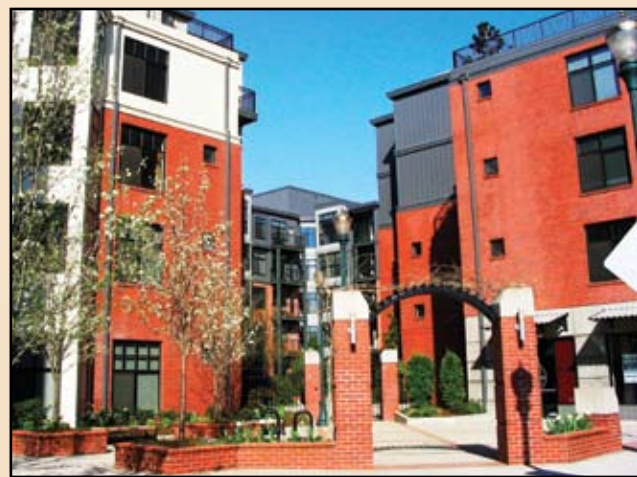
Kearney Plaza Today: Post-tensioned slab Courtyard

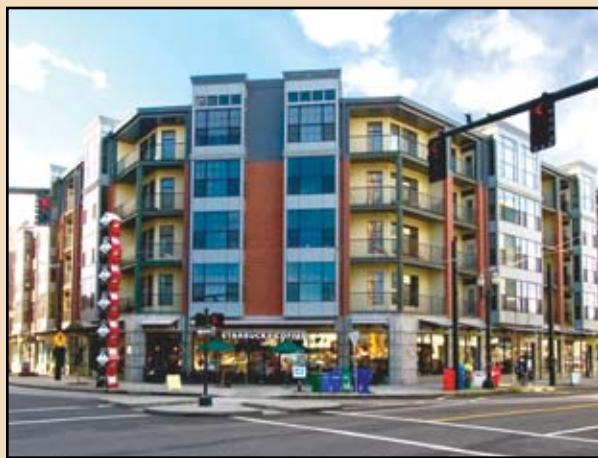
Kearney Plaza Today: Retail

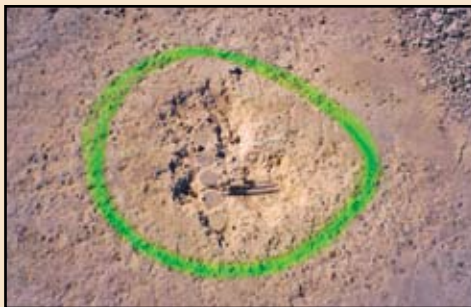
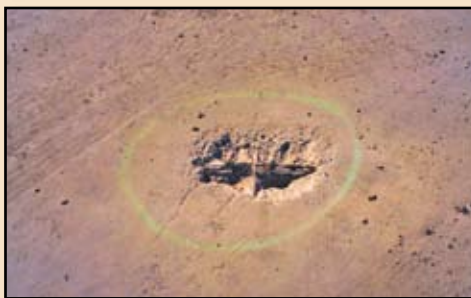
Exposed Post-tensioning tendons

Post-tensioning Tendons and Deformed Bar Reinforcement were exposed and investigated at several locations. In only one of the 6 cases of exposed tendons, the protective plastic sheathing exhibited signs of melting but the strands and grease appeared to be still intact. The exposed reinforcing bars did not show signs of heat scarring, and there was no indication of concrete delaminating or spalling around the deformed bars.

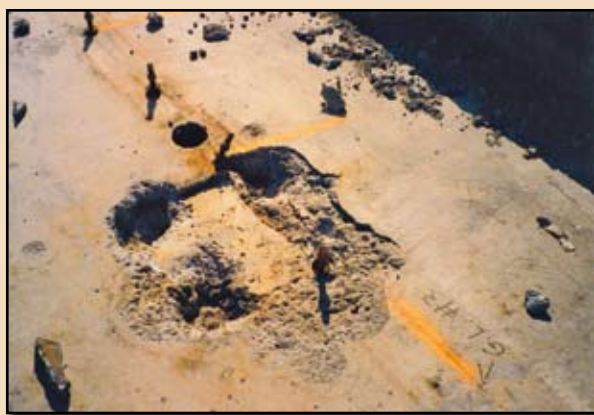
Along with investigation and repair of slab concrete portions, there was a substantial number of steel anchor bolts and hold-down anchors protruding through the slab surface. A large percentage of these were bent or damaged during the fire or subsequent cleanup operations. All bent or damaged anchor bolts and all hold-down anchors were load tested in place, with some requiring repair.

Loss of embedded anchors
