Glulam Beam Repair/Reinforcement

Tinora High School

Defiance, Ohio

By Gary W. Gray, P.E. and Paul C. Gilham, P.E.

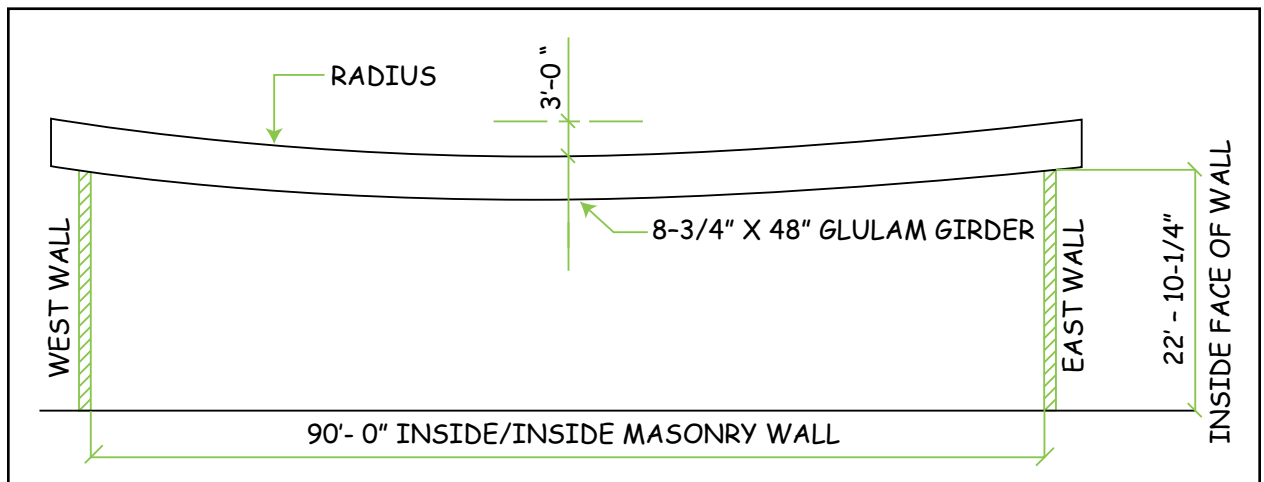
One of the beams located directly above the center court line (Beam #5; *Figure 1*) had been reported to have cracked near the mid-span. Upon investigation of this beam, it was determined that the glulam beam had undergone a structural "bending failure" and was no longer adequate to safely support the roof above. The failure had initiated at a knot near mid-span at the bottom lamination, and the crack had propagated upward and outward in a flat "V" pattern which is a classic type bending failure in wood beams. The crack had propagated up from the bottom face of the beam approximately 12 inches at the time of the structural investigation (*Figure 2, page 12*).

Figure 1: Profile of glulam beam girder (Beam #5)

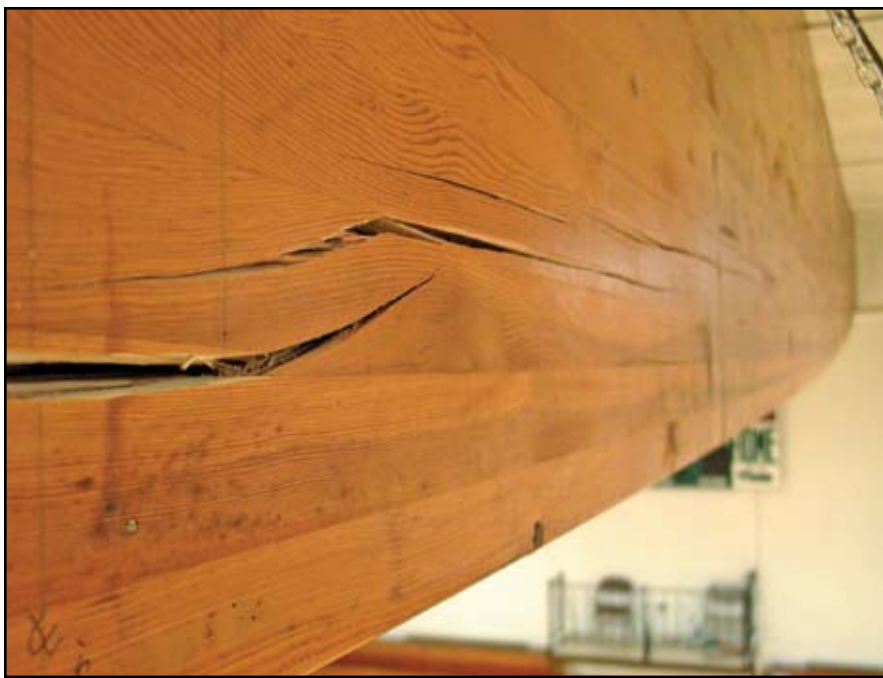
Beam #5 had deflected approximately 3 inches lower than the adjacent beams, and the open crack at the failure zone was approximately 3/4 of an inch wide and completely through the full width of the beam. The section of beam above the

crack (although overstressed) maintained enough structural integrity for a period of time to prevent a catastrophic collapse of the beam. There were no visible signs of distress at the masonry walls supporting the beam ends due to horizontal displacements resulting from the beam failure.

Figure 2: Failed beam due to overstress in bending

The design analysis indicated that the addition of the ballast weight nearly 20 years earlier had resulted in an approximate 40% increase in dead load-only bending and shear stresses. In addition, glulam beams manufactured prior to 1970 did not utilize specific graded tension laminations which are now required by current laminating standards. Various full size glulam beam tests have been performed by the American Institute of Timber Construction and other agencies, which have predicted an allowable stress reduction of approximately 25% for glulam beams manufactured without these specific graded tension laminations. This equates to the beams used in the Tinora High School gymnasium being overstressed approximately 24% under permanent dead loads, and approximately 62% under full design load requirements (DL + SL). These beams were originally designed

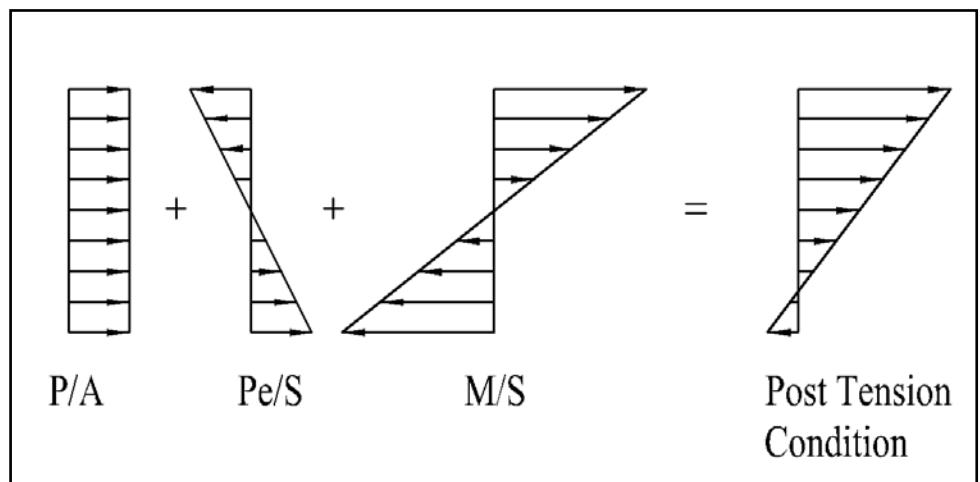
Figure 3: Combination of stress with post-tensioned system

force to the beam. This force was applied eccentrically to the beam's neutral axis and produced a bending moment to the member. *Figure 1, (page 11)* shows the combination of the post tensioning stresses and the applied stresses. The P/A compressive stresses and Pe/S bending stresses are due to the cable tensioning. The M/S bending stress is in the opposite sense of the cable stresses and is due to the applied dead and live loads. The resulting tensile stress at the bottom of the beam in the post tension condition must be less than the allowable tensile stress of the member. (*Figure 3, page 12*)

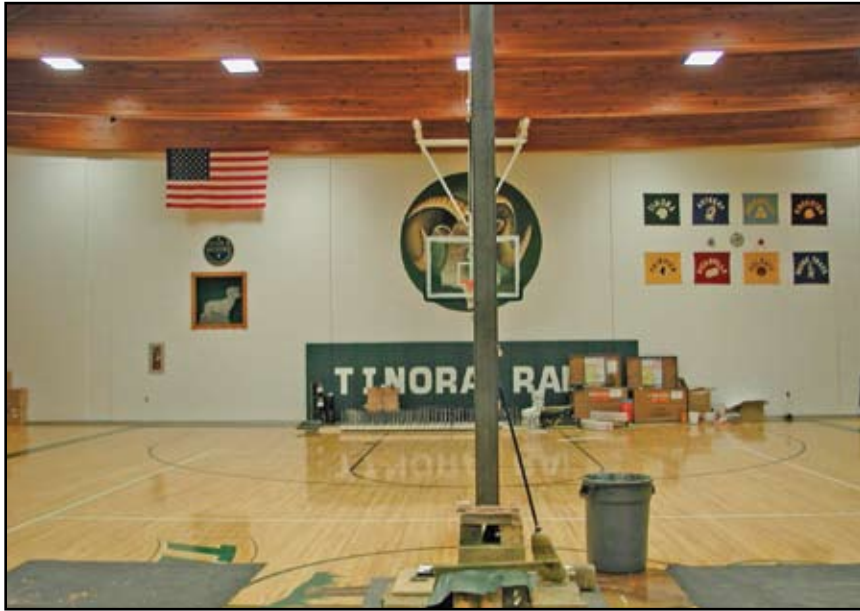
Figure 4: 6 x 6 HSS member used to jack beam to unloaded position during beam repair

Prior to the structural investigation, the owner had placed a temporary column support at the center span of the beam, but it was determined that the support was not adequate to safely shore up the beam. It was further recommended that the beam be adequately shored up using two 6 x 6 x 1/4 HSS steel columns to prevent any further damage to the beam and to safe guard against a beam collapse. These two temporary supports were located symmetrically 9 feet from the center of the beam to allow for direct access to the bottom of the beam at the failure zone for possible repair applications.

1. The beams were jacked up to approximately an unloaded position. A 6 x 6 x ¼-inch HSS was installed on timber cribbing with a 20 ton bottle jack at the base. The jack was used to close the cracks as much as possible. (Figure 4, page 13)
2. 1⅜-inch holes were drilled vertically in the beam from the soffit to a point 6 inches above the highest crack. Small port holes are drilled near the bottom of the beam and just below the top of the vertical hole. (Figure 5, page 13, and Figure 6, page 14)
3. The sides of the beam were sealed with an epoxy paste. The epoxy used in the shear dowels has a very low viscosity and if possible will travel along a void in a beam to the closest opening where it will run out. Sealing the sides of the beam prevented the liquid epoxy from leaking out of the beam.

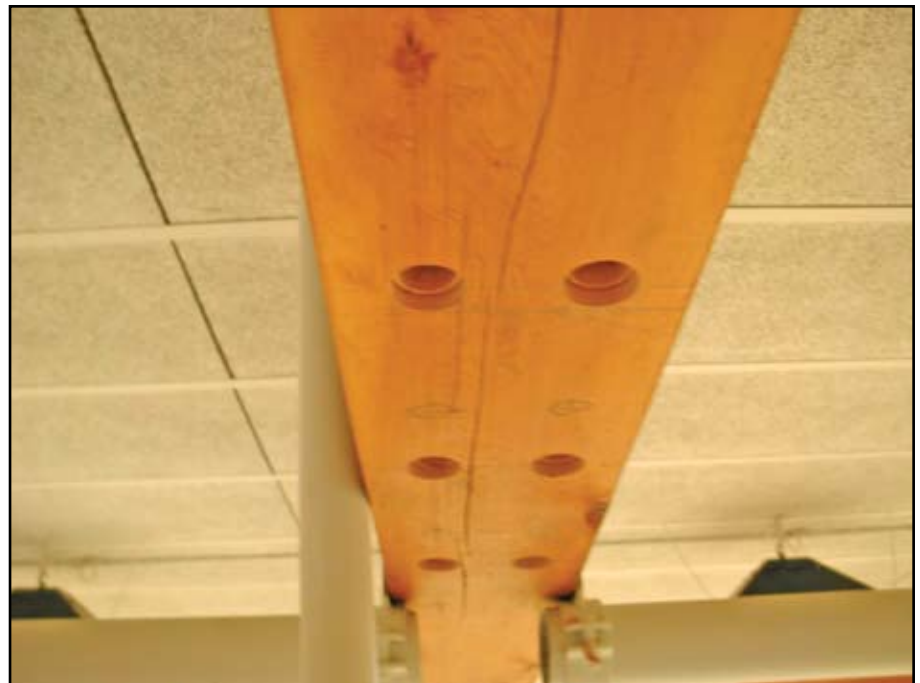
Figure 5: Holes drilled to receive Post-Tensioning Anchor Brackets

The cables are anchored to the beam using steel anchorage assemblies. Steel reinforcing bars are inserted into the holes drilled into the ends of the beams and the voids are pumped full of an epoxy. The allowable strength of the anchorages was determined from full scale testing. The cable anchorage is achieved using standard button type wedge anchors used in the prestressed concrete industry.

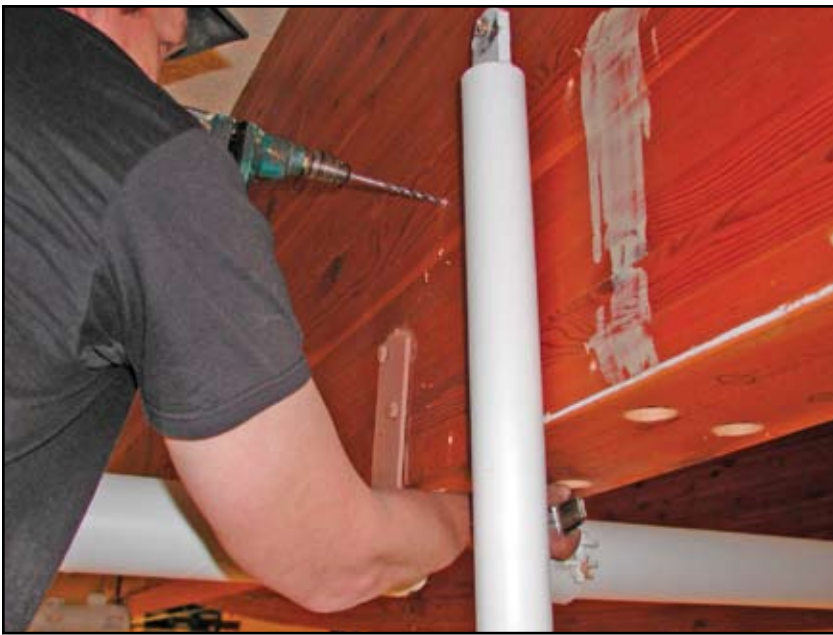
Figure 6: Drilling the injection and exhaust ports

4. Rebar is installed in the 1⅜-inch hole at the soffit and the hole is covered and sealed.
5. Epoxy is pumped into the lower port and pumping continues until epoxy spills out of the upper port. A third party inspector continuously inspects this process. In this case the owner hired an engineer from Gray Engineering to act as the inspector. To insure proper mixing and hardening of the epoxy, test samples are prepared consisting of shear dowels epoxied into glulam test blocks. These samples are sent to a testing laboratory where the dowels are tested in withdrawal to failure.

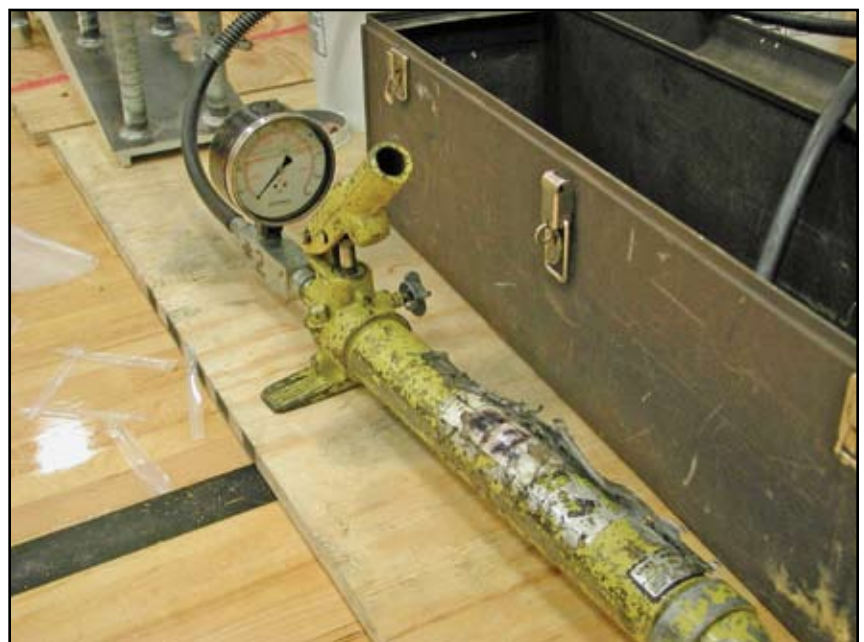
Figure 7: Calibrated Hydraulic jack

6. The cables are installed into the jacking assemblies and tensioned. This process begins with the innermost cables and continues outward. Five pairs of cables are required to supply the required negative moment and compression. Calibrated hydraulic jacks are used to apply tension to the cables. (Figure 7, page 14, and Figure 8)

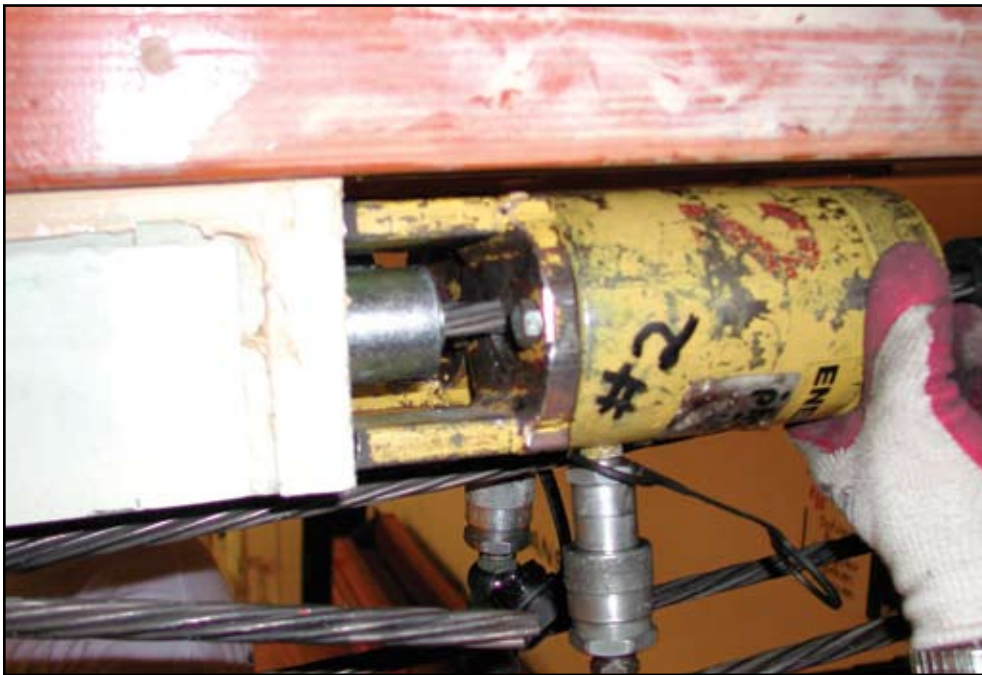
Figure 8: Head of hydraulic jack pulling on cable

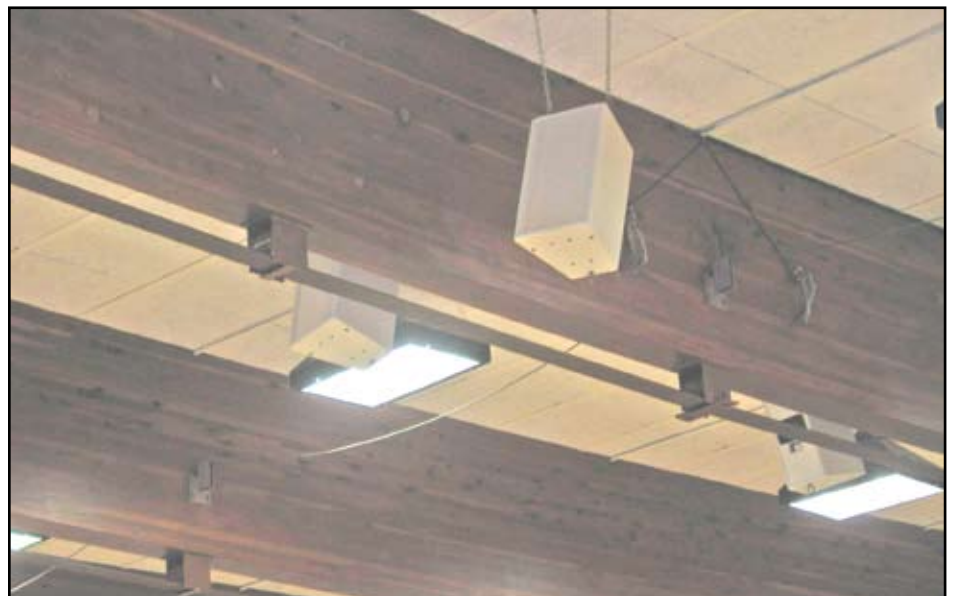
Completed repair/reinforcement of glulam girder beams

Installation of epoxy and rebar dowels, and post-tensioning using ½-inch ϕ high strength cables, to repair the failed glulam beam and reinforce others in the system provided an optimal solution. Post-tensioning has a proven track record, and even allowed for increased live load on the roof system. It also provided an aesthetically acceptable solution for the owner. Gym class is back in session at Tinora High School. ■
