Gas Station Canopy Failures

By Amir H. Farzaneh, P.E. and Vahid Louis Farzaneh, P.E.

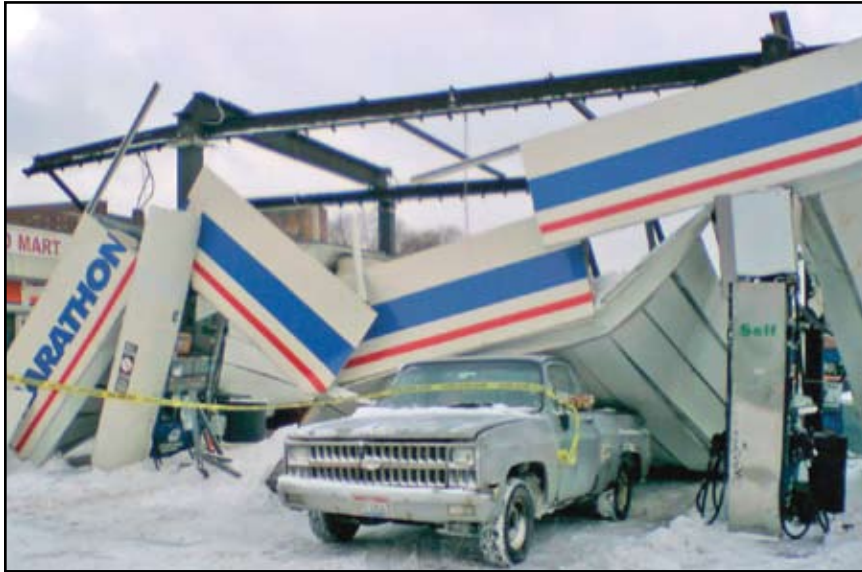
Snow related canopy failure in Cleveland Ohio during the winter of 2006/2007. Courtesy of WKYC.com.

In two cases of snow related canopy failures in Cleveland, Ohio, failure occurred due to detachment of cladding suspended from the framing. The first failure occurred after a prolonged period of freezing temperatures accompanied with high accumulation of snow fall. Weather records and measurements made by the authors indicate that the weight of accumulated snow did not reach the snow load design values required by local and national codes. The second failure occurred as soon as temperatures warmed above freezing, suggesting concentration of loading from ponded snow melt as the cause.

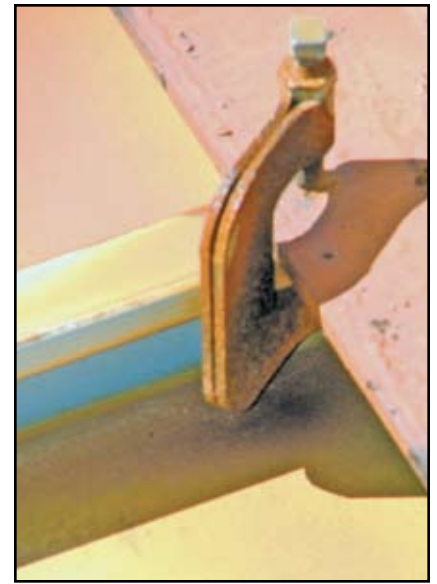
Light gauge metal cladding forms the canopy fascia and the soffit. The fascia displays the oil company's logo and colors. The soffit forms the canopy ceiling. For ease of construction, the soffit panels are suspended from the roof framing with clamps only. This type of fastening system is unsafe and has led to failures.

Clamp used to suspend ceiling panels from steel framing.

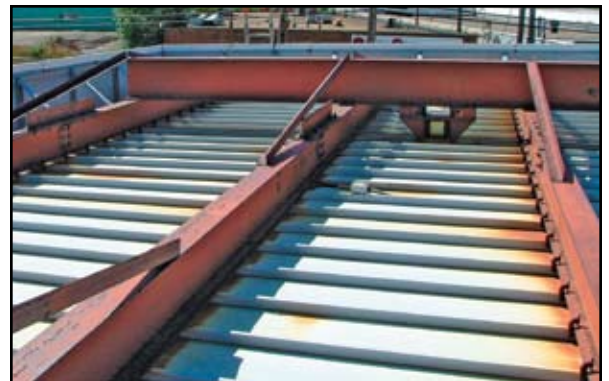
eter roof drains. The accumulation of debris and leaves, as well as trash thrown on the roof, can lead to partial or complete clogging of the roof drains. The fascia and the soffit form an open dish and support the full weight of snowfall.

The weight of accumulated ice and snow build up has resulted in cladding failures. Fascia and soffit panels have detached from the framing and fallen on cars, people, and equipment below.

Typical flat canopy framing, ceiling, and fascia panel construction.

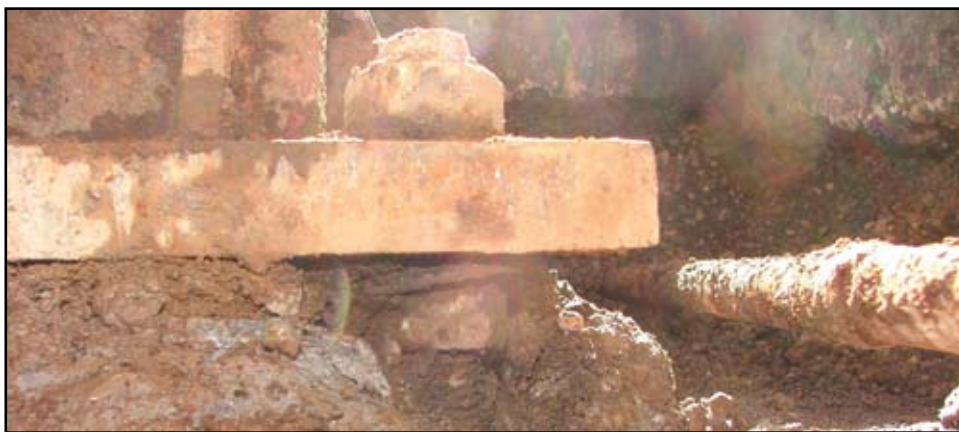
In one failure investigation in which wind speeds less than 50% of code requirements caused a two column canopy to lean, the culprits were found to be improperly designed and fabricated base plates, insufficient anchor bolts, and insufficient footing size. Occurrence of code specified wind load would have been a disaster. Imagine carrying an umbrella in a strong wind.

When drawings were reviewed as part of canopy failure investigation, the authors found that the framing design complied with the appropriate codes and standards. That is, with the exception of base plate and anchor bolt design which were found to be less than stellar.

Anchor bolts and washer are being pulled through oversized holes in the baseplate, causing the canopy to lean.

Steps required to reduce the likelihood of canopy failure include design and analysis by a competent structural engineer, preparation of detailed construction drawings and specifications for the superstructure, foundations, and connections, building in accordance with construction documents, and routine maintenance by the station owners.
