# Lessons Learned

## Structural Upgrade of Sutro Tower San Francisco, California

By: Ronald O. Hamburger, S.E.

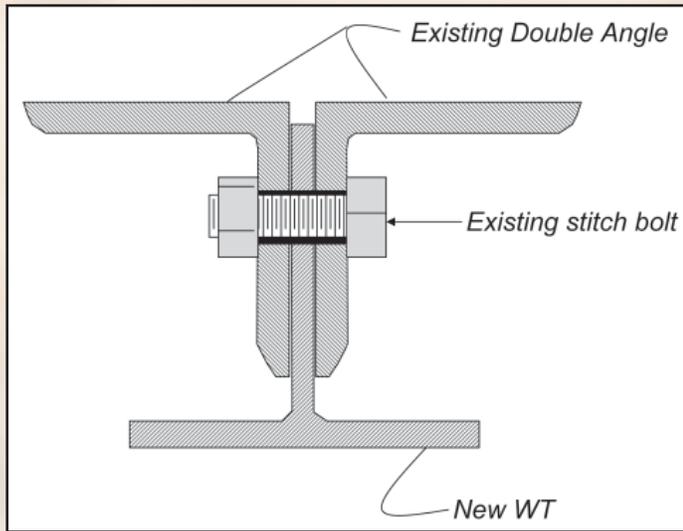
The deficient lacing members were more difficult to reinforce. These members generally had adequate tensile capacity but inadequate compressive capacity. Conventional strengthening of the lacing by replacing them with stronger section members, or reinforcing the section itself would have increased both the tensile and compressive load carrying capacity of these members. This, in turn, would have resulted in greater loads on other members in the tower, as it responded to ground shaking in an inelastic manner. Consequently, it was desired to find a way to increase the nonlinear compressive deformation capacity of the lacing members without increasing their tensile stiffness or strength. In some cases, this could be achieved by converting bays braced with single diagonals to double angle bracing, and in so doing, decreasing the slenderness of the braces without increasing their tensile capacity. However, due to the geometry of the tower and the presence of extensive

Figure 5: Cross section of retrofitted double angles.

cabling, wave guides and other equipment related to the broadcast transmission use of the tower, it was not possible in all cases. For these cases, the double angle braces were upgraded with the insertion of new WT members between the back-to-back legs. New WT reinforcement was connected to the double angles, using the bolts originally provided in the double angles for intermediate attachment, but using slotted holes in the new WT members, so that the stiffness of the reinforced section matched that of the original member. As illustrated in *Figure 5*, this resulted in a cross section that had the approximate appearance and slenderness properties of a wide-flange section, but the axial stiffness and tensile strength of the original double angles.

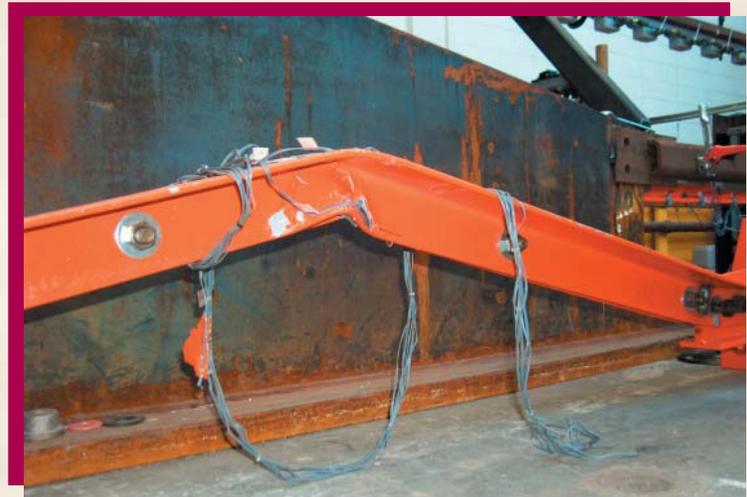
Unstrengthened specimens exhibited poor inelastic behavior with local buckling initiating at points of plastic hinging at mid-span (*Figure 6*), followed by fracturing. Fracture also occurred at plastic hinge locations at the ends of the braces (*Figure 7*). Strengthened braces, however, performed much better, avoiding local buckling (*Figure 8*) and displaying remarkably stable hysteretic behavior, both in tension and compression, validating the design approach.

Figure 6: Local buckling at mid-span of double angle brace in compression

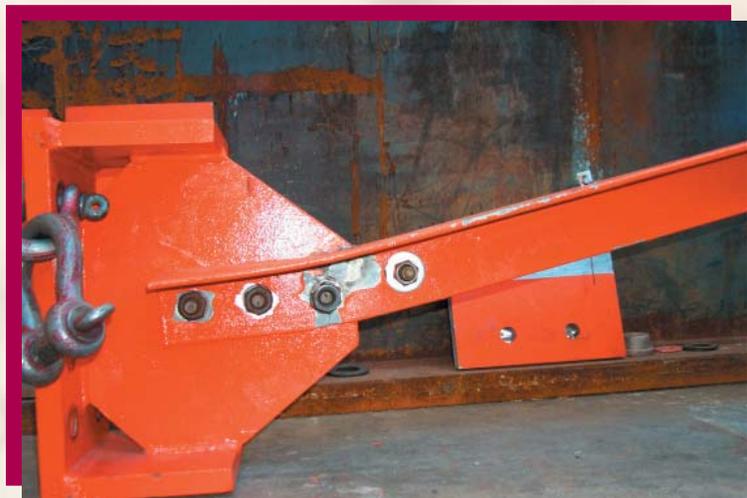
Figure 7: Fracturing of angle at point of plastic hinge development at brace end connection

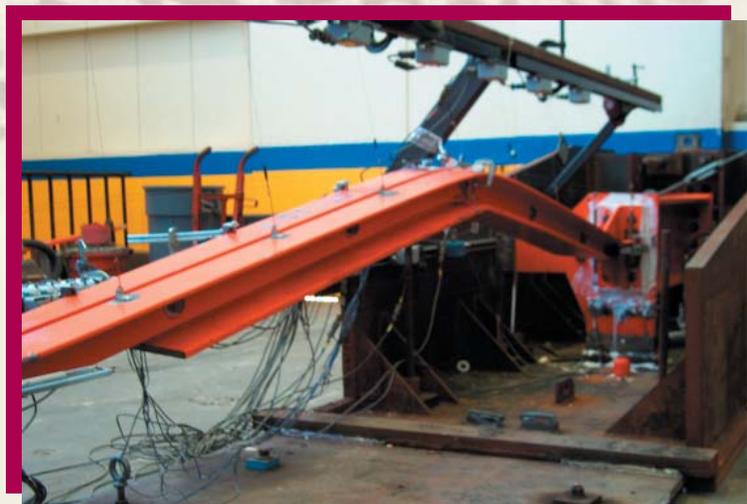
Figure 8: Buckling behavior of reinforced brace specimen
