Façade Woes... to WOW!

The Graphics Arts Building located at 25 Foster Street in Worcester, MA fell into a critical state of disrepair due to years of neglect, vacancy and poor early 20th century construction. A major construction project was undertaken to upgrade this aging building into a state-of-the-art multi-use educational facility when it was purchased by the Massachusetts College of Pharmacy and Health Sciences (MCPHS). Established in 1823, MCPHS has one of its three campuses located in the City of Worcester, Massachusetts. A growing student body numbering nearly 3400 had placed a severe strain on the college facilities. To address this situation, the college has invested nearly \$100 million dollars in its physical plant since 1997. The development of this property, renamed the Living and Learning Center, completed this phase of the Worcester campus development.

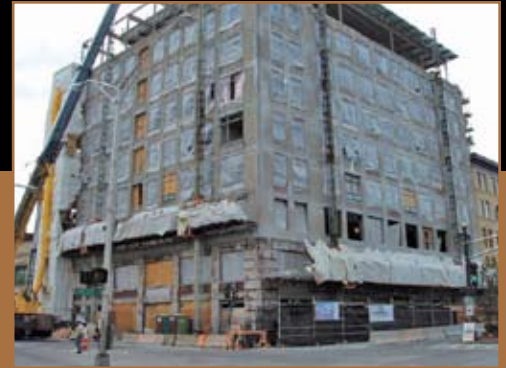
Figure 1: The North and East elevations with the extent of the façade repairs.

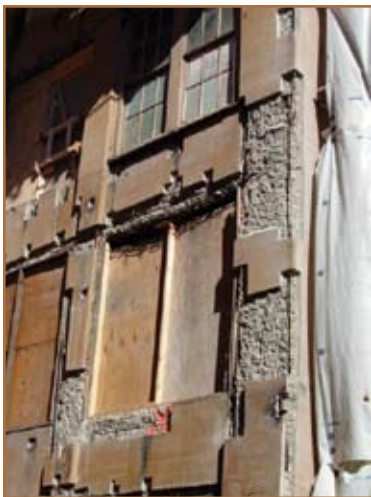
Figure 2: Close up view of the prepared concrete in the South elevation. Removal depths of three inches were commonplace.

Spalled concrete repairs consisted of the contractor providing a minimum surface preparation in conformance to the International Concrete Repair Institute guideline of a minimum of a Concrete Surface Profile of a CSP-6. A CSP-6 represents a broken aggregate with a concrete profile of +/- 1/8 inch. This was accomplished by saw-cutting the spall perimeter using hand held grinders with diamond blades, and chipping hammers using both spade and bush hammer heads. During this process, the reinforcing steel was examined. The contractor’s mechanics followed American Concrete Institutes (ACI) guidelines by preparing the reinforcing steel back to a clean condition if 25 percent or less of the steel was exposed. When more than 25 percent was exposed, the crew took care to remove concrete behind the rebar to a minimum of 3/4 inch. Where loss of steel was a factor, additional mild steel was attached to replace what was lost, under the direction of the engineer.

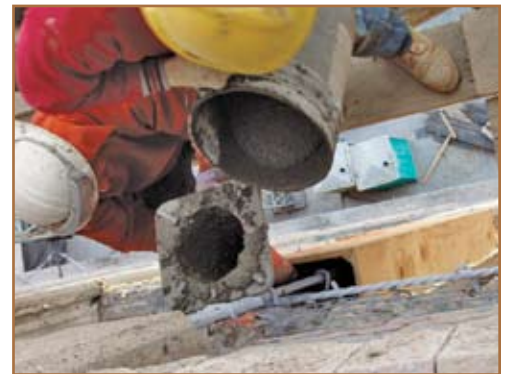
Figure 3: Workers placing the cementitious repair mortar via form and pour methodology into a sealed plywood form.

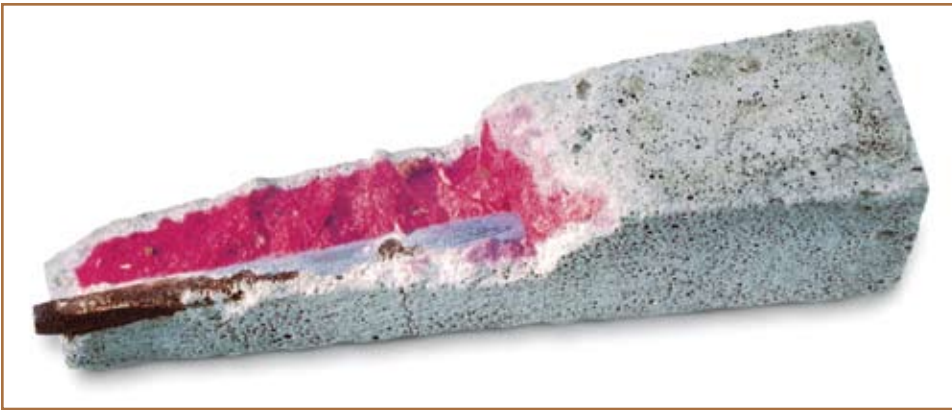
alkaline environments and creates a bright pink reaction. Carbonated concrete does not react with the chemical (*Figure 4*). Results for this building confirmed the presence of the “carbonation front” to an average depth of 15 millimeters (0.6 inches).

The carbonation effect will also take the path of least resistance, allowing it to migrate deeper into cracks in the concrete. Permeable concrete from poor consolidation, improper curing and improperly placed reinforcing steel, as well as concrete with surface defects and cracks, is most susceptible to carbonation. Field testing of this building confirmed carbonation contamination to a depth of nearly 80 millimeters (over 3 inches) in some locations.

Figure 4: Photo showing the chemical reaction of phenolphthalein with an alkaline environment and it clearly identifies the presence of a “carbonation front”.

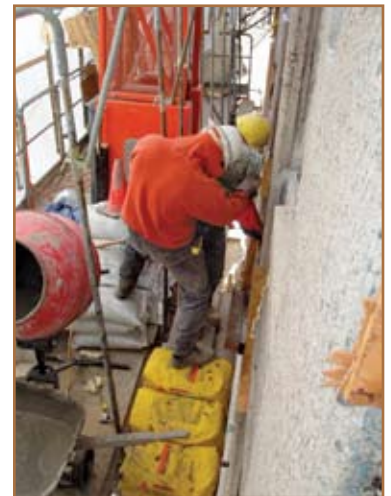
Figure 5: Contractors set up including repair mortar, bagged stone, electric mixer and wheelbarrow.

polymer-modified, silica-fume enhanced product (*Figure 5*). This selection was based on density, flexural values, bonding characteristics and ease of placement. Vibration was critical in the placement of this mortar to ensure all voids were filled, and to eliminate void and bugholes in the final product. In the larger forms, to provide a void free finish, the contractor used a combination of rebar’s to tamp in the mortar and hammers to tap the formwork.

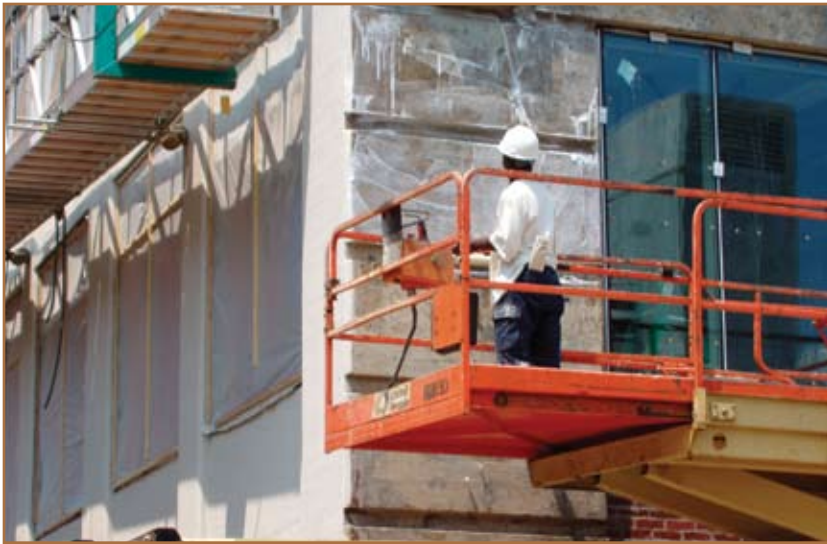
Figure 6: Contractor placing the SACI to the façade via a pump sprayer.

In order to provide protection against latent corrosion to untreated concrete areas with existing reinforcing steel, the engineer elected to use a surface applied amino-alcohol corrosion inhibiting treatment (SACI) as part of the overall rehabilitation plan. Surface preparation prior to the application of this treatment consisted of a high pressure water blast to remove any surface laitance, atmospheric and biologic soiling and any loose, flaky or friable concrete. The concrete was allowed to dry for 24 hours before proceeding with the application. The application of the treatment called for two saturating coats applied at a loading rate of 200 square feet per gallon per coat. One hour transpired between coats to allow for complete penetration of the treatment before the subsequent coat was applied (Figure 6). After drying overnight, the surface was rinsed to remove a surfactant residue from the SACI that forms after the treatment is absorbed into the concrete. This surfactant (soap residue) is used to prevent premature drying of the treatment and to aid in the penetration of the SACI into the concrete. In addition, it facilitates the absorption of the SACI through its liquid and vapor phase into the concrete's capillaries. Testing of the SACI confirmed penetration to a depth of 80 millimeters (3.2 inches) after 28 days. The selected treatment migrates through the concrete capillaries and re-passivates reinforcing steel in carbonated and chloride contaminated environments. It is effective in chloride contaminated environments with up to six to ten pounds per cubic yard of concrete. The inhibitor achieves this by bonding to the surface of the steel, displacing chloride ions and forming a protective layer on the steel surface. This treatment effectively reduces active corrosion on the surface of the reinforcing steel by a minimum of 65% compared to the untreated concrete and reinforcing steel. Performance testing of the amino-alcohol based corrosion inhibitor (AACI) has been proven utilizing a linear polarization resistance measurement (LPRM) technique. Embedded remote monitoring probes and sensors can be incorporated into the overall scope of the project to provide the owner with an on-going corrosion rate and corrosion potential monitoring system, if desired.

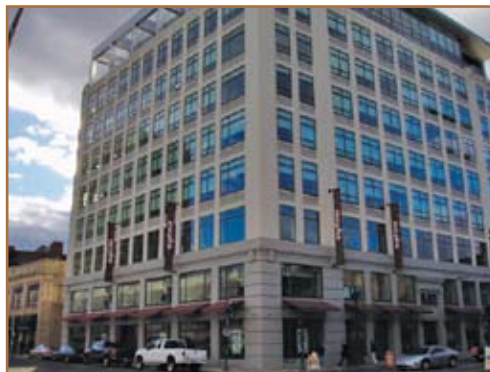
Figure 7: North and East elevations of the finished project.

To provide an aesthetically uniform façade and to halt the progress of the "carbonation front", the architect chose to incorporate an anti-carbonation coating. The coating selected was a state-of-the-art, water-based, elastomeric anti-carbonation façade coating. It provides protection to the underlying concrete from environmental attacks such as ultraviolet light degradation, atmospheric staining, biologic soiling, freeze-thaw cycling and carbonation induced corrosion. The coating chosen incorporates low-temperature crack bridging capabilities down to -20 degrees (F). In order to provide the best methodology to blend the new repair mortars into the existing weathered concrete that remained in place, the architect utilized a textured base coat followed by a smooth top coat. Two standard colors were chosen to provide accent and punch as the final façade finish (Figure 7).
