St. Mark's Church

Historic Restoration By Mark K. Howell and Tim Crawford

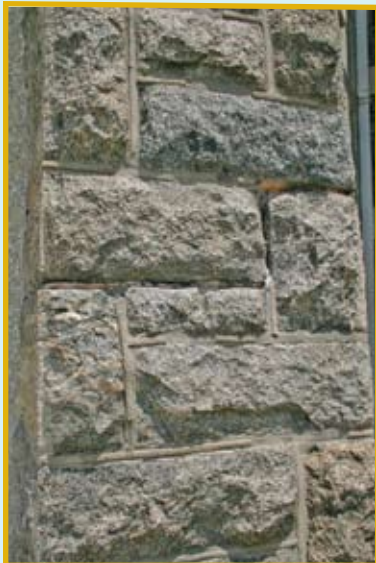
the inspection identified a need for a great deal of tuck pointing on the masonry (Figure 1). Repairs also were needed for certain portions of the woodwork (Figure 2), and significant patching was necessary for the limestone (Figure 3). The contractor determined that there was much more deterioration in the mortar joints and the ornamental stucco repair work than originally scoped, whereas the blue stone for the coping was not as deteriorated as initially thought. The good news, however, was that the contractor determined that the deterioration was caused by age. No defects in materials were recognized; rather, it was simply an old building that had not been recently maintained.

Figure 1: The inspection identified a need for a great deal of tuck pointing on the masonry.

Several mortar samples were made in order to find the right color mix for the deteriorated mortar ribbon joints and the random joints needing re-pointing (Figure 7). Ribbon joints have a 3-D profile, consisting of an elevated bead of mortar out of plane with the surrounding mortar joint. It appears basically as the reverse of a grapevine joint. After placing samples on the wall and evaluating color after a week of drying, the contractor selected a high-grade mortar material (Jahn M110 Historic Pointing Mortar) made specifically for restoration applications to replace the original lime-sand-cement mortar mix.

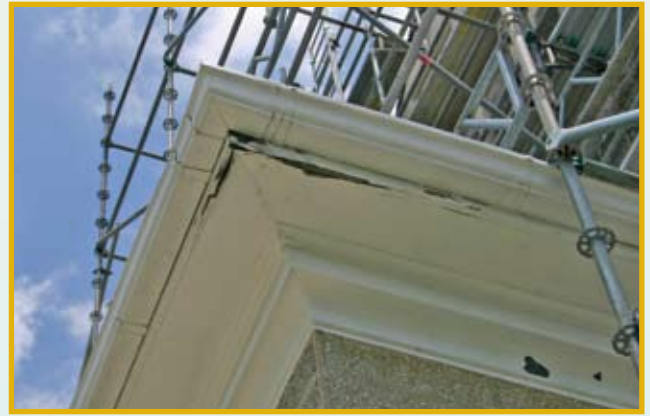
Figure 2: Repairs were also needed for certain portions of the woodwork.

Another repair area involved the wooden trim and details, including doors and soffits, which had rotted in various locations. New wood was installed in those areas, and the wood in all of the locations was coated with an industrial-grade exterior paint (Figure 8). The contractor also

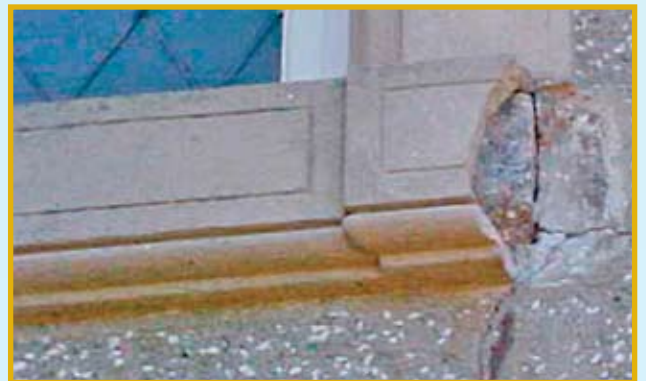
Figure 3: Significant patching was necessary for the limestone.

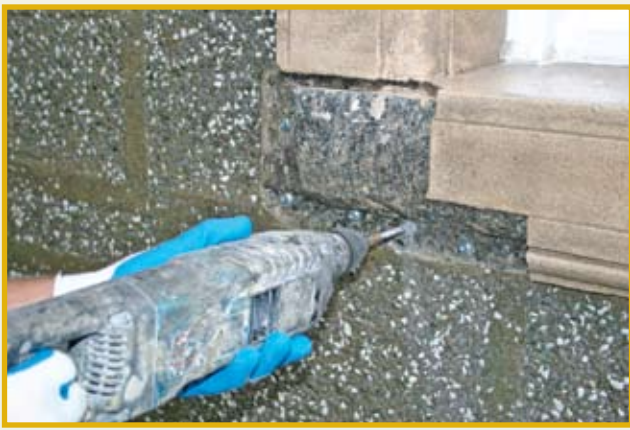
Figure 4: Deteriorated and spalling areas were removed and replaced.

anchors in the substrate, apply mortar, carve ornamental details and stain the stucco to blend all existing sections with the new repair areas (Figure 4). This process is not pointing, but rather replacement of a detailed stucco finish. It was partial in that only deteriorated and spalling areas were removed and replaced.

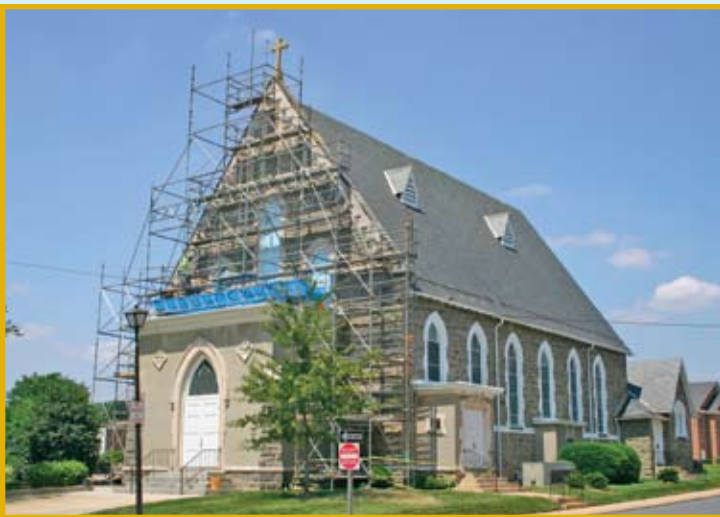
Figure 5: Scaffolding was erected at the main entrance to the church in a manner that still allowed access to the structure during the work week

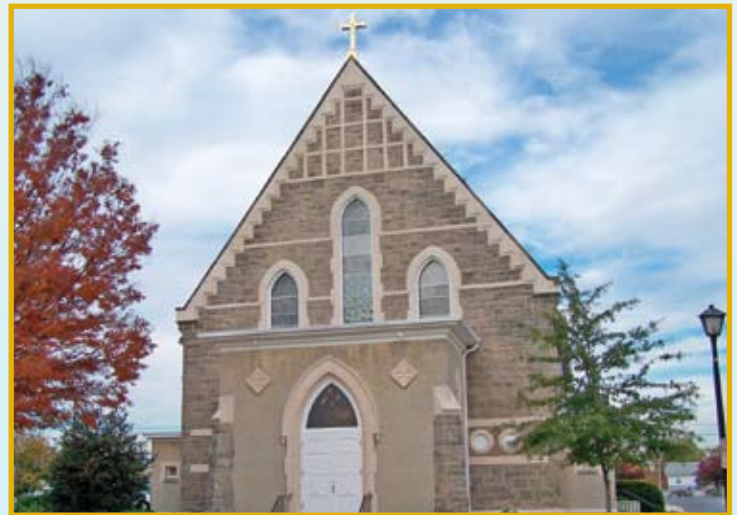
Figure 9: The restored St. Mark's Church
