Old Masonry Schools

Garbage or Gold?

By Ronald G. Vandehey, P.E.

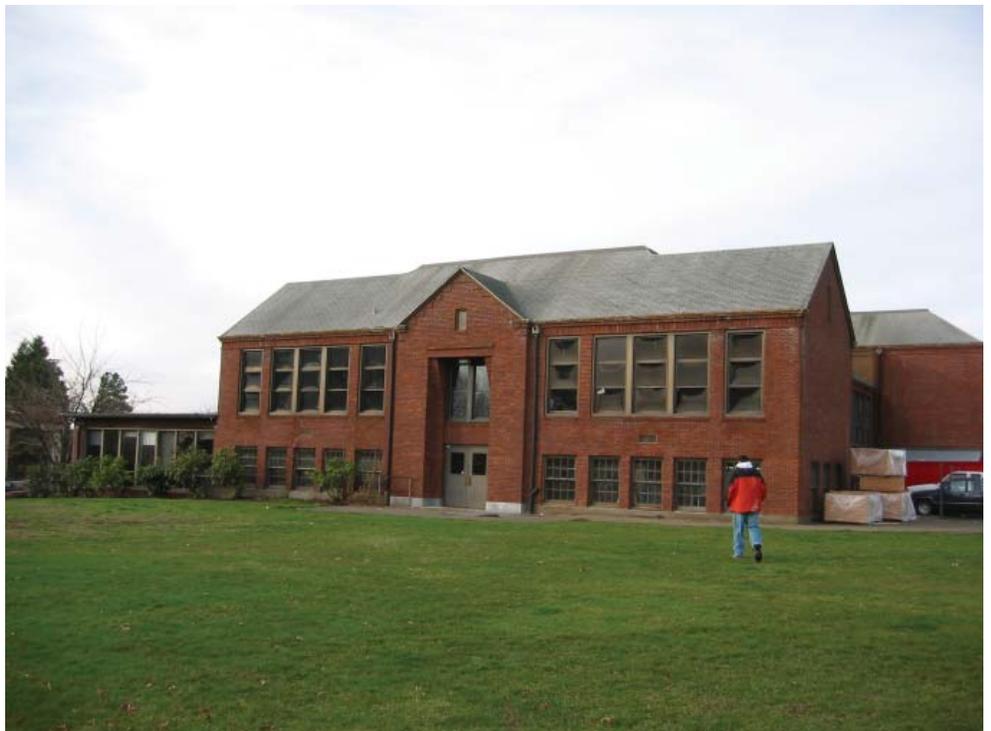
Central Elementary School Newberg, Oregon

A seismic study was conducted to determine the requirements to bring the Central Elementary School to the level of the State of Oregon 1993 Structural Specialty Code standards, which were based on the 1991 Uniform Building Code. Originally constructed in 1935, with additions in 1958, the school totalled over 37,000 square feet. The Central Elementary structure was inadequate to resist seismic loads due to unreinforced clay tile walls and inadequate ties between the floors and the walls. Without an elevator to meet ADA standards, outdated mechanical, electrical and classrooms, the school district built a new school and sold the building to the Parks and Recreation District for \$1.00. Unable to cost effectively renovate the building without the seismic upgrade, the building remained vacant for nearly 10 years.

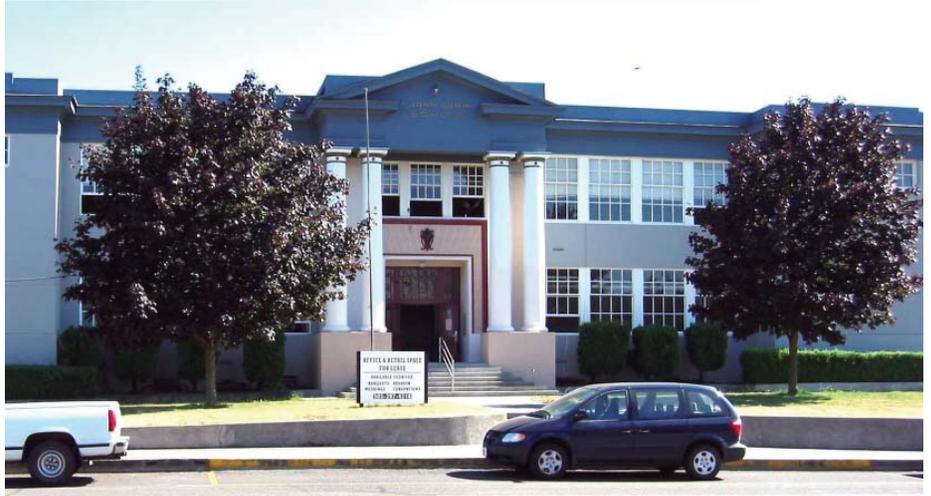
John Gumm School Seismic Upgrade St. Helens, Oregon

Constructed in 1919, the John Gumm School is a three-story building with wood framed floors and roof. The lower floor's basement exterior walls are concrete, and the upper two floors are clay tile bearing walls. The parapets are an assortment of clay tile and wood studs. The original price to upgrade the building using conventional methods was estimated at over 2.5 million dollars. Equating to a cost of over \$70 a square foot, it was impractical for the school district to keep the building and a hard to sell the property. After the school district put the building up for sale, many groups tried to purchase the property but withdrew due to the expense of upgrading. The building was eventually sold to the Old School Group for nearly the price of the land.

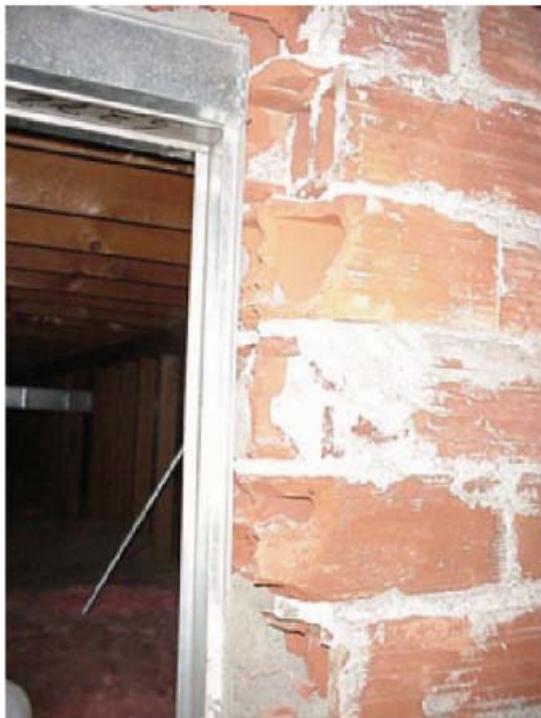
Figure 1: Typical Clay Tile

As shown in *Figure 1*, the cells in hollow clay tile run horizontally without steel reinforcement. Typically, the walls span from floor to floor and the only tie between the blocks is the mortar that binds them. For Central Elementary School, the exterior walls also supported the exterior brick veneer, and the wall had little capacity to resist out-of-plane seismic loads.

Hollow clay tile units are brittle and subject to shattering. Unreinforced masonry units may have cracks, loose blocks, or mortar failure. Door openings are usually weak due to support at the head and inadequate framing at the sides. Spaces at the sides and top of the wall to provide for interaction of the structural system and support angels are often not supported.
