## The Road to Resiliency

### 2014 South Napa Earthquake Retrospective

By Scott Adan, Ph.D., P.E., S.E., SECB

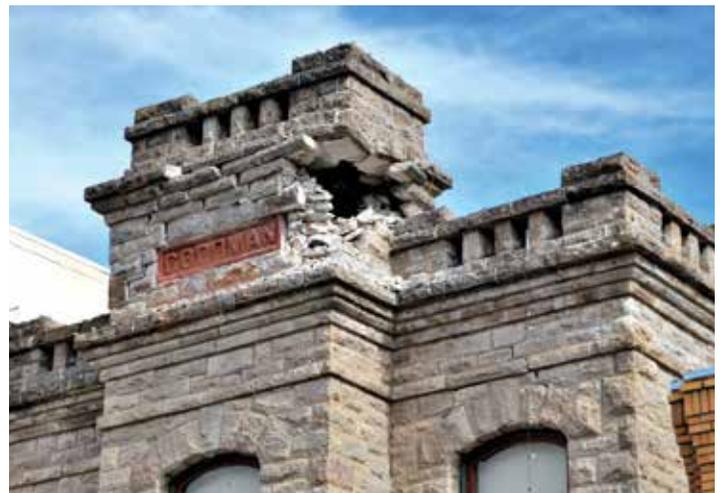
During the earthquake, as shown in *Figure 1*, the building's turret was significantly cracked and damaged. Also, it was reported that excessive outward movement and damage occurred at all four building corners. The building was posted "Unsafe."

Figure 1. Goodman Library turret and front façade damage.

After the damage, the building was targeted for repair and restoration. California's State Mitigation Assessment Review Team (SMART) in collaboration with the Office of Emergency Services (Cal OES) conducted an assessment of the retrofit and damage.

In the interim, the building has been fitted with temporary scaffolding on the north, south, and west sides. Additionally, at the time of the EPEP follow-up survey,

the building's placard had been revised to "Restricted Use" to allow access for repairs. Repair work began this spring.

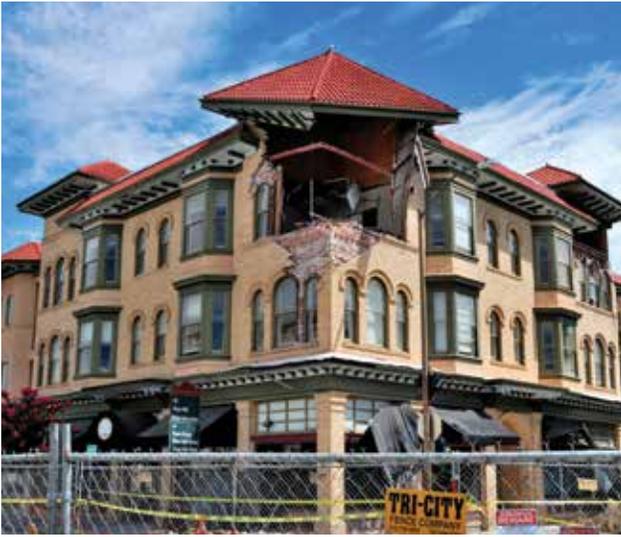
Figure 2. Alexandria Square following the 2014 South Napa earthquake.

During the earthquake, as shown in Figure 2, a portion of the third-story cupola collapsed onto the sidewalk below. At these high cupola locations, steel strongbacks were anchored to the walls. However, as shown in Figure 3, the anchorage and

At the time of the EPEP follow-up survey, the building was essentially restored and rebuilt. Alexandria Square officially reopened in June of 2016. Reportedly, repair costs exceeded \$1 million.

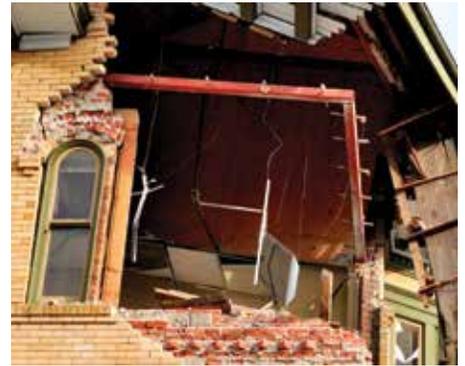
strongback bracing was ineffective at this level. Other portions of the building were relatively undamaged. The building was initially posted "Unsafe." However, shortly after the earthquake, the less heavily damaged portions of the building were reopened, and the placard re-posted to "Restricted Use." Subsequently, the building was immediately targeted for repairs and restoration.

Figure 3. Ineffective steel strongback bracing in the third-story cupola at Alexandria Square.

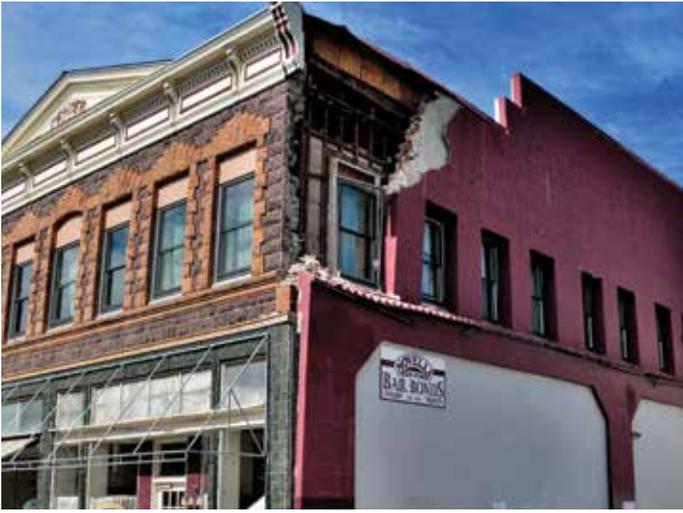
Figure 4. Napa Law Center following the 2014 South Napa earthquake.

Built in 1904, the Napa Law Center Building is a two-story, unreinforced brick masonry building. Prior to the earthquake, the building's owner had been considering a retrofit as mandated by the city (*Napa Municipal Code*). However, at the time of the earthquake, no retrofit upgrades were constructed. During the earthquake, a portion of the second story south wall separated from the roof diaphragm and collapsed onto a car in the adjacent parking lot (*Figure 4*). Immediately following the earthquake, the instabilities associated with the URM walls forced the temporary closure of neighboring businesses. The building was posted "Unsafe." Following the erection of wooden protection barriers, the surrounding buildings were re-posted "Inspected."

In subsequent dealings with city officials, the building's owner was permitted to remove the front façade and redevelop the site. The plan is to number and inventory the stone blocks and then reuse the façade as part of a new five-story reconstruction on the same site. At the time of the EPEP follow-up survey, the reconstruction process was progressing.

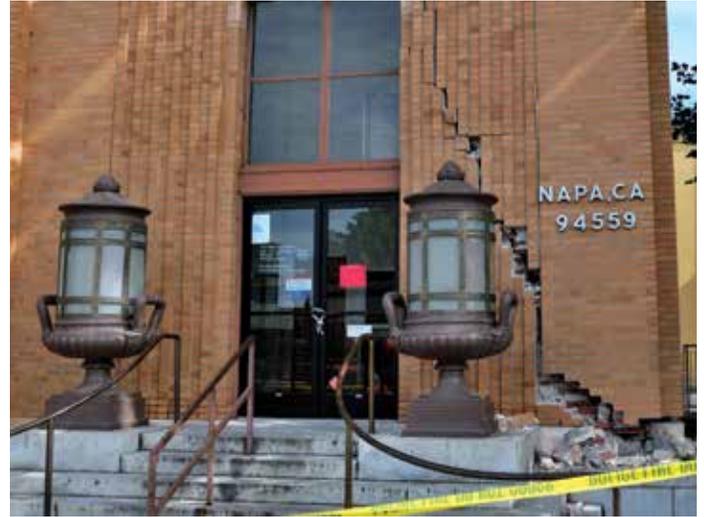
Figure 5. USPS Napa Franklin Station following the 2014 South Napa earthquake.

shown in *Figure 5*, during the earthquake, the massive brick masonry piers on both ends of the building ruptured and shifted laterally. The large inclined cracks exposed damage to the underlying steel frame columns. A number of the building's windows were also damaged. The building was posted "Unsafe."

Following the earthquake, temporary bracing was constructed around the damaged exterior piers, windows were boarded up, and the location has since remained closed. In July of 2015, the USPS proposed demolishing the building. The agency estimated that quake repairs would cost \$8 million, while demolition would cost only \$500,000. Following a public outcry, the agency decided to place the building on the market. It was reported in March 2017 that a local developer and broker purchased the property for \$2 million, with the intention of restoring it into a boutique hotel with a possible residential component.

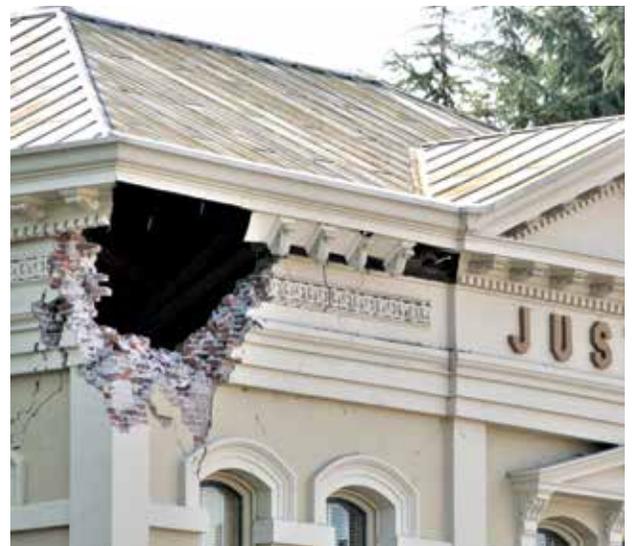
During the earthquake, the building's URM façade sustained significant damage (*Figure 6*). Diagonal cracking

occurred through many of the window spandrels and, at the southeast corner, a portion of the façade collapsed. The building was posted "Unsafe" and has since remained closed.

Figure 6. Napa County Superior Court building following the 2014 South Napa earthquake.

Temporary bracing and a moisture barrier were constructed around the building's exterior. After the damage, the building was targeted for a significant repair and restoration effort. The Federal Emergency Management Agency (FEMA) has tentatively agreed to pay more than \$500,000 toward the \$635,000 building's earthquake insurance deductible. The Napa County Board of Supervisors approved a \$3.3 million contract to design and manage the restoration project. This is in addition to the previous \$2.4 million contract to assess and stabilize the damaged building. Some of the walls are so severely damaged they are slated to be disassembled and reassembled, brick-by-brick. The repair work is scheduled to be complete in July of 2018.

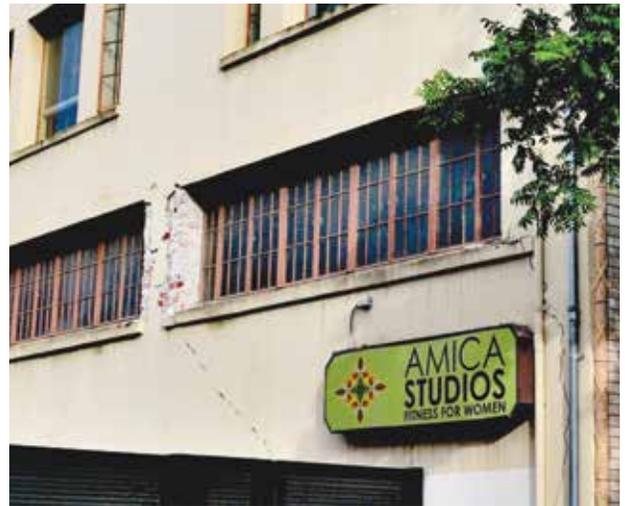
Built in 1928, the Gordon Building is a two-story unreinforced brick masonry structure. The building has not been retrofitted. During the earthquake, the building's rear brick masonry bearing wall sustained significant damage (Figure 7). Diagonal cracking occurred through the supporting brick piers and lower wall. Horizontal cracking occurred at the base of the roof parapet wall and above several of the window spandrels. The building was posted "Unsafe" and has since remained closed. Temporary vertical bracing, parapet bracing, and tension anchors at diaphragm-to-wall connections were constructed to stabilize the structure.

The scanning investigation concluded that the earthquake motions expanded areas of previously known weaknesses and also created new ones. However, at the time of this writing, there were no known further investigation or restoration plans associated with returning the building to operational status.

Figure 7. Two-story Gordon Building following the 2014 South Napa earthquake.
