STRUCTURAL PRACTICES

Observing Deficient Façade Repairs

By Dan Eschenasy, P.E.,
SECB, FSEI

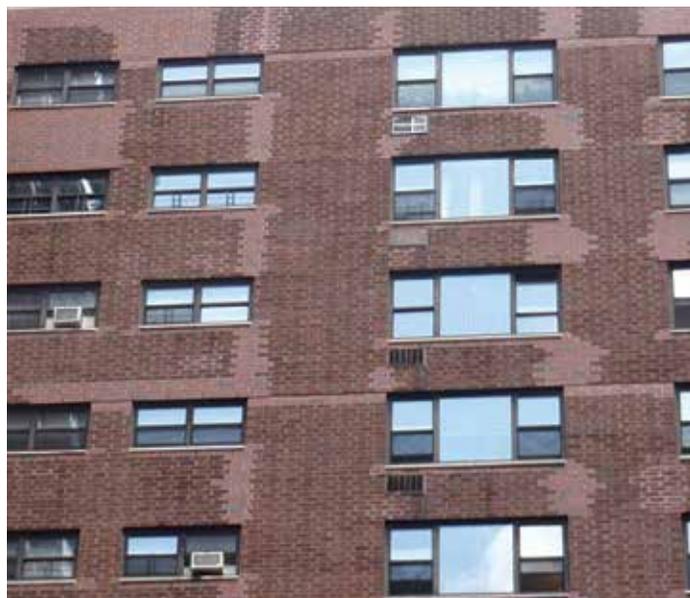
Figure 1. Cavity wall from the early 1960s. Different brick colors indicate various repair campaigns.

Around the 1950s, cavity walls started to replace transitional envelopes in high-rise buildings. The idea of the cavity wall was derived from hollow wall systems, a solution that had proven successful over time. Following some positive fire and structural tests near the end of the 1950s, most local codes permitted such construction types. The first generation lacked sufficient joints in the face brick. It took almost twenty years to understand the serious problems posed by the thermal expansion of the face brick or by the water evacuation from the cavity. Almost all façades built during that period had to undergo a major retrofit that included cutting joints and adding or reconstructing flashing (Figure 1).

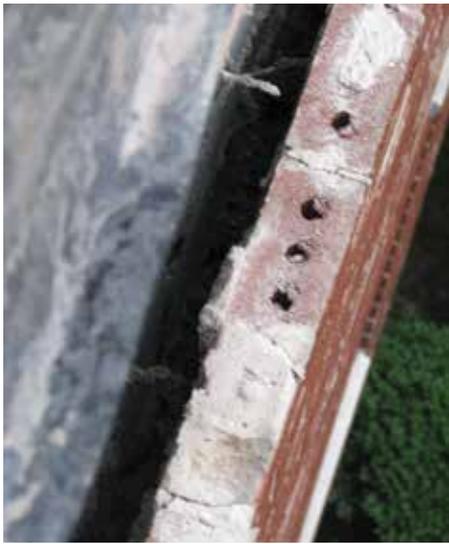
Figure 2. Cavity brick face collapse. The corroded tie does not engage the face brick anymore.

Several recent collapses of face brick have revealed the lack of sufficient metal ties anchoring the brick veneer. Missing or corroded ties created problems and had been reported by forensic engineers since the 1990s, but they were considered rare or unique cases (Figure 2). Because this type of deficiency had not been identified as specific to the first generation cavity walls, remedy efforts may have been limited. Several recent accidents and pressure from the New York City Department of Buildings (NYC DOB) should result in a retrofit campaign to identify and repair this type of defect.

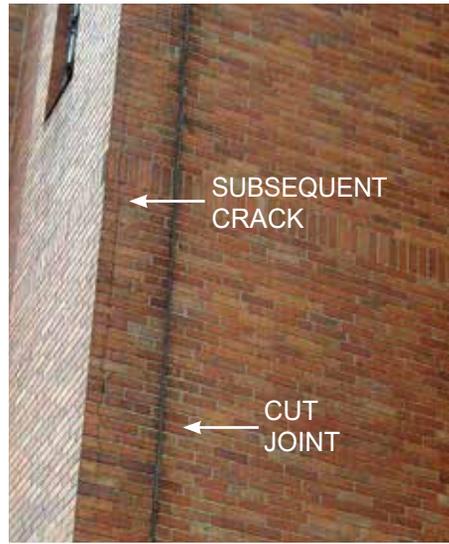
Figure 3. Ineffective repair. The vertical joint was cut without cleaning steel – a new crack appeared.

Engineers and architects that entered the field as a result of the local law had few resources from which to gain specialized knowledge. With a lack of better solutions, they adopted and extended to other types of façades the use of joints as a repair method. This might have been a period of over-reliance on joint cutting solutions. Cases exist where façades had horizontal expansion joints cut along steel spandrels or the building's corners

(Figure 3). In contrast to the jagged cracks that form randomly and that may lead to pieces of brickwork falling, a joint is, in essence, a man-made crack that can be managed. Of course, the technology of joint caulking is far from perfect, and a joint itself might become a source of water penetration. However, cutting joints in the outside wythe of cavity walls proved to be an effective solution for releasing the stresses produced by restraints on the tendency of the face brick to move.

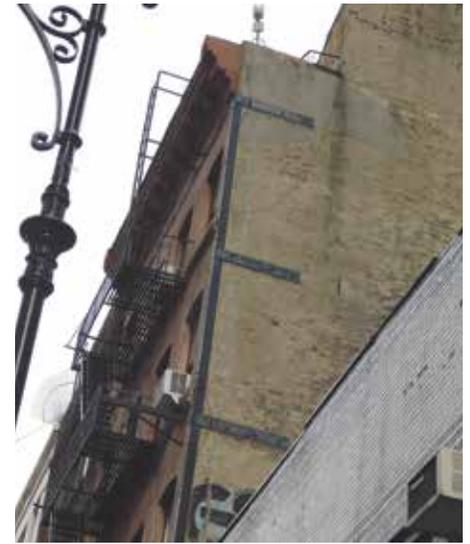
Figure 4. Bearing masonry corner repair.

immediate restoration of continuity. The most common solution uses steel plates anchored into the intersecting walls. This solution is not expensive but is liable to fail (Figure 4, page 27). The proper repair should entail reconstruction of the masonry at the corner.

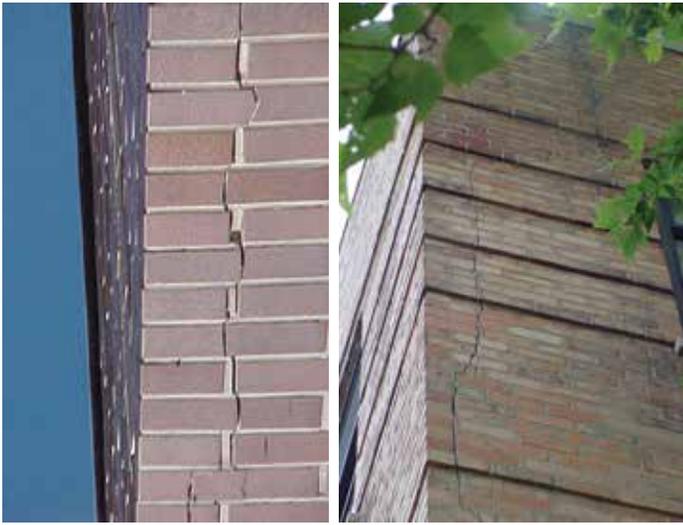
Figure 5. Typical corner crack. Cavity wall (left); Transitional façade (right).

Vertical cracks around building corners represent a typical distress of transitional façades (Figure 5). They have occurred in many different face materials: brick, terracotta, and even stone. In the case of brick faced buildings, long vertical cracks rarely occur at other locations. Masonry cracks at corners of skeleton construction do not necessarily affect the structural stability of the building but might constitute a danger to pedestrians.

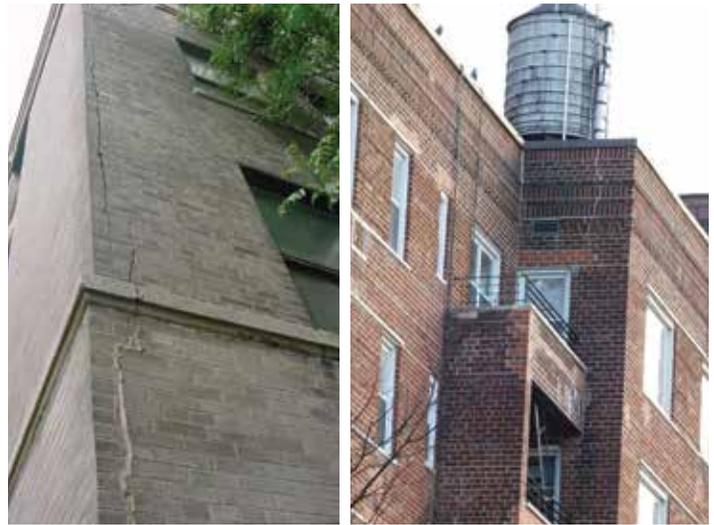
Figure 6. Ineffective crack repairs at corners. Elastic compound fill (left); Mortar fill (right).

The first method that was used for crack repair involved plugging the cracks, with mortar (Figure 6). This avoided the danger of brick separating and falling, and reduced the rate of water penetration. However, the

cracks started to open again. Placing elastic compounds in the crack was not more effective. These solutions did nothing to arrest the corrosion of the underlying steel.

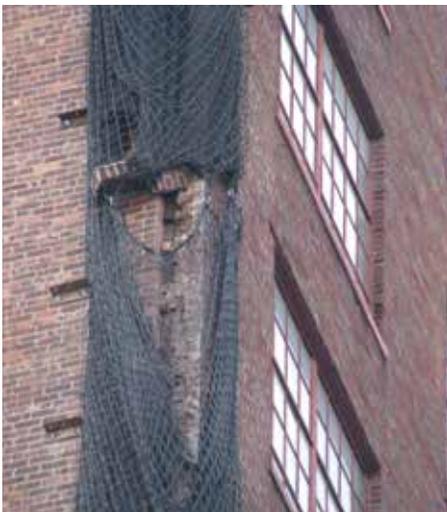
These new joints served the intent to avoid the damaging combination of movement of the perpendicular fronts, but they severed the horizontal continuity of the masonry. Collapses occurred in cases when the repair did not include anchoring the new vertical corner stack to the steel (Figure 7). On the positive side, joints on both sides of the corner allowed the new brick to expand when exposed to the weather, without being restrained by the old masonry that had already exhausted its ceramic expansion.

Figure 7. Collapse at corner. Masonry fill along cut joints.

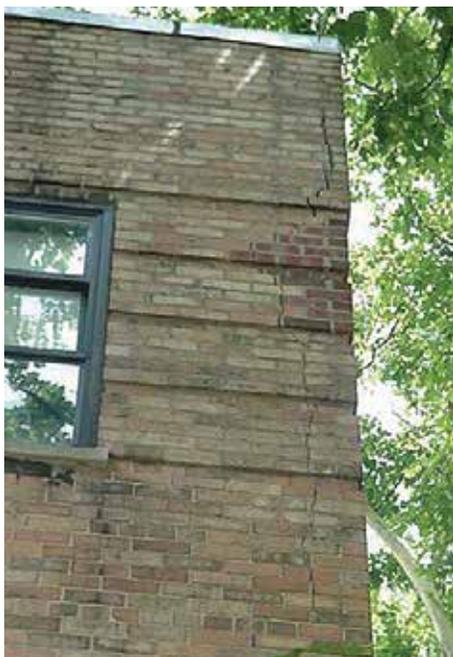
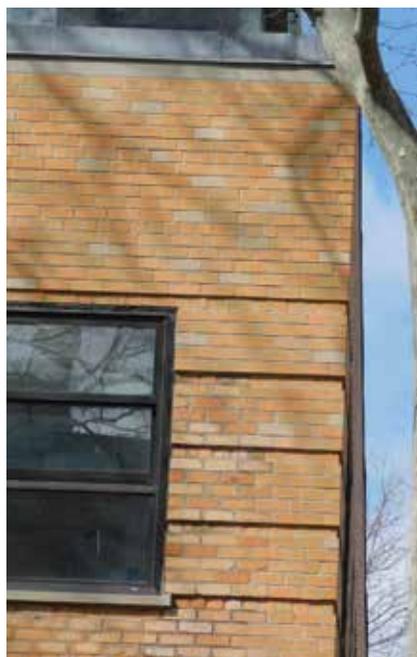
Figure 8. Corner repair without cut joints – before and after.

In 2001, the author designed the repair of a 1940 transitional façade that displayed severe cracks, especially at its exterior corners. The design involved removing sufficient bricks to allow the cleaning and rustproofing of the corner steel columns. The removed bricks were replaced with new bricks bonded to the remaining bricks. After 15 years, no cracks can be observed around the corner (Figure 8).
