## The Existing Bridge

## The Existing Conditions

## Repair Design

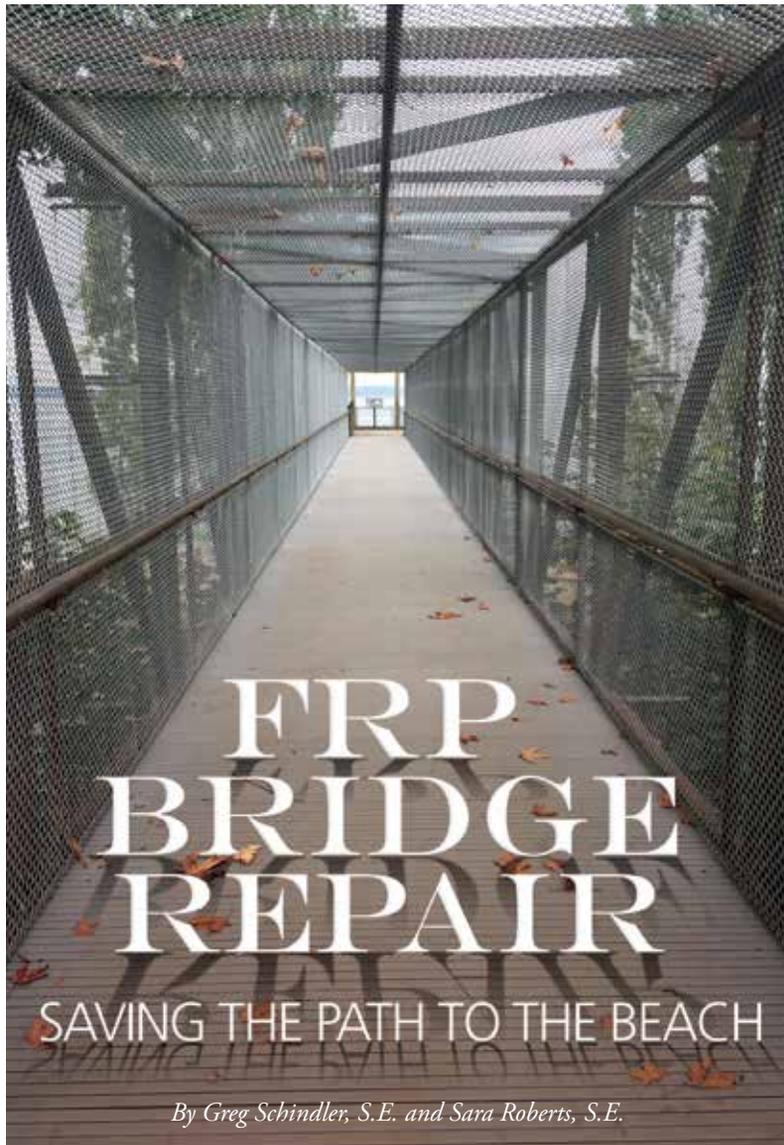
Bridge walkway with new FRP decking.

Several types of decking were investigated as options to replace the timbers, and it was determined that Fiberglass Reinforced Plastic (FRP) T-bar pultruded grating would provide the best alternative as it is weather resistant, non-corroding, and lightweight. The open cross-section allows unrestricted air flow to the steel truss members. Initially, the repair design intended to replace the corroded stringers with new weathering steel HSS sections. During discussions with the FRP grating supplier, Fibergrate Composite Structures, it became apparent that a better long-term solution would be to use FRP structural members for the stringers. The three HSS 4x3 deck stringers were replaced with four stringers of 6-inch by 3/8-inch double FRP C-shapes, also provided by Fibergrate. New weathering steel tabs were

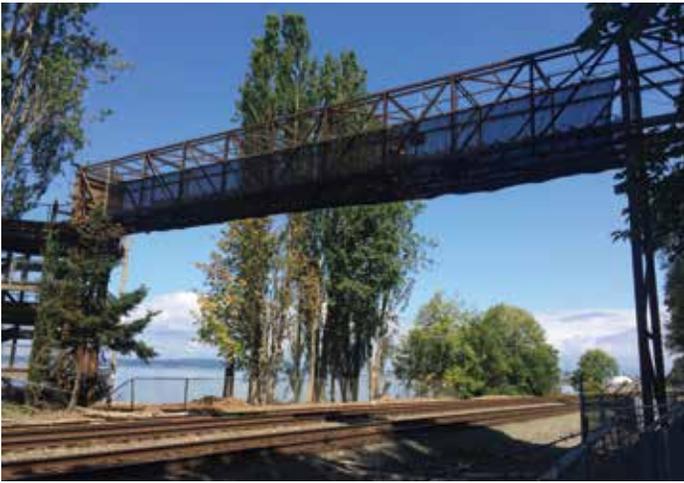
*Bridge during repair.*

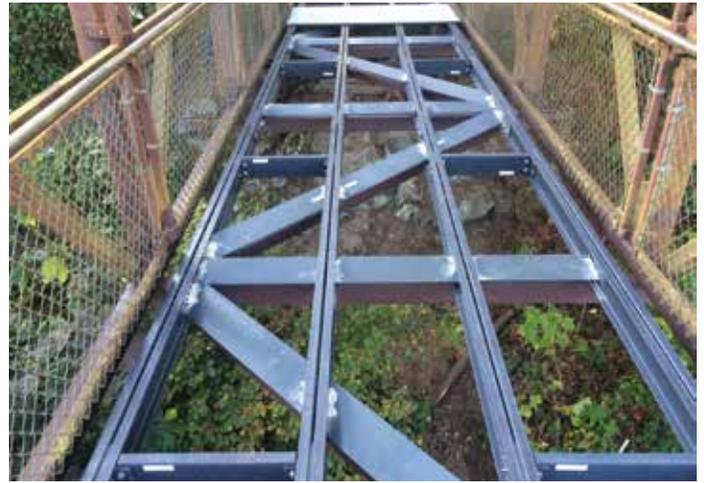
*New FRP deck framing.*

welded to the tops of the existing cross beams and the FRP C's were bolted to these.

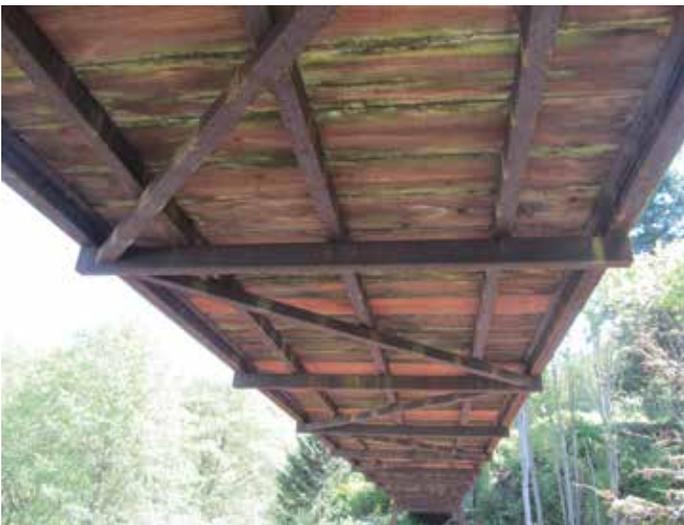
*View from below – before.*

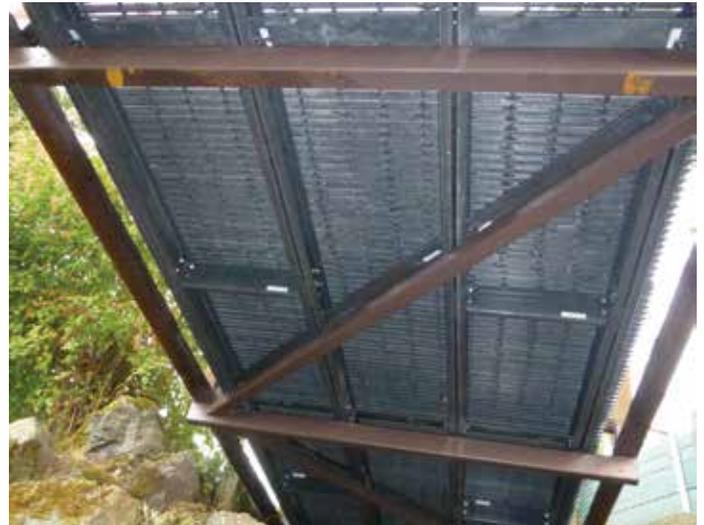
*View from below – after.*

The chosen FRP decking has a T section with small spaces at the walking surface. This shape is often used near pools and other places where people walk barefoot. It was chosen for the Howarth Park project to minimize the possibility of pedestrians dropping small items through the cracks onto the active railroad lines below. Also, to minimize the buildup of sand on the remaining steel cross beams and diagonals below the deck, flat sheets of 1/4-inch FRP were installed above those members as sloped "sand shields" to shed the sand that falls through the grating.

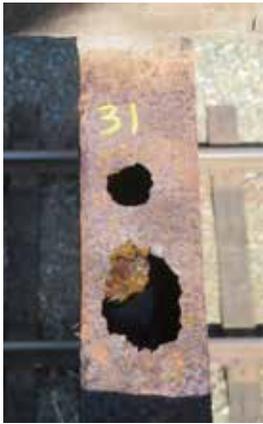
The primary members of the box truss – the chords, diagonals, and cross beams – all were found to have minimal loss of section. The protective patina seemed to be performing as intended. The walking surface of the bridge consisted of 3x12 timbers laid across three HSS 4x3x $\frac{1}{8}$ -inch longitudinal stringers, which in turn rested on HSS 5x3x $\frac{3}{16}$  cross beams at the truss bottom chord panel points. When some of the timbers were removed to test the HSS stringer members, it was discovered that many had corroded so badly that large holes were present on the top faces. This was the result of a design detail

that allowed the wood members to prohibit drying of the steel surface. Also, the timbers were bolted to the stringers with bolts tapped into the steel tubes. This allowed water to make its way into the tubes, corroding them from the inside. In addition, there was a lot of sand trapped in the joints between the timber walking surface members. The foot traffic from the beach delivered a continuous supply of chloride-laden beach sand to the steel surface. As a result of this discovery, the bridge was immediately closed to the public and a design commenced to replace the degraded members.

Typical corrosion in steel stringers.
