Preserving NAVY HISTORY with Design-Build

By Mark Hirschi, S.E. and Frank K. Humay, Ph.D., S.E.

Located on Ford Island at Joint Base Pearl Harbor-Hickam in Hawaii, Building 26A was constructed in 1935 for an aviation storehouse and an airplane hangar for the Navy's Fleet Air Base. The facility survived the December 7, 1941, surprise attack on Pearl Harbor (Figures 1 and 2) and in the 75 years since has undergone several changes in use. In 2014, the Navy elected to convert Building 26A into a new training facility for the Center for Security Forces (CENSECFOR). This conversion included repairing exterior deterioration and upgrading the structure to meet current seismic, hurricane, and antiterrorism criteria. A design-build team led by Hensel Phelps was awarded the \$15.1 million contract to update the historic building.

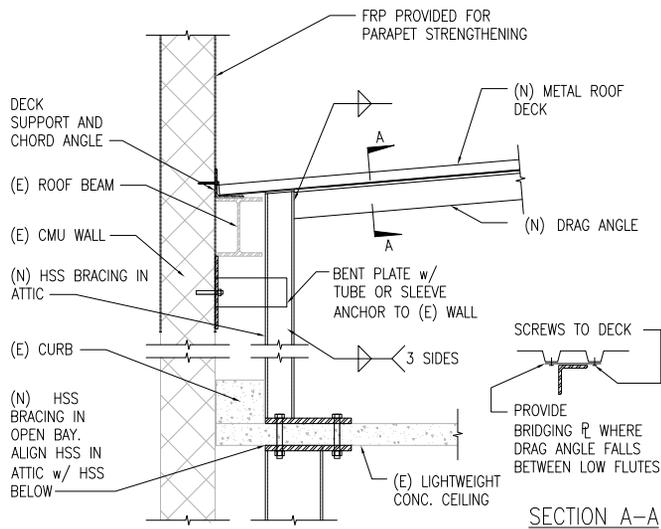
Figure 3. Bracing and deck connection detail.

One significant deficiency uncovered was the lack of a competent structural diaphragm at the roof. Neither existing horizontal rod bracing nor tongue and groove sheathing were found to have adequate strength and detailing for the diaphragm demands. In addition to not having sufficient shear capacity, the existing tongue and groove sheathing was in poor condition. Since the project also required removal and replacement of all roofing materials and insulation, the design-build team decided to replace the wood sheathing with metal roof deck. This substitution not only addressed structural concerns but served as a long-term betterment included within the project budget. Transfer of shear forces to the exterior masonry walls was accomplished using continuous steel angles, which also acted as chord reinforcement (Figure 3). Due to the significant length of the walls, the ungrouted and unreinforced masonry was found to be compliant for in-plane seismic forces.

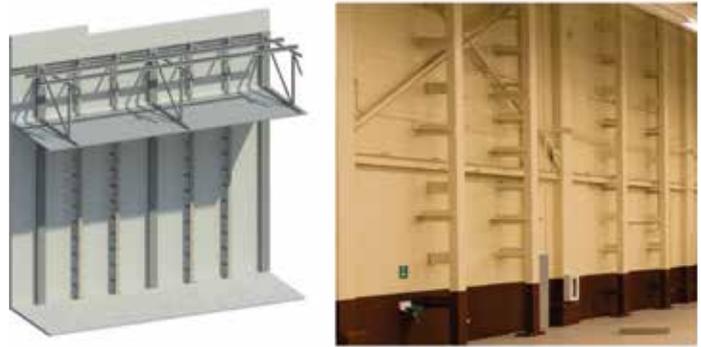
Although the exterior masonry walls were found adequate to resist in-plane shear forces, strengthening for resistance to out-of-plane forces was required. In addition to seismic forces, wind pressures based on a risk category II with a wind speed of 130 miles per hour were considered.

Figure 4. Steel wall bracing.

Because of these challenges, the design-build team developed an alternative structural steel bracing system that supports the walls only from the inside of the building (Figure 4). The bracing consists of steel HSS members spanning from floor slab to lightweight concrete ceiling and from ceiling to roof deck. The braces are attached to the masonry walls with steel angles welded to the HSS sections and a combination of tube screen and sleeve anchors connected to the ungrouted masonry walls. Either a wedge of solidified epoxy or an expanded metal sleeve bearing against the interior face shell of the masonry block provide anchor pullout capacity. The design-build team developed a field testing program to confirm the installed anchor's pullout strength to alleviate any concerns about achieving adequate anchor capacity within the old masonry. This field testing program involved pull-testing anchors to a proof load of approximately twice the maximum capacity needed and holding the proof load for at least two minutes. Seven anchors were tested before construction began, and roughly one out of every 75 anchors were tested during construction.

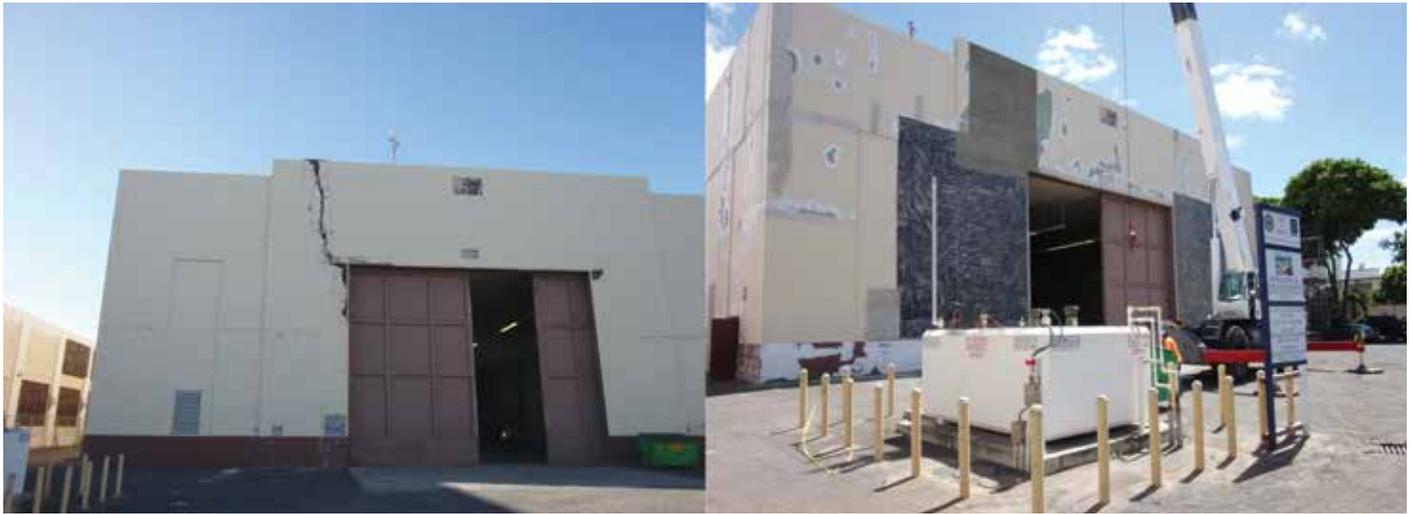
Figure 5. Extensive repair with FRP strips.

Deterioration of the existing structure also posed challenges at Building 26A. For example, several large cracks with significant displacement and slip were identified in the exterior masonry walls adjacent to one of the large hangar doors. To address this condition, the masonry cells adjacent to the crack were filled with expanding foam so that the masonry cells at the crack could be grouted without grout filling the entire wall. This ensured that the building's seismic mass was not appreciably impacted. Also, FRP strips were added across the large cracks to provide continuity for transfer of forces from one side of the crack to the other (*Figure 5*).
