Grant Street Pier

DRILLED SHAFT REPAIR

By Dominic A. Webber, P.E., S.E. and
Howard A. "Hod" Wells, P.E., LEED AP, ENV SP

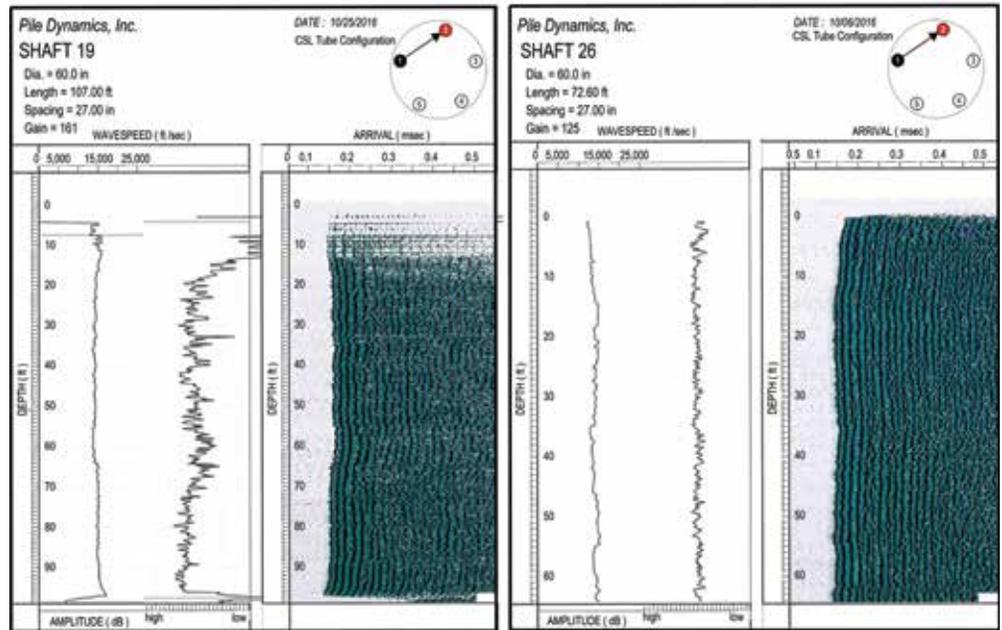
CSL Data: compromised drilled shaft on the left, sound drilled shaft on the right.

Each drilled shaft was evaluated using Crosshole Sonic Logging (CSL) in accordance with ASTM D 6760. The tests are performed by a transmitter probe that converts electrical pulses into ultrasonic waves. A receiver probe measures the ultrasonic waves. The probes are sent down parallel steel pipes that are cast in the shafts. There are a total of five pipes for CSL per drilled shaft. The CSL data indicated possible flaws in the top 8 feet of one shaft and the top 3 feet in the other shaft.

Although core samples taken from the center of shafts did not reveal flaws, the concern was about the cover around the reinforcing cage. Thus, a request was made for the top four feet of the shafts to be exposed for visual observation, where moderate-sized chunks of concrete from the loose fill were found embedded in the sides of the shaft. The contractor was then required to probe the six inches of concrete cover using a rotor hammer drill with the longest available drill bits. On more than one occasion, while drilling vertically into the cover, the concrete offered little to no resistance. Also, the air from the drill would periodically force water out of holes on the opposite sides of the shaft. This process revealed weak, porous concrete cover of the shafts.

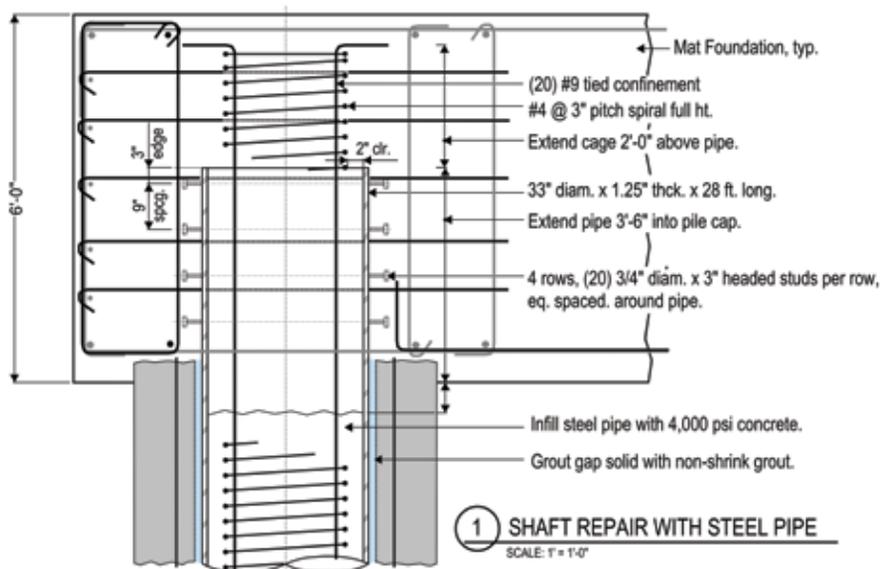
The analytical model used in the original evaluation was revised using the structural properties of the repaired shaft, with particular attention given to the boundary conditions at the top of the pipe. Although there was an approximate 7% shift of axial demand to the adjacent uncompromised shafts, the concrete-filled pipe recovered most of the stiffness of the original shaft to make the compromised shafts effective. The analysis also showed that it was essential to develop as much bending capacity at the top of the pipe as possible to minimize the redistribution effect. Consequently, this bending resistance was achieved considering three components – the addition of a spirally tied reinforcing cage to help engage the concrete core of the pipe, the embedded portion of the pipe extension above the bottom layer of slab reinforcement, and headed studs added around the pipe perimeter to directly engage the pipe wall in bending. Additional detailing was needed in the mat slab to support the high local demands from the pipe flexure at the top. This bending moment at the bottom of the pipe was redistributed to the shaft by the socketed 12-foot embed length, where the shear demand to engage bending was limited to the shear capacity of the shaft reinforcement. This determined the effective embedment of the pipe in the competent portion of the original drilled shaft below.

Altered structural conditions at the top of the concrete-filled steel pipe repair.

Ultimately, a 36-inch diameter auger was used to core the center of each shaft a minimum of 12 feet below the location where it was believed, based on drilling and CSL data, each existing shaft was compromised. This allowed a 33-inch diameter x 1.25-inch thick steel pipe to be placed inside the core and extend 42 inches into the mat slab. Overall, a 28-foot length of pipe was needed for each shaft. This allowed the concrete-filled pipe to act over the compromised portion of the drilled shaft and ultimately transfer loads back to the existing shaft below.

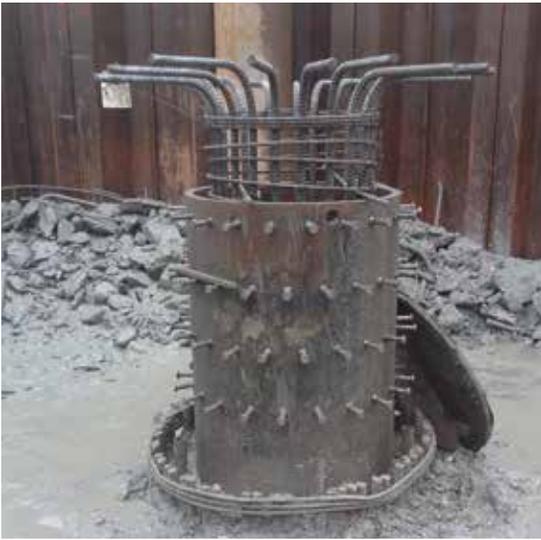
Foundation under construction: a repaired shaft (left) and bottom layer of reinforcement in mat slab (right).
