CONDITION ASSESSMENT and Repair

An Existing Composite Concrete Slab and Steel Beam Framed Parking Structure Part 1

By D. Matthew Stuart, P.E., S.E., F. ASCE, SECB

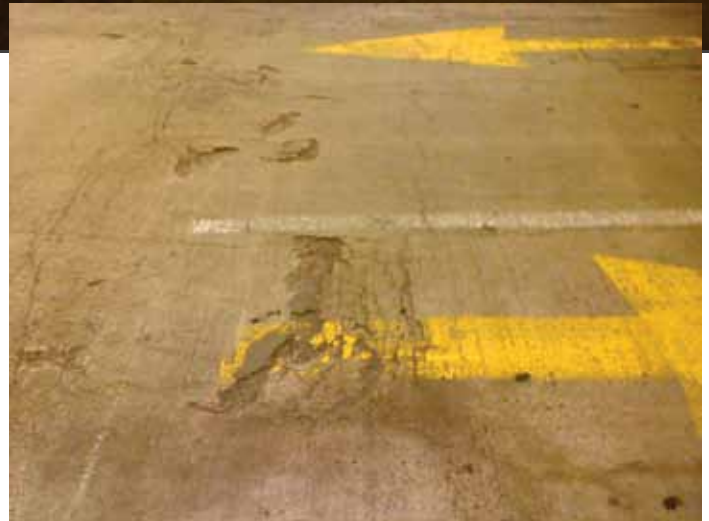
The condition assessment revealed isolated but widespread and significant concrete surface cracking, spalling and sub-surface delamination. In addition, the majority of the framed areas of the sub-grade parking facility exhibited widespread, significant deterioration of the galvanized composite metal deck. Deterioration was also occurring at the exposed structural support steel associated

Typical Surface Spalling and Cracking.

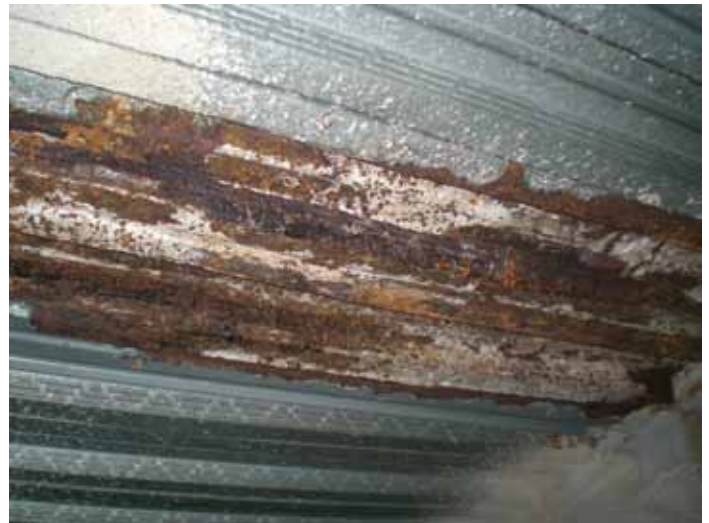
Typical Composite Metal Deck Corrosion.

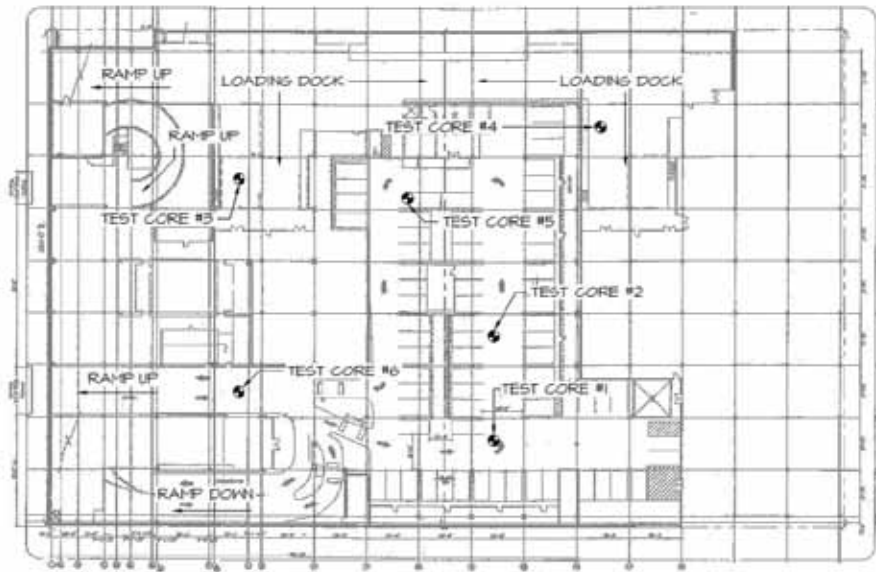
Concrete Core Location Plan.

A total of six concrete core samples of the slab, four in the parking and ramp areas and two in the loading dock area, were obtained for the purposes of conducting a petrographic analysis of the concrete. X-rays of the slab at the proposed core locations, which were all at or in the immediate vicinity of exposed deteriorated metal deck, assured that no electrical conduits or significant internal reinforcement would be damaged during the coring operation. Core sample #5 came from an area of the driving aisle that had been painted, while core samples #1 and #2 came from an area of the driving aisle that had been coated with an epoxy topping.

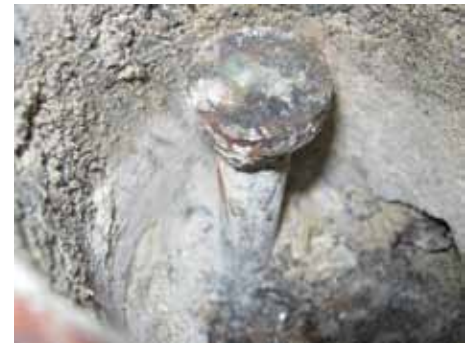
Deteriorated Headed Stud.

headed studs associated with the composite steel beams. X-rays of the slab at the proposed core locations again assured that no electrical conduits would be damaged during the procedure and indicated the specific location of the headed studs. A total of four headed studs were exposed for visual observation in the vicinity of two of the original test cores (#2 and #5) and near other areas of deteriorated metal deck. A core was also removed at a stud located directly below an area of the slab that exhibited surface spalling.

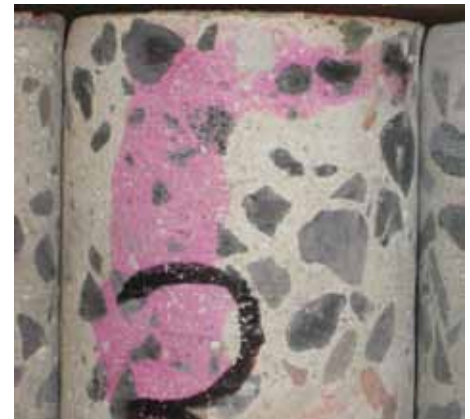
Carbonation Test Results at a
Concrete Core Sample.

Field tests for the presence of carbonation in the exposed concrete located within wear surface spalls adjacent to the core sample locations using phenolphthalein were positive for the presence of carbonated concrete. Additional carbonation tests confirmed the presence of carbonated concrete in the upper 1/8 inch of the wear surface of core samples #2 and #5. ■
