STRUCTURAL FORENSICS

Engineering Evaluation of Fire Damage to Concrete Foundations

By Peter Marxhausen, M.S., P.E.

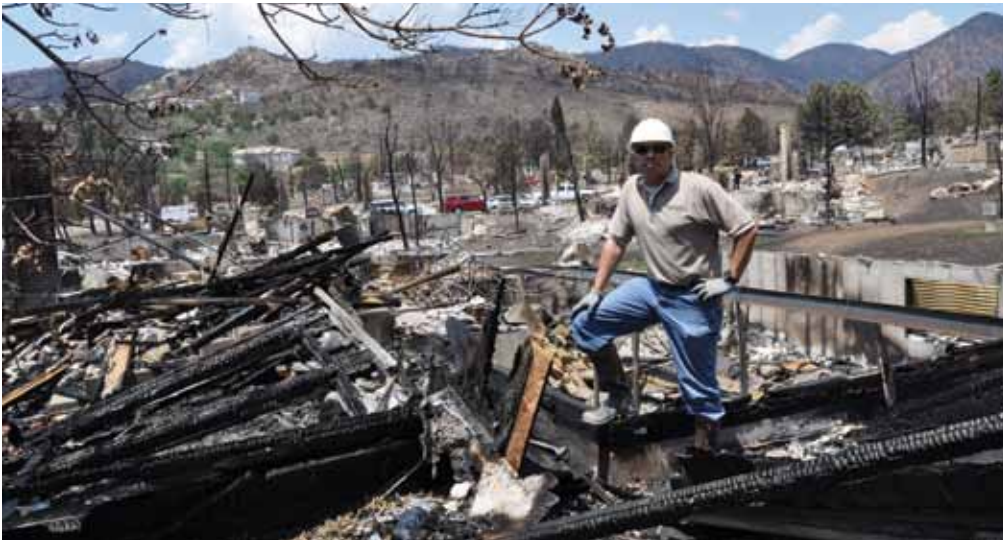
Figure 1. View showing the widespread damage that occurred through this suburban neighborhood following the Waldo Canyon fire.

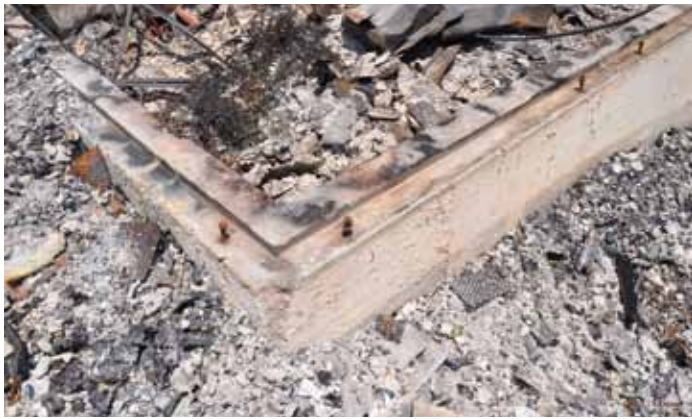
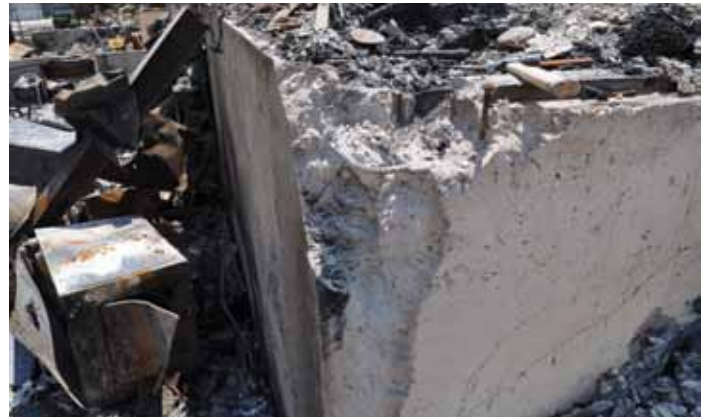
Figures 2 and 3. Views showing how heat-damaged concrete exhibits low strength and crumbles easily when struck four to six times with a hammer. The rebar is exposed, and the fractures are through the paste, not the aggregate. Without conducting any further testing, this foundation is considered not suitable to be re-used in reconstruction of the structure.

A review of the distress in *Figures 2 and 3* shows the effect of four to six hammer strikes on an area of heat-damaged concrete. Healthy, undamaged concrete would have likely required the better part of a day to accomplish the same damage using the same hammer.

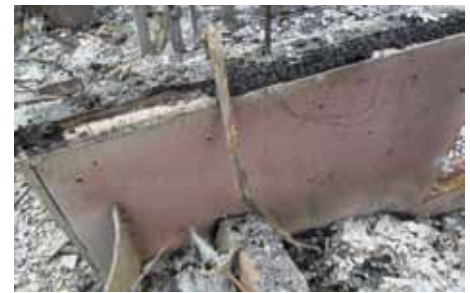
The color of the concrete paste should also be reviewed since a color change may indicate exposure to temperatures of greater than 550 degrees Fahrenheit. Concrete exposed to temperatures greater than approximately 570 degrees often turns a shade of pink, associated with chemical changes of the iron-containing compounds in the aggregates and paste matrix. At much higher temperatures, which are not commonly encountered during typical structure fires, the concrete can turn back to a light gray and then eventually to a yellowish-brown color. Concrete that has turned pink is damaged and should be replaced.

Figure 4. View showing the characteristic pink hue of heat-damaged concrete. The signature pink color is a strong indicator the concrete is severely damaged and cannot be re-used for reconstruction.
