FULL METAL JACKET

Part 2: Solutions

By D. Matthew Stuart, P.E., S.E., F. ASCE, F. SEI, SECB, MgtEng and Richard H. Antoine III, P.E., S.E.

Part 1 of this series discussed the investigation of an existing timber-framed, multi-story building, that is over one hundred years old, and the resulting evacuation of the occupants due to an unsafe condition at the main support columns of the building. This installment discusses the nature of the deterioration observed and the solutions considered for repair.

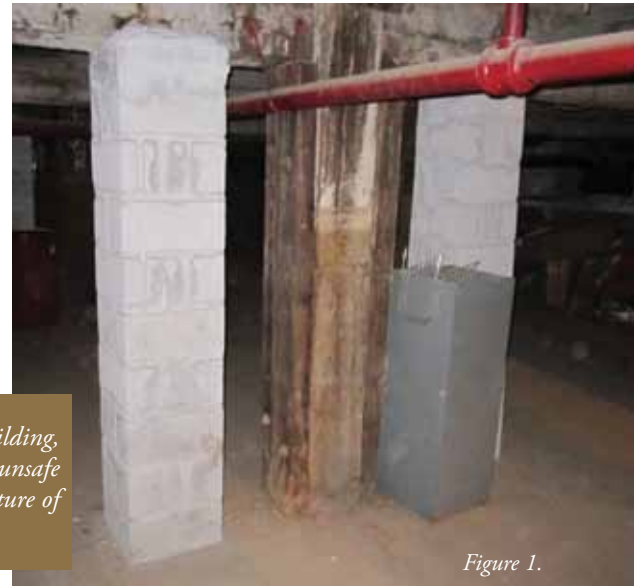
Figure 1.

The deterioration and damage of the timber columns could be attributed to two primary causes: moisture and insects. It was unclear to what extent each column base had deteriorated, but visual observations indicated that at least three of the eight affected primary wood columns had lost almost all of the cross-sectional area at the base below the top of the basement slab on grade. Partial removal of the concrete slab from around the column bases at the remaining five locations, to determine the extent of deterioration, was not possible because the slab in the same immediate area provided the only support for the 3x12 side plates.

This restriction occurred because it had been observed that, as the deterioration progressed in the main building columns, the load had been transferred to the 3x12 side plates via the existing through bolts. As a result, the 3x12 side plates were beginning to exhibit localized crushing at their bases, which allowed the building to settle vertically. The resulting deflection subsequently allowed the second floor framing to move and rotate as the columns dropped unevenly into the voids left by the deteriorated timber. Continued vertical movement was also allowed by the deterioration of the column side plates; however, at the worst areas of deterioration of the 3x12's, masonry piers had been previously installed adjacent to the building columns (Figure 1). Unfortunately, these supplemental supports were only able to engage the first floor framing, rather than assist with the transfer of the main building column loads from any of the other floors above.
