Changes in Codes, Standards and Practices Following Structural Failures

Part 1: Bridges

By Robert T. Ratay, Ph.D., P.E.

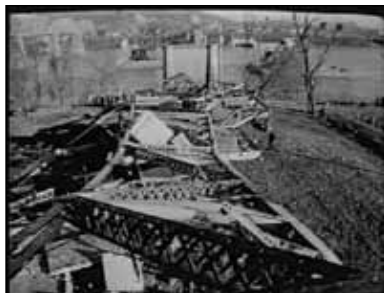
Figure 1: Silver Bridge at Point Pleasant, West Virginia.

performing inspections, preparing reports, and determining ratings, in accordance with the provisions of the American Association of State Highway and Transportation Officials (AASHTO) *Manual for Maintenance Inspection of Bridges* at regular intervals not to exceed two years. This mandate followed the December 15, 1967 collapse of the U. S. 35 Highway Bridge connecting Point Pleasant, West Virginia, with Kanauga, Ohio (a.k.a. Silver Bridge), caused by the cleavage fracture in the lower limb of an eyebar in the suspension chain. Forty-six persons died, nine were injured, and thirty-one vehicles fell with the bridge. (Figure 1)

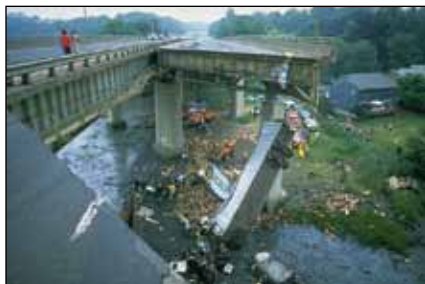
Figure 2: I-95 Bridge over the Mianus River in Connecticut.

- The 1986 publication by the Federal Highway Administration (FHWA) of a manual of inspection of fracture-critical bridge members, and widespread retrofitting of steel bridge girders with a fail-safe assembly below their pin-and-hanger girder connections. This followed the June 28, 1983 cleavage fracture failure of a pin-and-hanger connection and catastrophic collapse of a highway bridge carrying Interstate 95 over the Mianus River in Connecticut. (Figure 2)

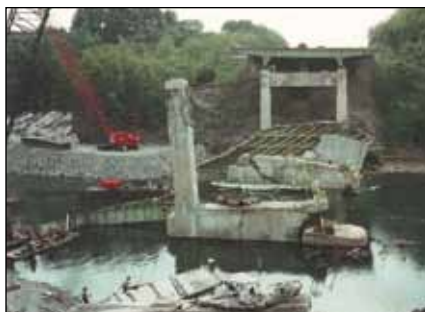
Figure 3: New York State Thruway Bridge over the Schoharie River.

- The Surface Transportation and Uniform Relocation Assistance Act of 1987 expanded bridge inspection programs to include special procedures for the inspection of underwater components, such as piers, of bridges. This followed the April 3, 1987 collapse of a bridge of the New York State Thruway over the Schoharie River as a result of river-bottom scour. (Figure 3)

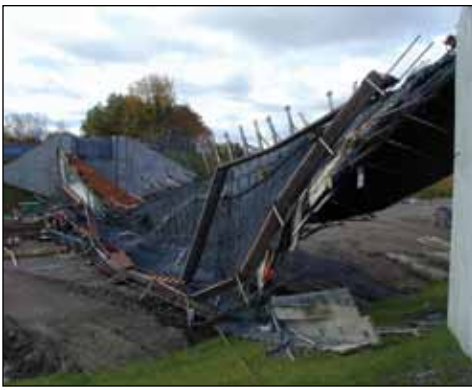
- Review of New York State and AASHTO design guides for composite tub girders, review of New York State Department of Transportation (NYSDOT) bridge construction approval and oversight procedures, and changes in the New York State and AASHTO bridge design specifications. This followed the October 10, 2002 collapse during construction of the Marcy Pedestrian Bridge in Utica, New York. (Figure 4)

Figure 4: Marcy Pedestrian Bridge in Utica, NY.

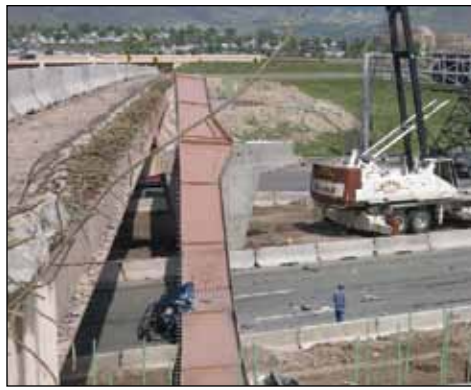
Figure 5: I-70 Overpass at Golden, CO.

to construction contractors concerning the design and certification of falsework, formwork, and bracing for the erection of highway structures". This followed the May 15, 2004 lateral stability failure of a fabricated steel girder installed a few hours earlier for the overpass of Route C-470 over Interstate Highway I-70 in Golden, Colorado, killing a family of three in a vehicle. (Figure 5)

- Revisions by the Colorado Department of Transportation (CDOT) to its Standard Specifications for Road and Bridge Construction requiring that an erection plan be developed at least 4 weeks prior to erection of a structural steel member, that a conference be held at least 2 weeks before beginning an erection, and that the contractor's Professional Engineer provide written approval of each phase of the installation; and, subsequent recommendations by the National Transportation Safety Board (NTSB) to the FHWA, to the Office of Safety and Health Administration (OSHA), and to AASHTO "to make consistent and compatible [their] organizations' regulatory requirements for and guidance

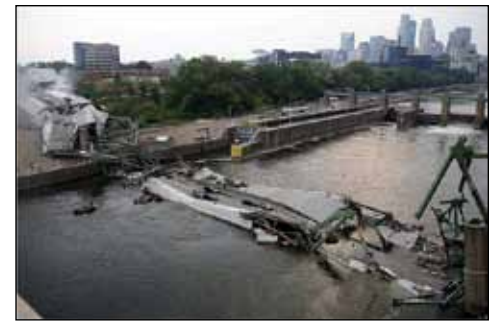
Figure 6: I-35W Bridge over the Mississippi River.

of an eight-lane 1,900-foot long I-35W highway bridge over the Mississippi River in Minneapolis, Minnesota, caused by inadequate load capacity, due to a design error, of gusset plates at a node of the main span of the deck truss that was subjected to loads during roadway work. Four-hundred fifty-six feet of the main span fell 108 feet into the 15-foot deep river carrying one hundred eleven vehicles. Thirteen people died and one-hundred forty five people were injured. The NTSB also faulted inadequate design review by Federal and State transportation officials, and the generally accepted practice at the time among Federal and State transportation officials of paying inadequate attention to gusset plate distortions during inspections.

- As a result of its extensive investigation, the NTSB made recommendations to the FHWA and AASHTO regarding, among other things, quality control procedures for the design of bridges by bridge design firms, and regarding safety inspection procedures. This followed the August 1, 2007 catastrophic collapse,

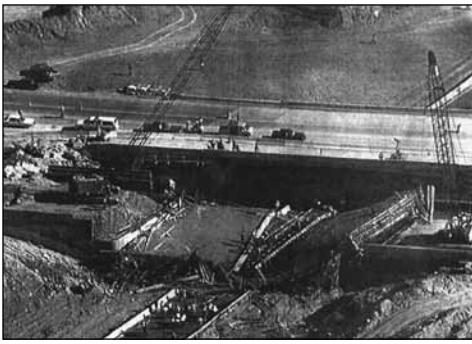
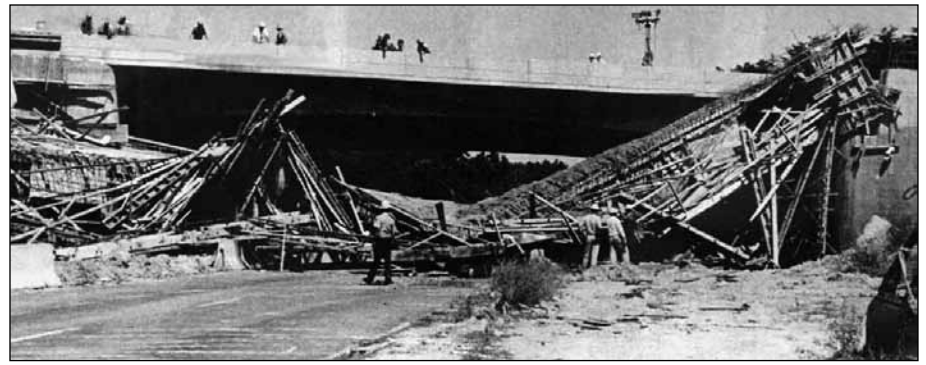
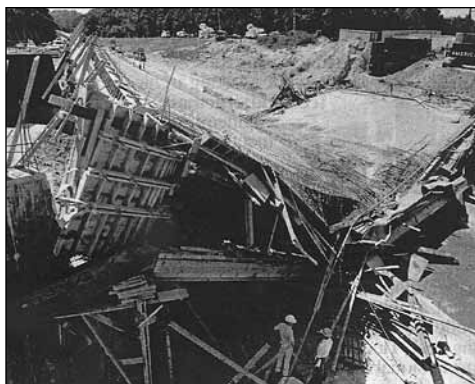
Figure 7: Baltimore-Washington Parkway. Aerial view of collapse. (From *The New York Times*, September 1, 1989)

Figure 8: Baltimore-Washington Parkway. Side view of collapse. (From ENR, September 7, 1989)

A highway bridge, built to carry Maryland Route 198 over the Baltimore-Washington Expressway, collapsed during construction on August 31, 1989, injuring nine workers and five motorists and killing one. The superstructure was designed as five parallel post-tensioned box girders spanning 100 feet between simple-support abutments. The bottom slab of the box girders was cast in early July and the webs were cast between July 21 and August 4. On the day of the collapse, workers were pouring the 8-inch deck slab. The collapse occurred five hours into the pour, when 120 of the 160 cubic yards total was in place. The shoring collapsed “in a flash” without warning, landing all the formwork and 400 tons of steel and concrete on the roadway below. (Figures 7, 8 and 9)

Figure 9: Baltimore-Washington Parkway. End view of collapsed falsework. (From ENR, September 7, 1989)

A forensic investigation by the FHWA and its consultant, T. Y. Lin International, was performed, and their findings were presented in their report (*Report of the Investigation into the Collapse of the Route 198 Baltimore-Washington Parkway Bridge*) on December, 1989. They evaluated nine possible causes of the collapse, and systematically eliminated all but one. They concluded that the failure originated in one of the shoring towers and the most likely cause was the use of 5-ton screw jacks rather than the 12.5-ton screw jacks, shown on the approved drawings, on the tops of the shoring towers supporting the bridge. They also noted that “the top screw jacks were rusty”, that much of the cross-bracing had “large amounts of rust and heavy pitting” and that, in one section, the cross-brace pieces were connected by nails instead of the required bolts.

Based on the report of the investigators, an FHWA review board concluded that the failure occurred probably because the shoring tower assemblies were not constructed in accordance with the approved plans. The review board found no evidence that the FHWA (the owner) had not lived up to its contractual responsibilities, and ruled that it was the responsibility of the contractor to assemble the falsework system in accordance with the approved design. (It is to be noted that the FHWA did then, and does now, require a contractor’s engineer to certify that falsework has been assembled according to approved drawings before it is loaded.) As a result, a fine of over \$900,000 was levied by the state against the contractor. Additionally, of course, the injured individuals filed lawsuits of their own.

This followed the FHWA review board’s recommendation that, in order to prevent similar occurrences in the future, falsework specifications should be revised to define more clearly the responsibilities of material suppliers, contractors, and engineers. This recommendation was signed into law by the US Department of Transportation and Related Agencies Appropriations Bill of Fiscal Year 1991, which states in part that “...the Committee on Appropriations directs the Federal Highway Administration to undertake the research project recommended in the 1991 report entitled *Investigation of Construction Failure Maryland Route No. 198 Bridge Over the Baltimore-Washington Parkway*.” The bill goes on to specify that the research project should produce approved guidelines, improved specifications, and a falsework construction handbook.
