CONSTRUCTION ISSUES

Good Design Should Consider Poor Execution

By John Bouldin and John "Buddy" Showalter, P.E.

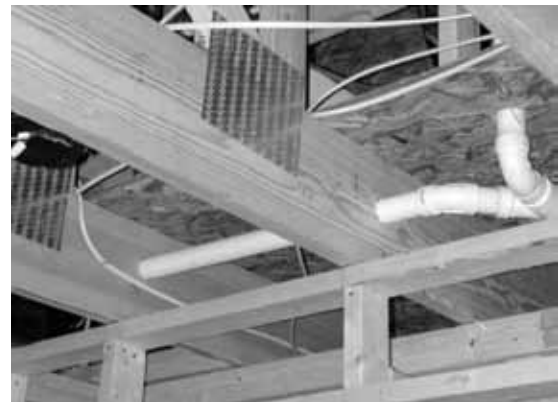
Figure 1.

Figure 1 shows a live-load bearing truss system with a plumbing drain pipe installed through the bottom chords of adjacent trusses. While these bottom chords strongly

resemble dimension lumber floor joists, they are not that simple. In this example, we must consider at least three possibilities: 1) the plumber erred in the installation by treating truss chords like dimension lumber joists; 2) the truss designer allowed for the reduction of cross section in the original truss design and thus there is no problem; or, 3) the system designer did not take into consideration that a plumbing drain had to be installed in this location, and the plumber had little choice as to where the pipe had to go. Each of these possibilities plays a role in the design, inspection, and performance of the completed framing system. Designers are encouraged to think beyond the structural skeleton to anticipate and provide solutions for accommodating HVAC, plumbing, and electrical systems.

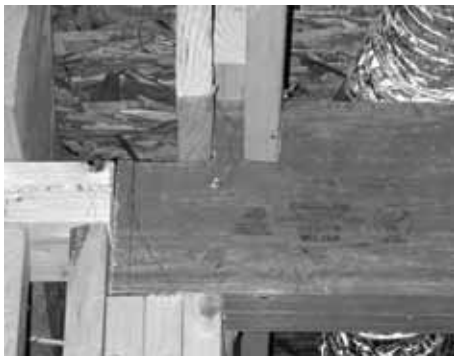
Figure 2.

Figure 2 shows a laminated veneer lumber (LVL) beam that has been end-notched above a bearing point. EWP manufacturer specifications prohibit notching of EWP beams to prevent misapplication. While industry standards such as the *National Design Specification® (NDS®) for Wood Construction* permit notching up to $\frac{2}{5}$ the depth of the member on the compression side of the beam, it is important that the designer clearly indicate if a condition like this is permitted on the design drawings.

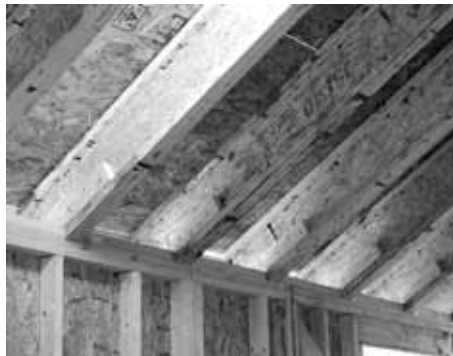
Figure 4.

Figure 4 shows a series of I-joist rafters that were installed like dimension lumber rafters. As can be seen, each I-joist is improperly notched in a 'bird's mouth' fashion, which so weakened the roof system that it had to be replaced. Proper specifications exist to create a bird's mouth, but no I-joist manufacturer allows this type of installation. Including the proper detail on the plans would have been a good approach by the building designer. The cost of replacement could have fallen on the designer had the detailing not been clearly called out. This also raises an interesting dilemma for the project manager – if this was the last house in the subdivision to be built, how many other built and delivered homes may harbor this same defect?

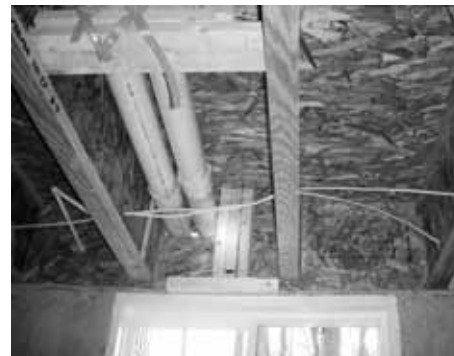
Figure 6.

A problem situation is shown in Figure 6, where an EWP rim board is properly doubled across the top of the foundation window so as to create a header to support the joists. An obvious problem is that point load blocking is resting on top of the vinyl window directly. It is generally agreed that vinyl window jambs are insufficient to bear structural loads. This happens more often than might be expected, and may be due to mis-location of the window opening in the foundation wall by

the foundation contractor, but could also be due to an oversight in the original design of that load path.

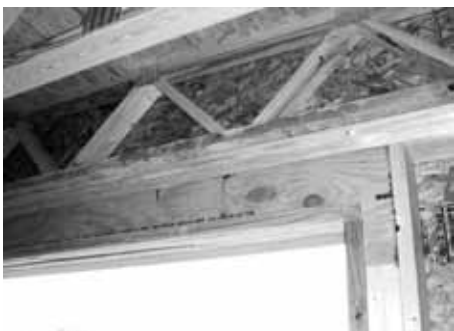
Figure 3.

A serious example of LVL modification can be seen in Figure 3, where the entire header across a garage door opening has been notched. When this issue was raised with the builder, his comment was that the remaining depth was sufficient to carry the load. Either the designer didn't consider the effect of a deeper header on the available opening height, or the plans were detailed poorly and the header was misplaced within the wall elevation. But most likely, the builder simply made a mistake and decided it was too expensive to consult a design professional regarding the adequacy of the beam.

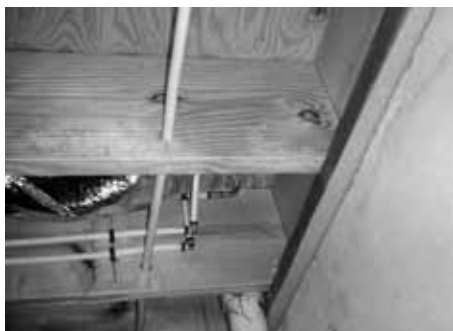
Figure 5.

Figure 5 shows a bearing condition that is common to all types of framing. The joists properly bear the minimum required 1.5 inches on the sill plate, but the sill plate itself overhangs the inside of the foundation wall by 1.5 inches. This subjects the sill plate to cross-grain bending stresses – one of the weakest properties of wood. This condition may be adequate depending on cross grain bending stresses, but the design or product literature would have to clearly indicate that the material (typically only an EWP) can handle these stresses. It is interesting to note that the International Residential Code (IRC) requires a bearing length of 1.5 inches for sawn lumber joists resting on a wooden surface, but is silent on whether that surface must be fully supported. It's also worth noting that many I-joist manufacturers require 1.75 inches of bearing.

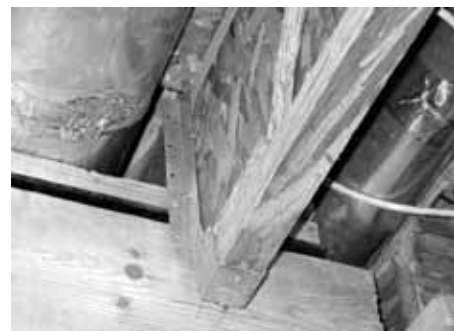
Figure 7.

Figure 7 (page 31) highlights an issue that may be more often associated with a design problem than with an installation issue. There is a vertical floor offset in two adjacent rooms, and the installer used an improper support strategy to handle this. Sixty percent of the holes in the joist hanger are empty because there is no structural member into which they can be properly nailed. Another type of dubious solution, in cases where the joists are lower than the beam, is to install a plywood sheet nailed to the beam, but dropped below it, to accommodate the holes in the joist hangers. Perhaps this can be suitably designed, but in the many instances the authors have encountered this situation, it appears to have been an after-thought accommodation. Designers are encouraged to give consideration to changes in framing elevations such as these, and to provide details as needed so that adequate support for framing and hangers is provided.

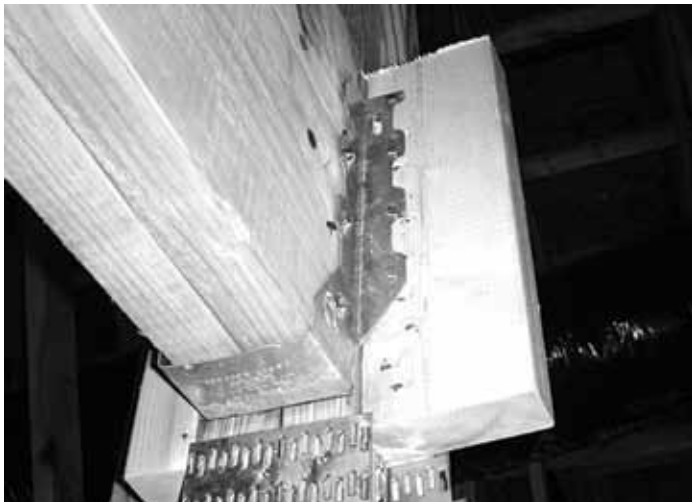
Figure 8.

Figure 8 demonstrates another very common deficiency – that of the incorrect use of a joist hanger. In this example, the outside flanges of the hanger have nothing structural to attach to, so the framers rather creatively added some ‘rabbit ears’ on the sides of the supporting truss member to hold the beam up. A concealed flange hanger is the proper hanger for this situation, but was not used here.

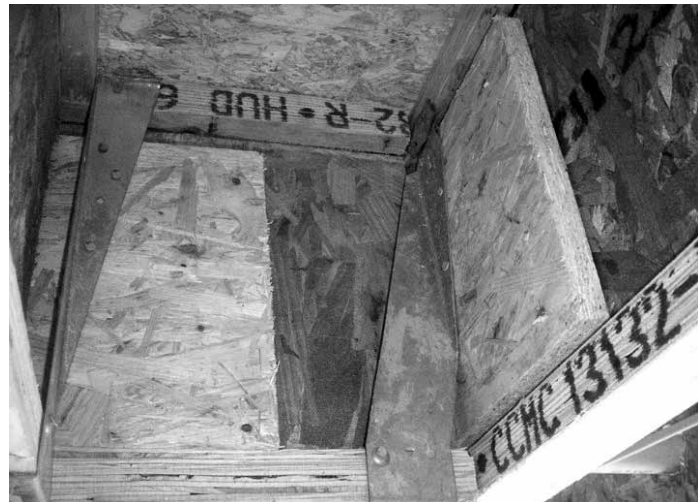
Figure 9.

In the last example, Figure 9 shows a common retrofitted installation of an I-joist header where the original I-joist encountered an obstruction and had to be cut. The primary support is provided by top flange hangers that must be secured to the tops of the adjacent joist flanges. In each of the two cases in this photo, the installers attempted to force the

top tabs of the hanger in between the bottom of the existing subfloor and the top of the I-joist flange after the subfloor had been glued and screwed in place. Clearly, a face-mounted hanger would have been more appropriate.
