Avoiding Structural Failures During Construction

Part 1

By David B Peraza, P.E.

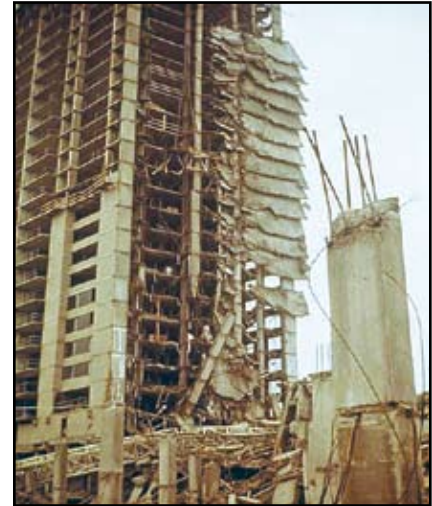
One of the most famous cases was the collapse of Baileys Crossroads in 1973. This 26 story residential tower in Fairfax, Virginia was almost topped out when disaster struck. Concrete was being placed on the 24th floor, and formwork was being removed on the 22nd floor. The fresh concrete was therefore supported entirely on the 23rd floor, where the concrete had been placed only 5 days before. The slabs collapsed, one on top of the other, all the way to ground, killing 14 construction workers and injuring 35 workers. *Figure 1* shows this building after the collapse.

Figure 1: The progressive collapse of the middle portion on this building in Baileys Crossroads, caused by premature formwork removal, resulted in 14 fatalities. Courtesy of the National Institute of Standards and Technology.

Since removal of formwork is closely tied to the contractor’s “means and methods,” the contractor is in the best position to prevent this type of failure. However, the Engineer of Record (EOR) can assist by requiring that the contractor prepare, submit, and follow a project-specific formwork plan. This plan should include criteria for deciding when formwork can be removed, and the number of floors to be shored or reshored. The formwork plan should be developed by an engineer, retained by and in consultation with the contractor. Compliance needs to be closely monitored, preferably by the owner or a firm retained by the owner.

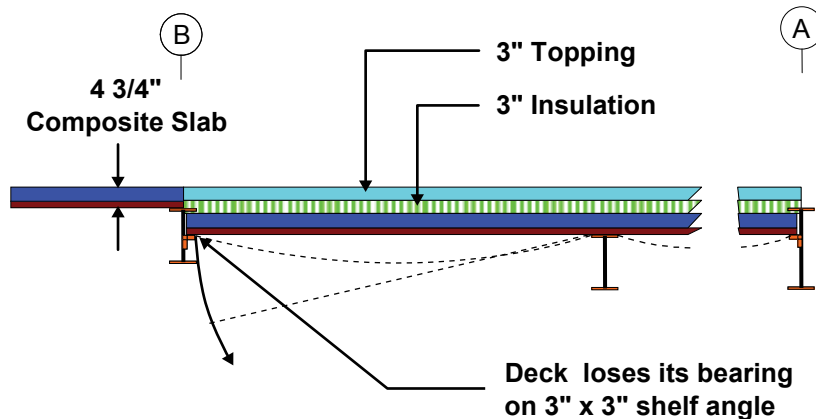
composite metal deck and concrete. The collapse occurred while workmen were placing concrete for the topping, after having placed concrete for the structural slab earlier in the day. One end of the deck slipped off its bearing, and the deck dropped open like a trapdoor, causing five workmen to fall 40 feet and sustain severe injuries.

There were numerous construction errors that were relevant. Most importantly, the topping was placed while the structural concrete was still fresh, and therefore, before it was acting compositely with the unshored metal deck. In addition, there was minimal bearing of the metal deck on the shelf angles and there were “half moon” puddle welds at the edge of the deck, no sidelap attachments, and no welding washers.

However, there were also errors on the part of the EOR. Most significantly, the EOR verbally approved the placement of the topping prior to curing of the composite slab. This erroneous information was given the morning of the accident, in response to a telephoned question from the contractor. Another unfortunate action was that the EOR noted on the shop drawings some – but not all – areas where metal deck needed shoring. In fact, the area that collapsed did need to be shored, but the EOR neglected to identify that. These gratuitous notations were made in spite

Figure 2: This metal deck collapsed while concrete for the topping was being placed over the newly-placed structural slab. Note also that depressing the structural slab to accommodate the insulation and topping slab introduced some constructability issues that affected the amount of bearing afforded to the metal deck.

- 1) Non-typical areas require special attention, both during design and during construction. For this particular case, a constructability review would have probably triggered numerous questions.
- 2) Avoid giving gratuitous advice. For example, if the contractor is responsible for identifying where shoring is needed, avoid taking on that responsibility unless you are prepared to do it fully and completely.
- 3) Avoid, whenever possible, giving verbal directions to a contractor. If necessary, follow up verbal instructions with written memorandums immediately. This minimizes the possibility of misunderstandings. Often, the process of memorializing a decision triggers additional thought and clarity. Also, taking time to discuss the issue with a colleague may provide additional insight.

- 4) Competent and thorough inspections, of both typical and non-typical areas, are a vital part of the process.

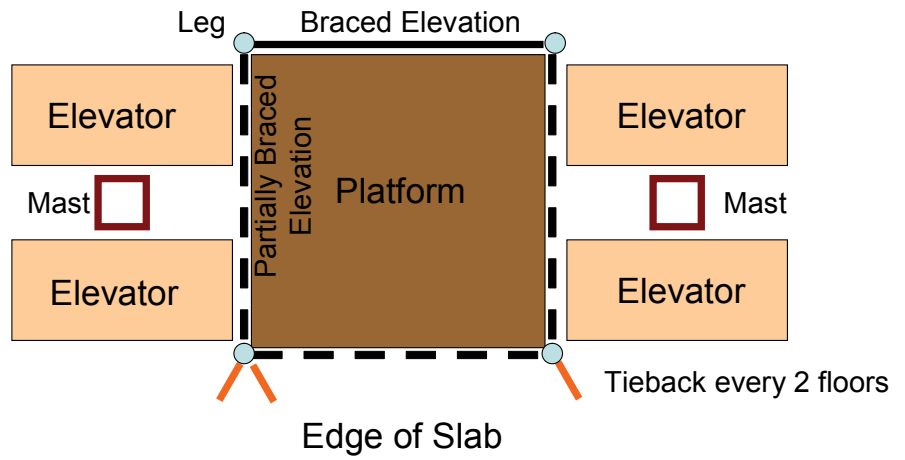
Figure 3a: A plan of a hypothetical platform for a hoist complex. The heavy line indicates a side that provides full bracing to the legs; the dashed lines indicate sides that provide partial bracing.

Figures 3a and 3b show a common scaffold-like system for a construction hoist complex. The restraint conditions for the legs are more complicated than that of most building columns. The landing trusses are typically

moment-connected to the legs, providing the legs with rotational restraint; but the legs are usually spliced with a spigot connection that acts as a pinned connection; and filler bracing, which reduces the headroom to about 6 feet – 8 inches may or may not be effective as a brace, depending on its location. Furthermore, the entire system is typically braced against the building every two or three floors – not every floor.

A common assumption by scaffold engineers who design these structures is that the legs have an effective unbraced length of about 6 feet – 8 inches, which is the clear height between the filler braces and the floor members. However, this assumption can be unconservative, particularly in cases where the system is not braced at every floor, as is illustrated in Figure 3b. To determine the true strength of such a structure, it may be necessary to perform a sophisticated buckling analysis of the structure. This analysis would be geometrically non-linear and would include the actual restraint conditions provided to the legs.

- Perform a peer review of significant scaffold structures. Depending on the arrangement of the hoist complex, the analysis may be simple, or it may require a sophisticated buckling analysis.

- Retain an engineer to inspect the structure. The inspections are typically done once initially, then each time the structure is modified, and then once per month. The inspections help ensure that the structure is built according to the plans, that unauthorized modifications are not made, and that the structure is not misused.

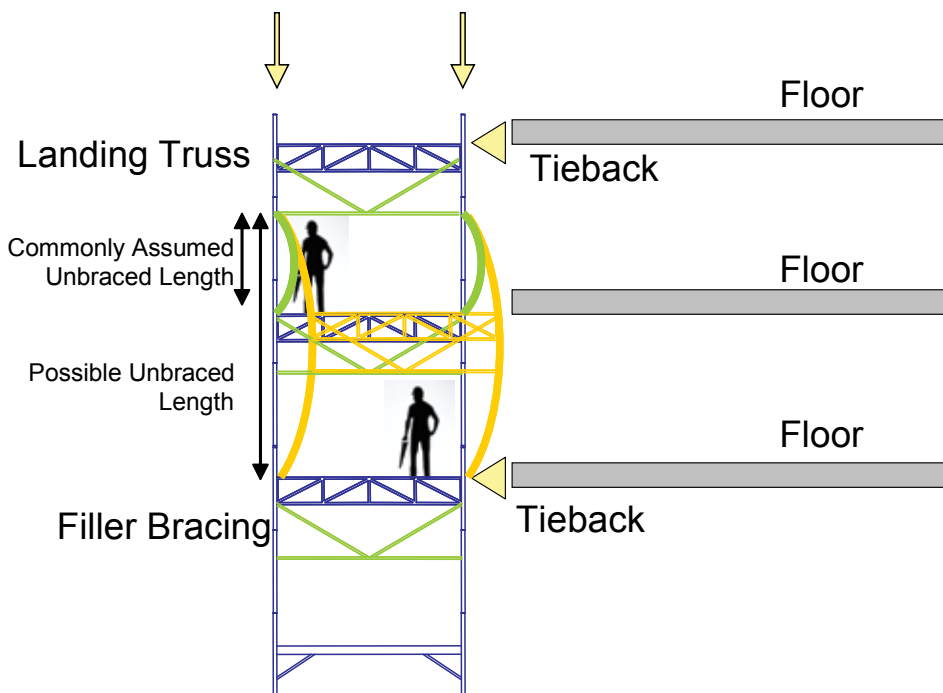
Figure 3b: An elevation through the hoist complex, showing partial bracing.

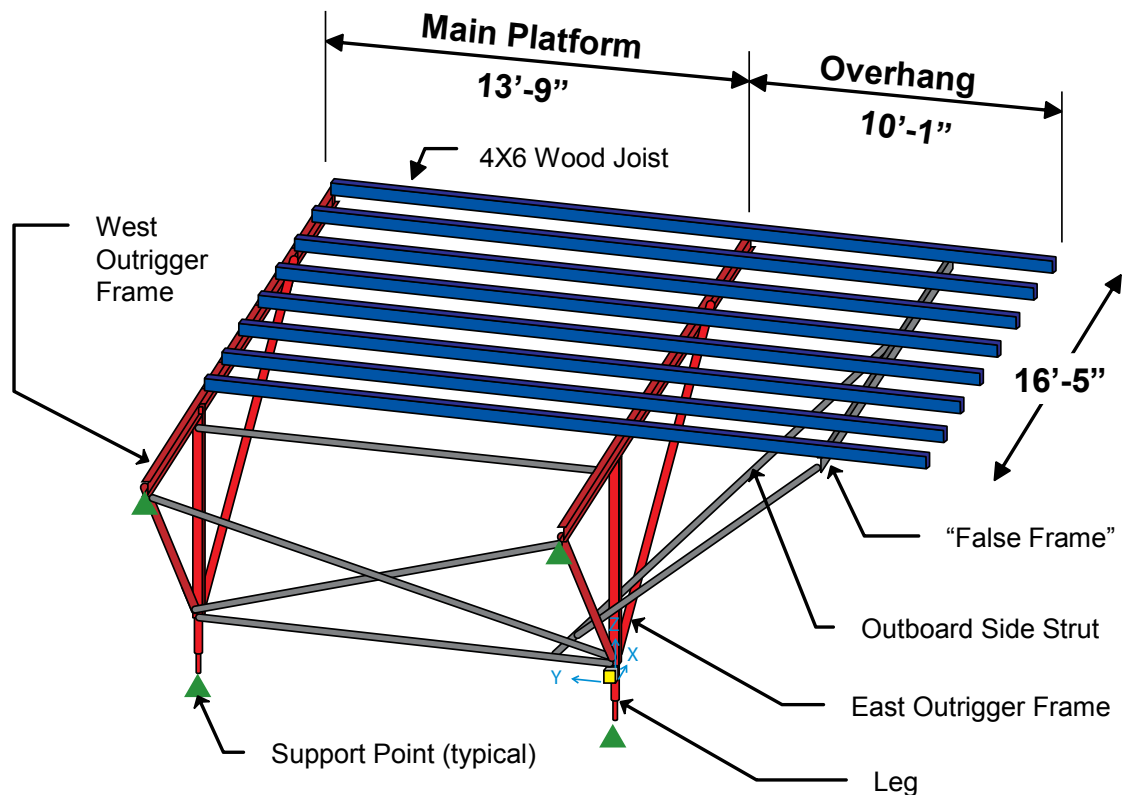
Figure 4a: This shows the construction of a work platform that failed.

frames that were supported on the building floor slab and that reacted against the underside of the slab above. There was no mechanical attachment between the outrigger frames and the slabs. The platform that failed was non-typical compared to other platforms on the building. The typical platform was only slightly wider than the two outrigger trusses that supported it. The failed platform had a large overhang to one side. A “false frame,” which consisted of a channel and two diagonal struts, apparently was added to support the overhang. Figure 4a is a three dimensional view of the platform structure.

Analysis showed that the most likely cause of the failure of the platform was inadequate structural design of the platform structure. The structural design of the platform did not meet the OSHA requirement that scaffolds support four times the intended load, without failure, nor did it meet the ANSI A10.9 requirement that flying forms be designed with a safety factor of 2.5. The platform was constructed substantially in accordance with the shop drawings, and there was no evidence that it was being misused.

- Recognize that these structures need to be engineered.
- Require calculations, and signed and sealed drawings, for prototypical structures.
- Require project-specific calculations, and signed and sealed drawings, for non-typical or unusual structures

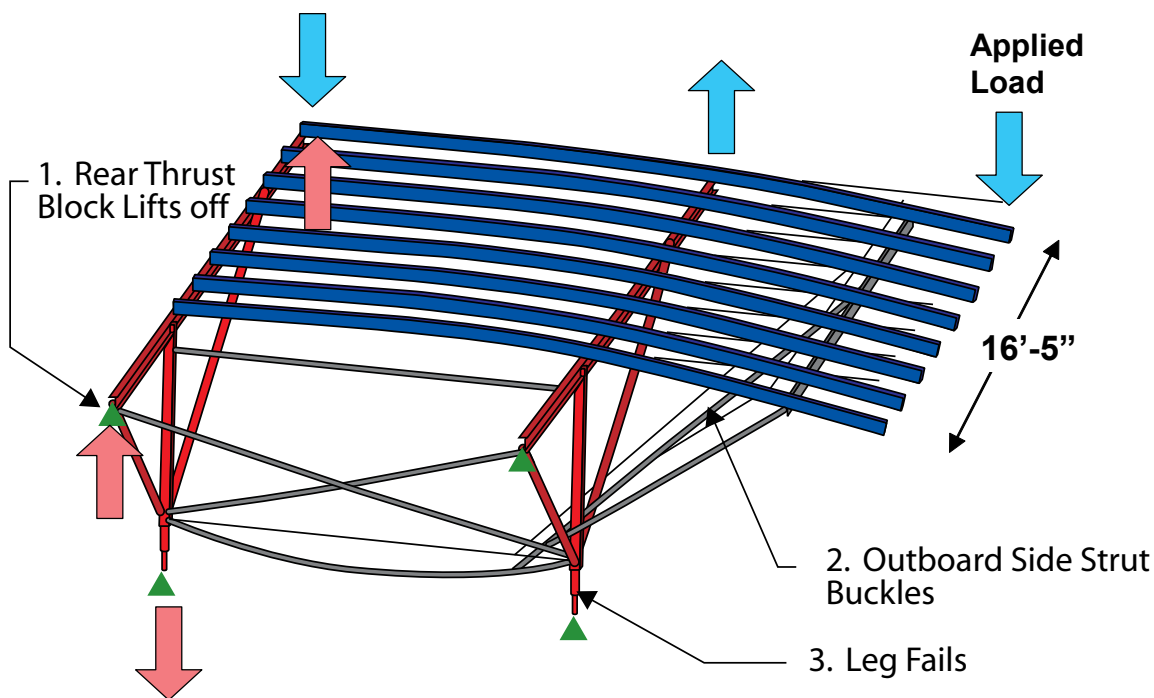
Figure 4b: This figure shows the failure mechanism of the work platform. An applied load near the corner of the overhang caused the far outrigger frame to disengage and become unstable. The blue arrows indicate forces on the wood joist; the pink arrows indicate needed reactions on the outrigger frame.

The failure most likely initiated when the rear thrust block of the west outrigger frame lost contact with the underside of the 20th floor slab, making the structure unstable. Figure 4b shows the likely failure sequence. The main factors that enabled this to happen were the excessive length of the platform’s side overhang coupled with the ineffectiveness of the false frame to support the overhang. These two factors allowed the wood joists to “see saw” about the east outrigger frame, so that modest loads applied on the overhang caused uplift on

the tip of the west outrigger frame, which was not capable of resisting any uplift loads.
