The 2008 Sichuan Earthquake

Assessment of Damage and Lessons Learned

By H. Kit Miyamoto, M.S., S.E., Amir S.J. Gilani, Ph.D., S.E., and Tom Chan, M.S., S.E.

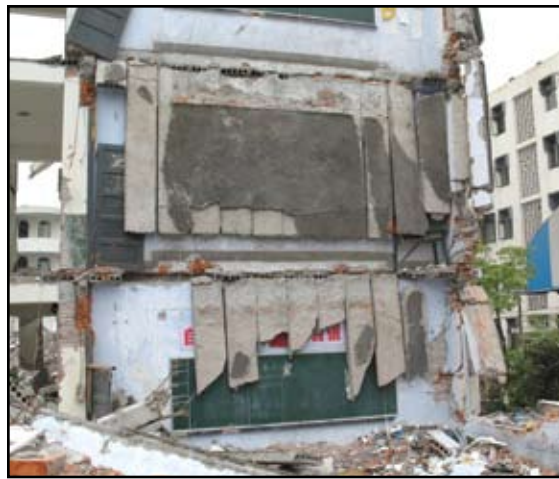
Figure 1: URM wall and RC floor plank collapse, Juyuan Middle School.

The three-story Juyuan Middle School, approximately 20 kilometers from the fault rupture, was hit hard. The school, constructed in 1996, housed 1,000 students, and more than 700 died when the building collapsed. Construction consisted of nonductile RC beams supported by URM walls, with precast concrete floor planks. *Figure 1* shows the collapsed floor precast planks. As shown, the planks pulled away from the walls on one side, and were hanging from the walls on the opposite side. This type of damage was quite common.

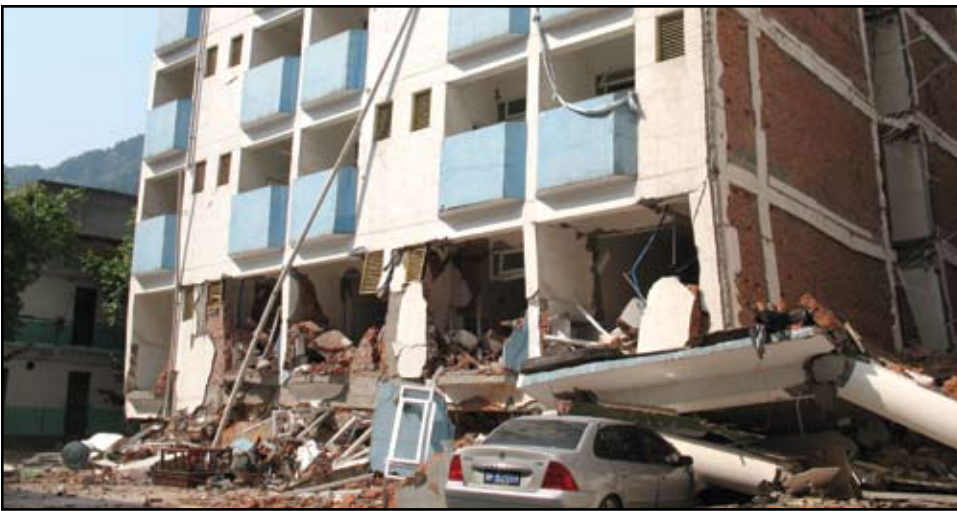
Figure 2: Soft-story collapse, Hanwang Hospital.

The five-story Hanwang Hospital was built in 1999. Construction consisted of nonductile RC framing and URM walls. The ground floor was designed as a parking garage; therefore, the URM bearing walls terminated at the first floor, creating a bottom story with much lower lateral stiffness. This soft story completely collapsed during the earthquake (*Figure 2*), and the upper floors dropped down one floor.

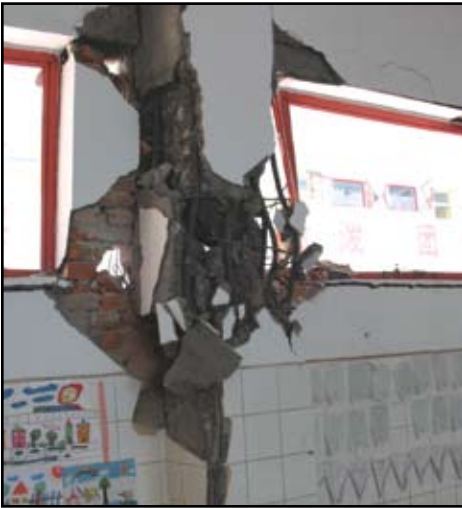
Figure 3: Captive column failure, Hanwang High School.

The four-story Hanwang High School is within 10 kilometers of the ruptured fault, and sustained significant damage but no collapse. Construction consisted of CIP-RC framing and URM walls. The walls had extensive damage, and concrete columns failed because the URM walls created captive columns (*Figure 3*).

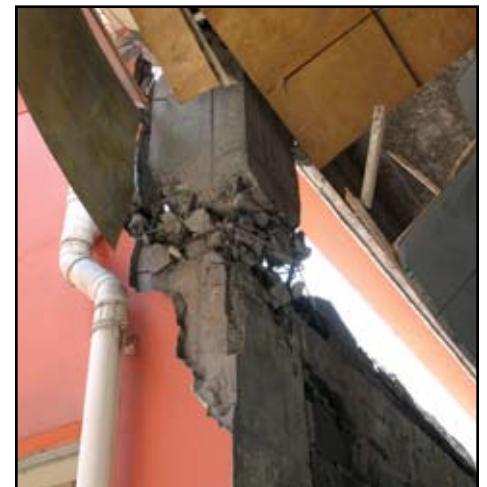
The Mianzhu Experimental School is located about 20 kilometers from the fault rupture. Framing was comprised of nonductile CIP-RC columns and beams, as well as URM infill walls, and there was significant structural damage. In particular, a large flexural demand and a lack of adequate confining transverse reinforcement resulted in severe column damage (*Figure 4*).

Figure 4: Column flexural damage, Mianzhu Experimental School.
