# STRUCTURAL FORENSICS

## Cases of Failure of Unreinforced Brick Walls Due to Out-Of-Plane Loads

By Dan Eschenasy, P.E.

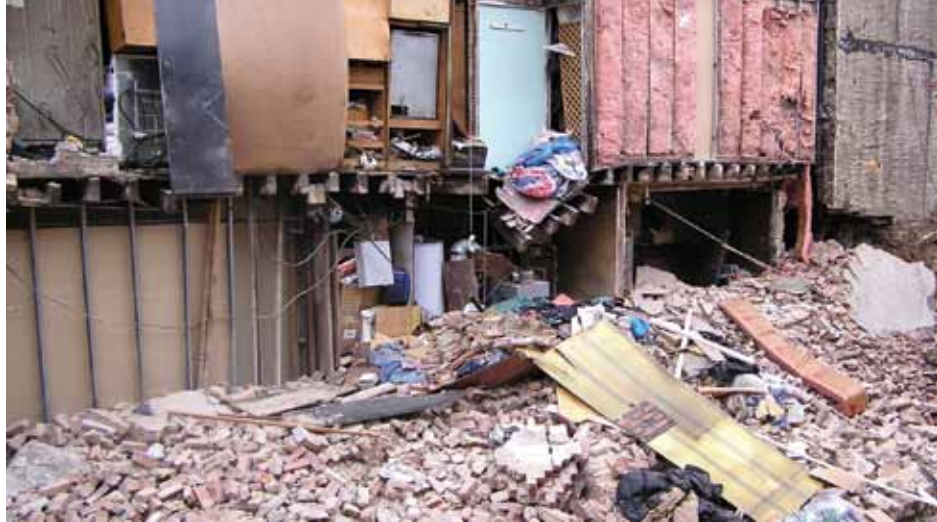
Wall collapse during excavation/underpinning. Note lack of joist ties to masonry.

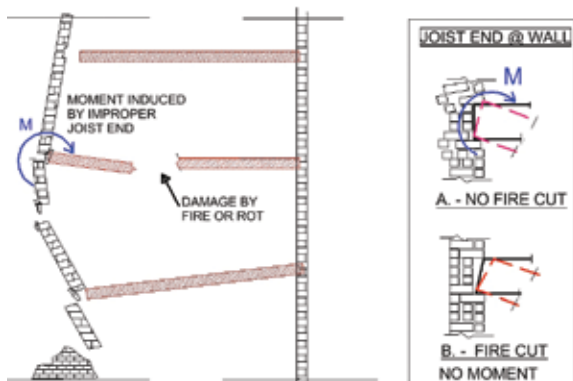
Figure 1: Out-of-plane moment due to collapsing floor.

The wall thickness requirements were intended to avoid the collapse of the bearing wall that may have become too slender in the event of a wood floor collapse during fire. Limitations of the percentage of openings in the wall that were intended to avoid large concentrations of stresses, resulted in the presence of a substantial shear wall. All elements of the building were required to be tied (wall intersections were to be toothed and tied with metal anchors; floor joists had to be anchored to both the bearing and the side walls). The empirical practice of tying of the building elements together and the measures intended to avoid total wall collapse seemed to have been precursors to the modern building integrity design provisions preventing progressive collapse.

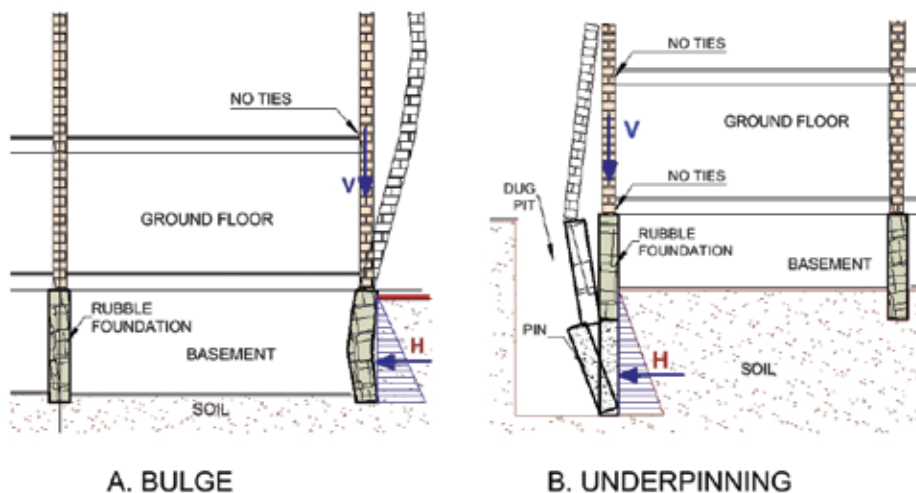
Figure 2: Out-of-plane loads on foundations. Higher vertical load has stabilizing effect at underpinning.

The most significant of the underpinning accidents that were investigated involved out-of-plane wall collapses that occurred after most of the pins had been placed. The analysis found that excavation in front of the foundation had transformed the existing foundation wall into a soil retaining system. The addition of the pins had increased the magnitude of the lateral load even more. In essence, the rubble foundation wall was subjected to loads for which it had not been originally designed. The deleterious result was magnified by an increase in the wall slenderness resulting from the added height of the underpin. As a result, the overturning of the entire assembly – masonry walls, rubble foundation walls and concrete underpinning systems – occurred when the loads could not be effectively transferred to the floor diaphragms (Figure 2).

It is interesting to note that the severity of incidents was in direct correlation to the

weight of the structure above, with the weight of the structure in fact improving the moment resistance and stability of the walls.

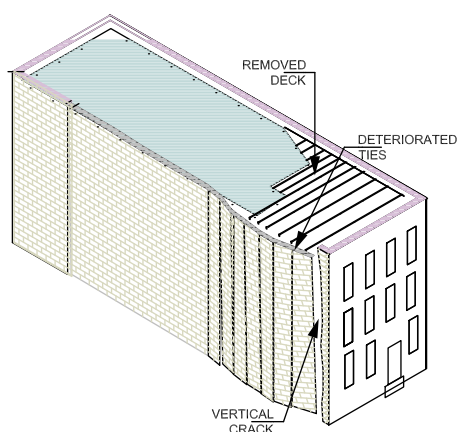
Analysis of another recent collapse found that it had occurred in a wall with a vertical crack at the corner that extended the entire building height. The wood floor framing system was comprised of wood joists; however, the wood planks had been removed (Figure 3). A relatively small local load created by a bulge at the basement could not be directly transferred to the shear walls because the diaphragm had been impaired and the direct corner connection was no longer present.

Figure 3: Lack of load path due to missing ties, vertical cracks or removal of flooring.

Some cracks, especially vertical corner cracks, may interrupt the continuity of load paths. Cracks should not be allowed to become “historic”. Walls with such cracks can collapse when subjected to even minor new out-of-plane loads.

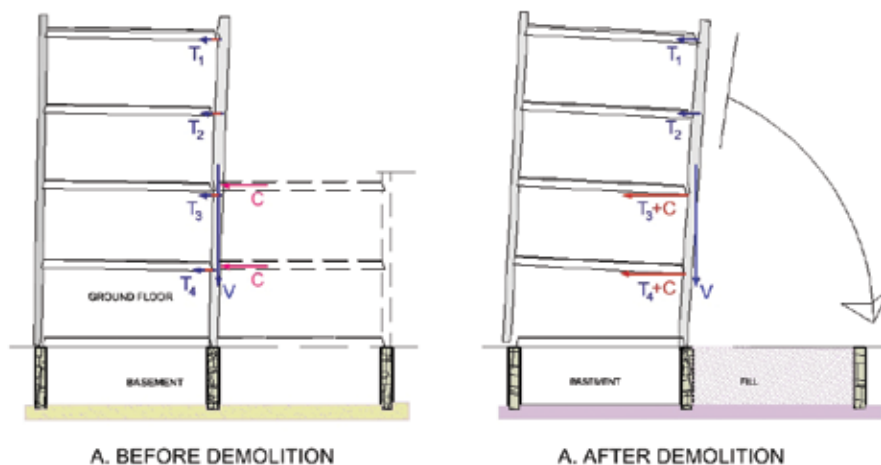
Figure 4: Out-of-plane moment produced by wall lean. Demolition of adjoining building increases demand on lateral supporting system.

Some abutting masonry buildings support each other. This is particularly the case when one of the buildings is leaning. The moment resulting from the lean, in fact an out-of-plane load, might overcome the capacity of the floor diaphragms or the shear walls. If the lean is stopped by the walls of the adjoining building, the condition might appear stable. Demolition operations need to be designed to take into consideration the possible destabilizing effect on the adjoining building (Figure 4).

In a recent case, the demolition exposed a bearing wall that was leaning. The building also had a full height vertical corner crack that interrupted the transfer of the forces to the shear wall. Various shoring solutions were tried but did not stop the ever increasing lean. Public safety required demolition.

Whatever the cause of the lean – foundation rotation, settlement or original out of plumb construction – the condition needs to be evaluated using detailed engineering analysis. Even when the safety factors are found to be acceptable, periodic inspections must be performed as settlement and creep can further increase the out-of-plane moments.

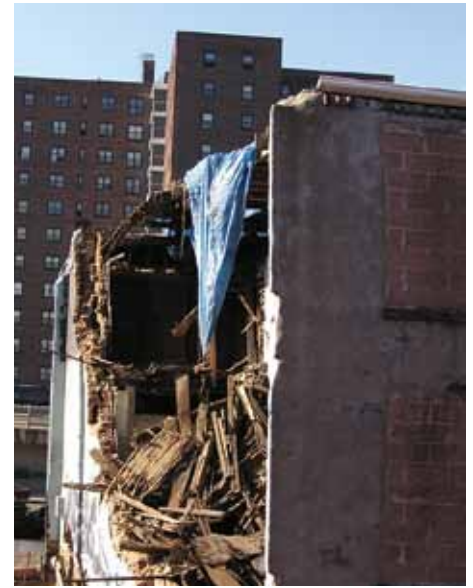
*Roof opening allowed rot of joists and decay of mortar in masonry.*
