# STRUCTURAL FORENSICS

## Unstable Shelves Put the Shake in Shakespeare

By Betsy Wilkinson, P.E., S.E.  
and Alberta Comer, MLS

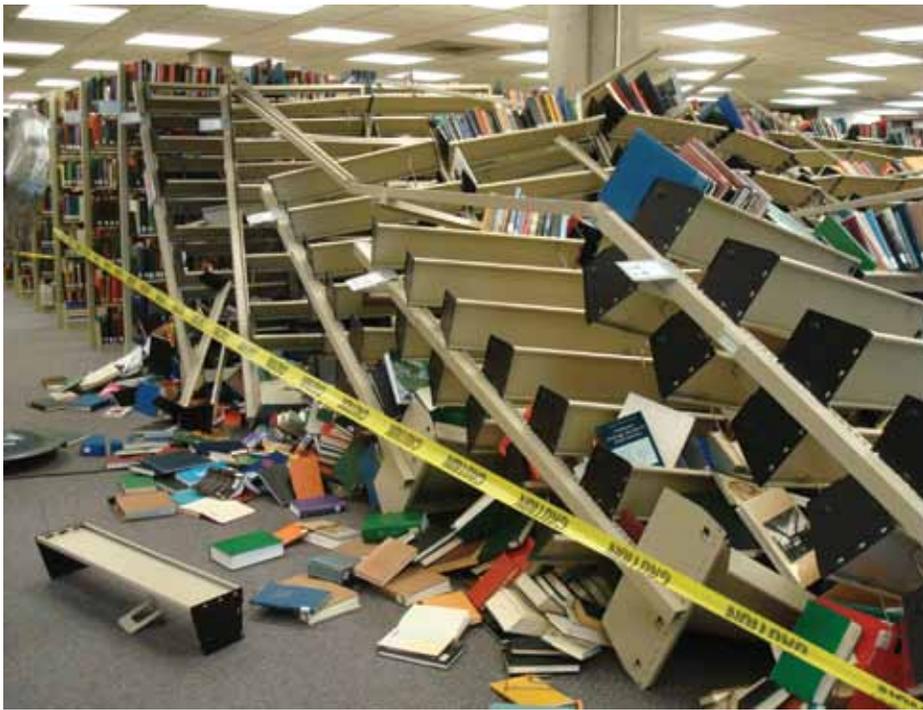
At the library, the Dean proceeded immediately to the second floor stacks where the ranges had fallen. There she found five ranges, each with 13 sections, collapsed and two more ranges precipitously leaning. Later it was determined that about 20,000 books were on the floor. The Dean called the Facilities Department and asked for their assistance in assessing the situation. Facilities responded immediately. After the General Construction Supervisor reviewed the situation, he determined that the area was unsafe for public or staff. Since each library floor is connected by 2 elevators and 4 stairwells, it was not practical to block off the entire floor. An electronic alert was broadcasted to campus that the Library was closing for the rest of that day and would also be closed the following day to allow time for safety measures to be put in place.

magnitude; however, the first two causes proved enough to make the difference. It was determined that a combination of two factors initiated the first shelf to fall over, which created a domino effect on the remaining shelves. At the time of the collapse, the books were being reorganized and re-shelved. In addition, some top braces were missing their bolts to the ranges. The shelf sections were also not bolted to the floor. It is believed that the initial row of shelves fell due to temporary shelving asymmetry and floor deflection. When a top brace was removed, this released the top of that shelf allowing it to deflect and then become unstable.

The seismic force must be determined for a typical shelf section. The seismic force is directly related to the weight of the shelves plus the books. The seismic analysis revealed a need to establish a pattern of bolted bases and top bracing. Not every row required bolting because the top bracing helps deliver the forces to a bolted row. For every row that was bolted to the floor, up to four more rows of ranges could be braced to that bolted row to use it for support during an earthquake. In addition, some of the bracing was bolted directly to building columns to eliminate some of the required floor bolting.
