## Tuscaloosa Tornado

### Preliminary Observations on Wood-Frame Buildings Damage Assessment

By Dr. David O. Prevatt, P.E.,  
Dr. John van de Lindt,  
Dr. Rakesh Gupta and  
Bill Coulbourne, P.E.

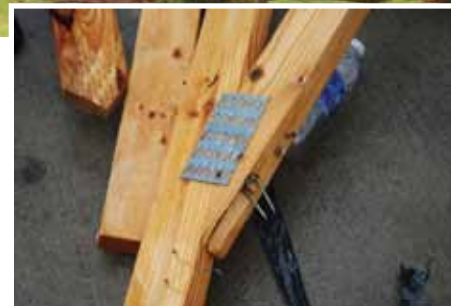
Figure 1: Toe-nailed connection for truss.

The study team found numerous instances where detailing in accordance with current building codes for hurricane-prone regions would have reduced the damage and potentially reduced injuries. Examples of damage included roof loss due to inadequate toenailed connections for trusses or rafters (Figure 1), porch or carport column uplift failures (Figure 2), and the attachment of sill plates with only concrete cut nails (Figure 3). The team also observed a lack of connections at the wall boundaries that may have contributed to the loss of exterior walls, especially when the building envelope was breached and the walls were pressurized from the inside (Figure 4, page 26). Many of these buildings were built before the existence of manufactured connectors that better provide a continuous load path. In addition, as expected in a tornado, windborne debris created many penetrations and openings through the building envelope.

For tornadoes of low to moderate intensity (EF0-EF2), it may be possible to save lives and reduce injuries by employing load path enhancement techniques known to work in hurricane-prone regions. At the moment, such measures would be optional for owners, but they need to be fully understood by builders and building code officials so that, for those who want them, the quality of the construction and inspections ensures improved building performance should the building be impacted by a tornado.

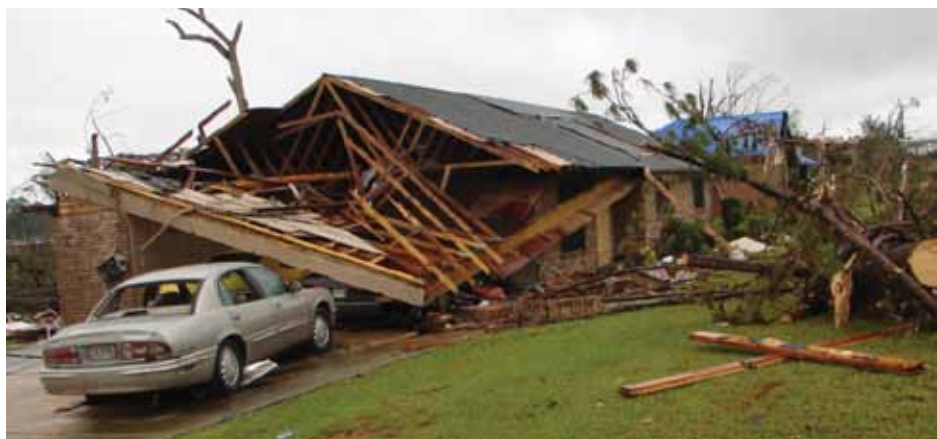
Figure 2: Carport column uplift failure.

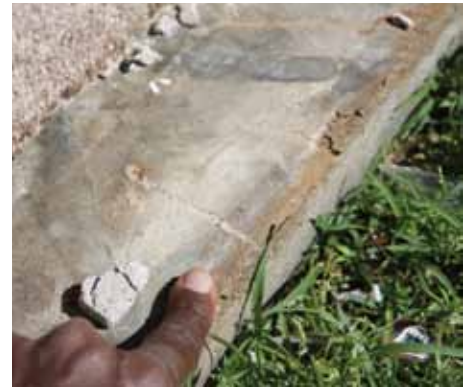
Figure 3: Evidence of cut nail at sill plate.

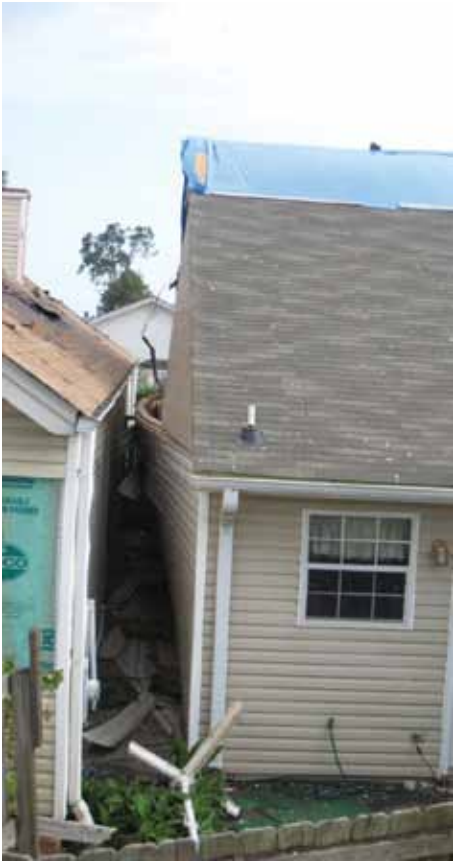
Figure 4: Pressurized exterior wall.

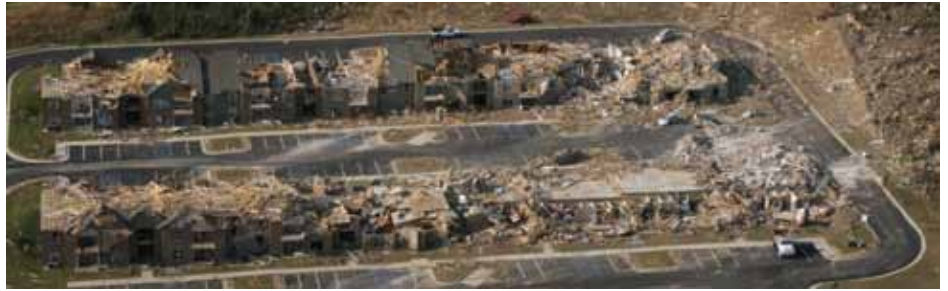
The team observed that for the highest tornado wind speeds (EF5), even new buildings built to more recent building codes were completely destroyed, as one might anticipate given that the forces are in excess of four to five times the design values. Figure 5 (page 26) shows

an apartment complex that was completed in 2010 and was about half occupied at the time of the tornado. The whole facility was damaged extensively because it was in the direct path of the tornado and wind speeds increased even further because of the terrain, which consisted of hills on all sides. Evidence suggests that the structures were likely designed and built according to the 2006 IBC, with hurricane clips between trusses and the top plates, code-required nailing of roof and wall sheathing, and anchor bolts in exterior wall sill plates every four to six feet. Part of the complex

Figure 5: Catastrophic damage at apartment complex.

was leveled down to a clean concrete slab, where even linoleum flooring was removed. This illustrates the difficulty of designing a wood frame building economically that can resist the effects of the most severe tornado wind speeds.
