# STRUCTURAL REHABILITATION

## Prescription for Repair

*The Triage, Life Support  
and Subsequent Euthanasia  
of an Existing Precast  
Parking Garage – Part 3*

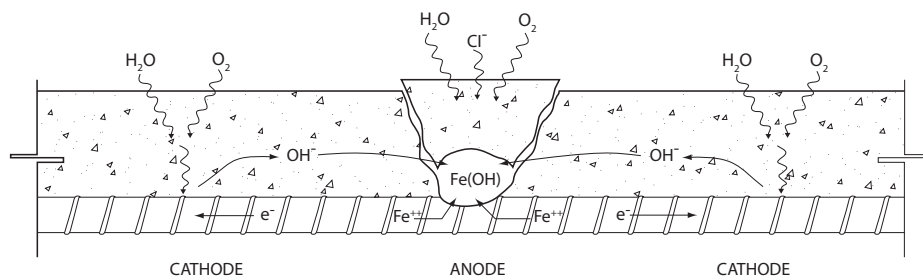
Furthermore, conventional concrete repairs, in the absence of chloride extraction or an active or passive galvanic protection system, would result in the accelerated deterioration of the remaining existing concrete due to the interruption of the incipient anode effect (see *Figure*). The incipient anode effect is a phenomenon by which steel corroding under the influence of chloride contamination dissolves, causing the formation of iron "ions" (tiny charged particles of iron). Simultaneously, electrons are released that flow along the bar and react with both air and oxygen at some point remote from the corrosion location. The corroding areas are therefore supplying electrons to surrounding areas of steel, effectively providing localized cathodic protection to the adjacent steel. If the corroding area is removed and a repair patch is installed, without dealing with chloride contamination in adjacent areas, the natural cathodic

protection system is disabled. As a result, new corrosion cells rapidly occur on either side of the repair, resulting in accelerated premature failure of the surrounding concrete.
