The Structural Investigation of a 19th Century Manufacturing Complex

By D. Matthew Stuart, P.E., S.E., F. ASCE, SECB

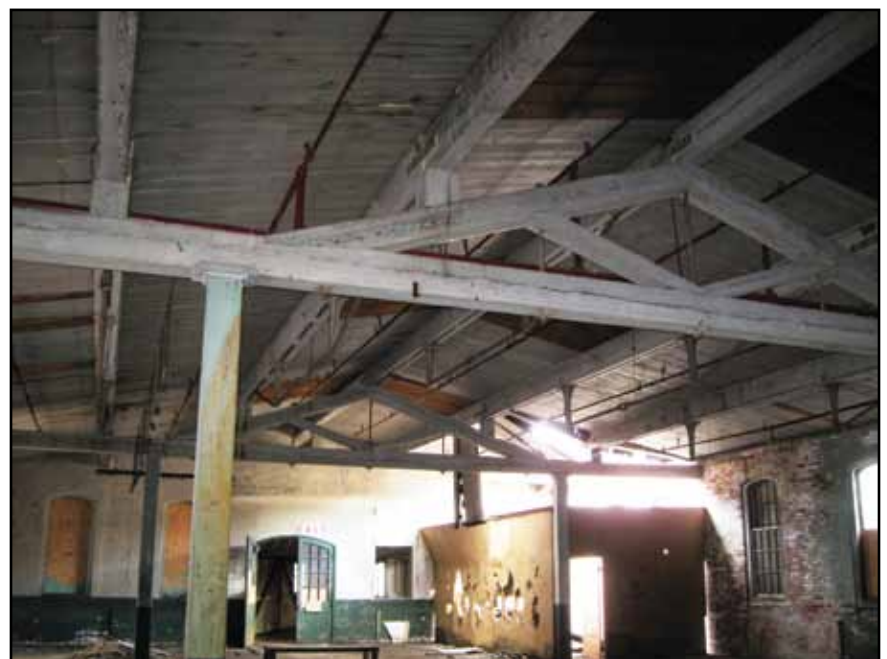
Queen Post Truss Spanning Between Gable Truss.

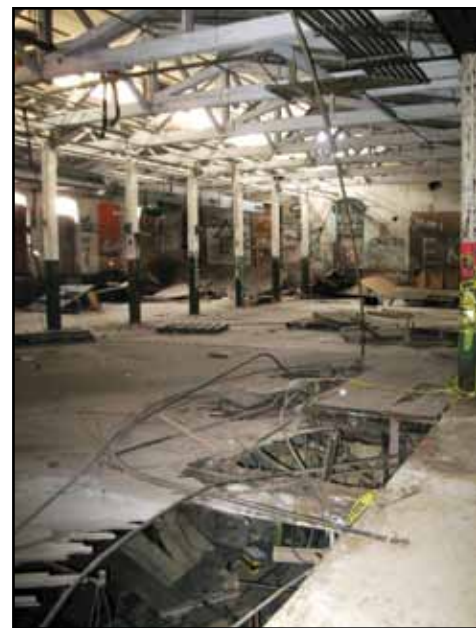
Collapsed 1st Floor Framing over Basement.

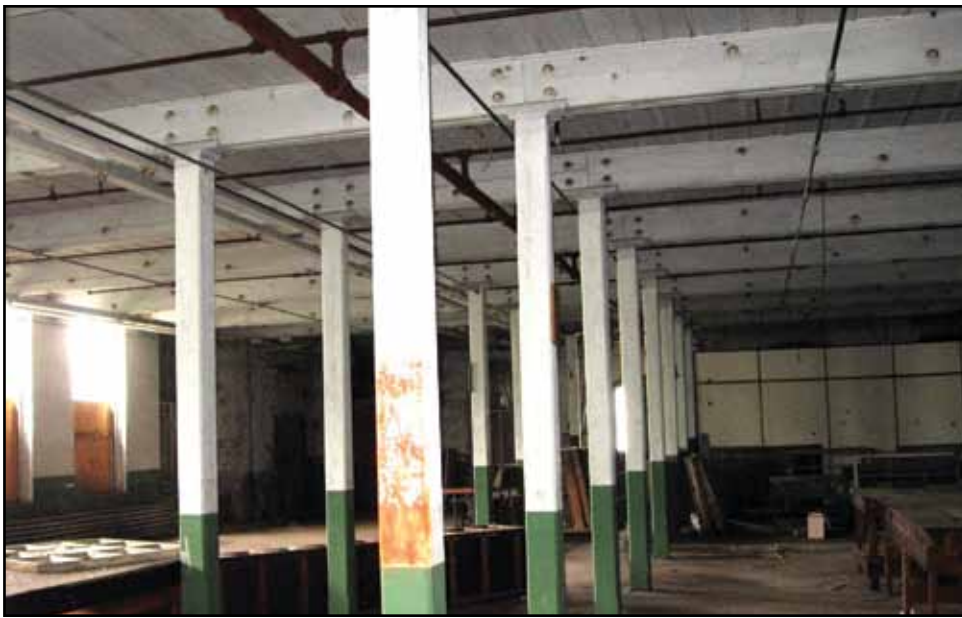
- 2) The primary timber floor support beams for two of the main buildings were constructed as two identical wood members bolted or sistered together. Butt joints of the individual pieces occurred over interior support columns, and were always offset such that only one beam joint occurred at any one location along the length of the member. For purposes of analysis, these members were assumed to be continuous over all of the interior supports, even though at least one of the members was discontinuous at the butt joint. This approach was based on the rationalization that the butt joints are capable of acting as a 100% negative moment splice of the individual beam, given the following assumptions:

- a) The nature of the butt joint allowed for the transmission of compressive stresses at the bottom of the individual beam, induced by the negative moment at the support columns via the direct contact of the adjacent butt ends of the adjoining wood beams.

- b) Tensile forces at the top of the individual beams induced by the negative moment at the supports were resisted at the butt joint by the spline jointed timber floor planking, which was assumed to be spiked together with at least 60d nails.

3-Span Continuous Wood Beams.
