Mast Swap

By Paul A. Gossen, P.E., F. ASCE and David M. Campbell, P.E., M. ASCE

After 25 years, the masts of the Tennessee Pavilion showed signs of deterioration and structural deficiencies. Replacement of the masts, while keeping the fabric membrane in place, created a challenge for the engineer and erector.

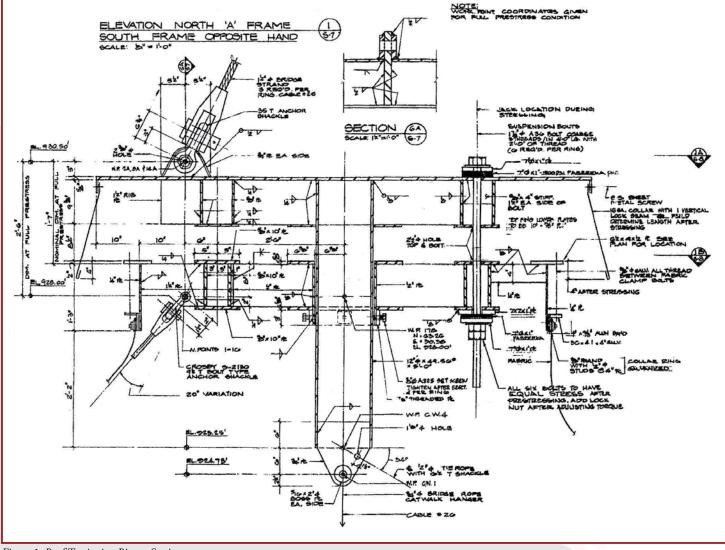
Figure 1: Roof Tensioning Ring – Section.

As illustrated in *Figure 1*, a stationary ring is suspended from the tripod by three cables. A secondary ring is suspended below the stationary ring by 6 threaded rods. The cone-top fabric and radial cables

are fastened to the secondary ring. Tightening the threaded rods, thus pulling the secondary ring toward the apex of the tripod, tensions the system since the fabric and radial cables are anchored to perimeter foundations. Tensioning the radial cables causes them to lose their sag, thus introducing radial stresses in the fabric. At the same time, this introduces lengthwise stresses through jacking of the fabric at the "neck" of the tent. This operation stresses the fabric in two directions at once. Stressing the fabric in only one direction would result in wrinkles.

* The first tent was de-tensioned by threading down the nuts on the six rods that connect the stationary ring to the fabric support ring. A temporary anchorage was installed on the mast abutments and the edge catenaries. Radial cable anchors were transferred from the base plates of the masts to the temporary anchorage. The 190-ton crane was hooked up to the ring supporting the fabric and the fabric was re-tensioned slightly. The weight of the tent to the crane was 30,000 pounds (133 KN), but was increased to 40,000 pounds (178 KN) to retain some pretension of the fabric. Re-tensioning also provided space for rotating the masts back, which relaxed the load in the tie-back cable. This made it easier to detention the cable at the abutment. The purpose of this operation was to reduce the horizontal load component of the tie-back cable at the tripod apex as much as possible. At this point, the only forces in the apex connection were from the weight of the masts and the tie-back cable.

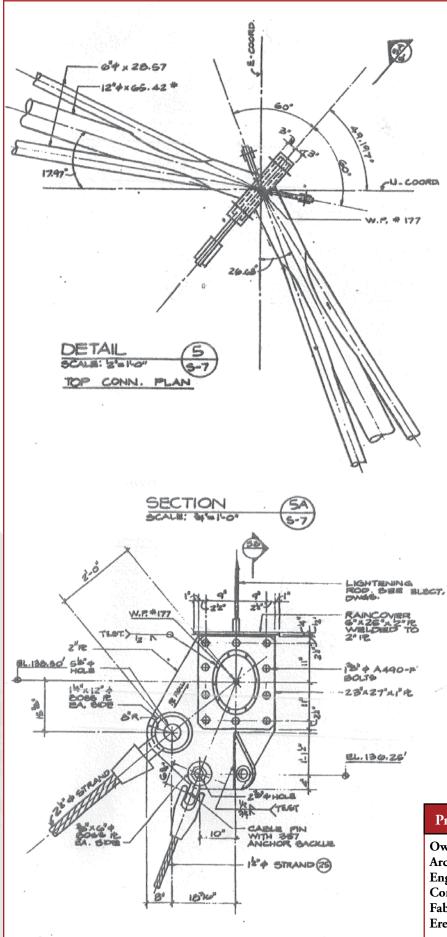
Figure 2: "Tripod" Top Detail.

Base plates of the masts that were removed also anchored radial and edge tent catenaries that needed to be temporarily tied to abutments that support the masts. Configuration of the tripod apex incorporated a detail that made exchanging the masts challenging (*Figure 2, page 40*). The mast tops had bearing plates that butt against each other. Sandwiched between these bearing plates is a plate that anchors the 21/2-inch ø (56 mm) tie-back cable. Load from the tie-back cable is transferred into the masts through (10) 1%-inch ø (35 mm) SC bolts. Unbolting this connection would release all three components simultaneously. Another consideration was to avoid disconnecting the tie-back cable, since it would

have been very hard to reconnect the cable at the tripod apex. A procedure was devised to support the tent from a crane while exchanging the old masts for the new. In all, three cranes were required: one 190-ton crane supported the tent and with its secondary hook, the top of the mast to be removed; a second crane picked-up the mast near its center of gravity, and; a third crane hoisted the work crew.

* A temporary weld was used to connect the sandwiched tie-back anchor plate to the bearing plate on the mast that would remain in place while the other was removed.

* A cable was fastened behind the bearing plate of the remaining mast and was strung to an existing tent anchor that lay in line with the tie-back cable. The purpose of this cable was to resist the horizontal component of the tie-back cable once one mast had been removed.

* By lifting the top of the mast that would remain, pressure at the mast's butt connection was reduced enough for bolt removal. A second crane was now able to swing the other mast away and set it aside. The mast with the tie-back cable attached remained in place for the time being. The replacement mast was then swungin and set on the existing anchor abutment. Space was very tight at the apex connection, since the top of the mast had to be needled through tent support cables. The assembly was lifted slightly to line-up the mast top with the tie-back cable anchor plates.

* Once the plates lined up, drift pins were used to align bolt holes. A 3-inch (75mm) long fillet weld was applied to fasten the new mast bearing plate to the tie-back anchor plate. The cable that had been installed behind the old mast bearing plate was disengaged and reinstalled behind the new mast bearing plate. The temporary weld between the old mast bearing plate and the tie back anchor plate was removed after a crane had been hooked to the center of the mast. This then enabled removal of the other old mast and installation of the second new mast. New 1³/₈inch ø (75 mm) ASTM A 490 SC bolts were installed to clamp the assembly together.

* Where bolts could not be installed due to misalignment, they were substituted with fillet welds around the perimeter of the plates.
