Building Envelope Solutions for the South Tower of the Milwaukee City Hall

Part 3

By Peter M. Babaian, P.E., S.E., Francesco J. Spagna, P.E., and Brent A. Gabby, P.E.

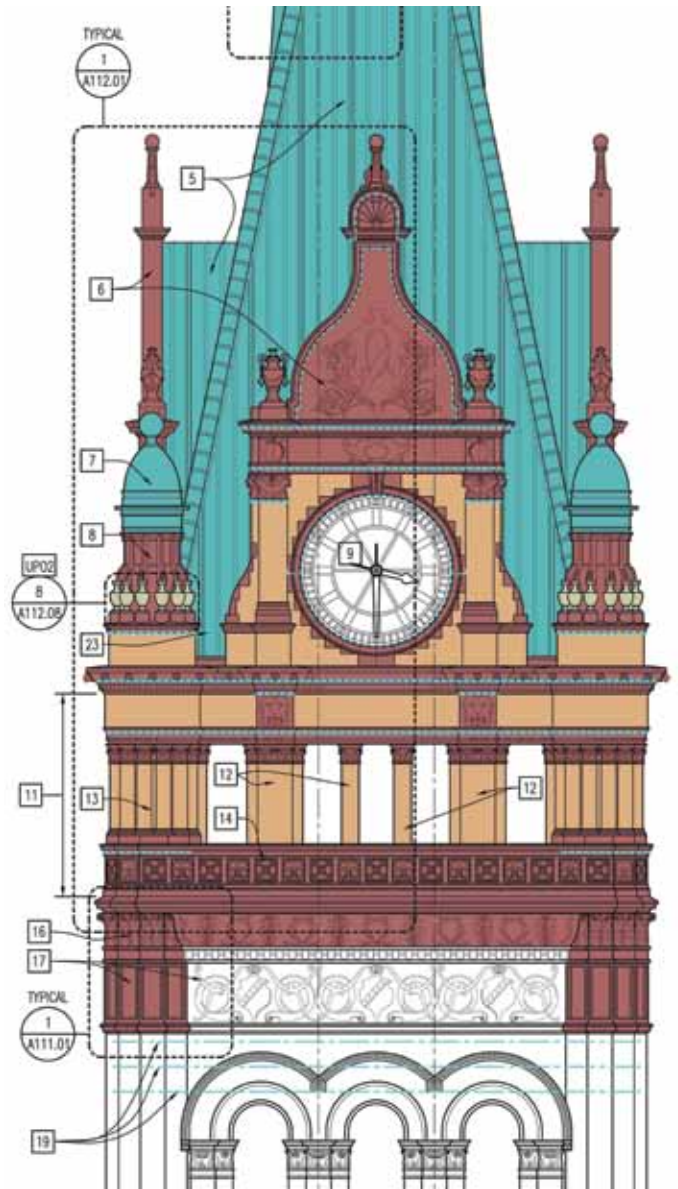
To change the wall system from load-bearing masonry to cavity wall construction, the design team carefully located new, epoxy-anchored relieving angles on the South Tower facades, typically at locations where the masonry stepped out of plane. The location of relieving angles is shown in *Figure 2*. In cavity wall systems, flashings are typically used at relieving angle locations to drain water from the wall system. By locating the relieving angles at steps in the masonry, the flashing drip edge was typically hidden in a shadow line and difficult to detect. This allowed the design team to introduce the flashings without altering the appearance of the building.

Figure 2: Scope of work elevation for the South Tower. New relieving angles are located at all new flashing locations (shown as horizontal blue dashed lines).

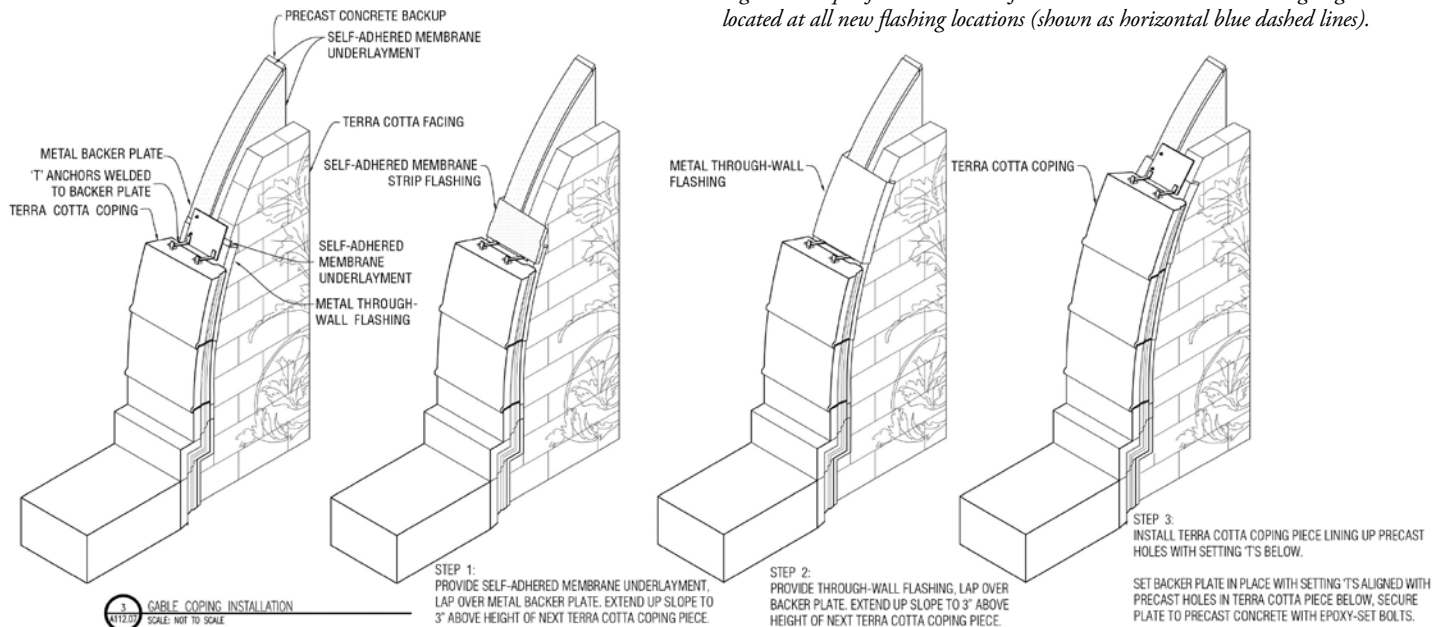
Figure 3: Sequence for installation of waterproofing, flashing, and terra cotta cladding.

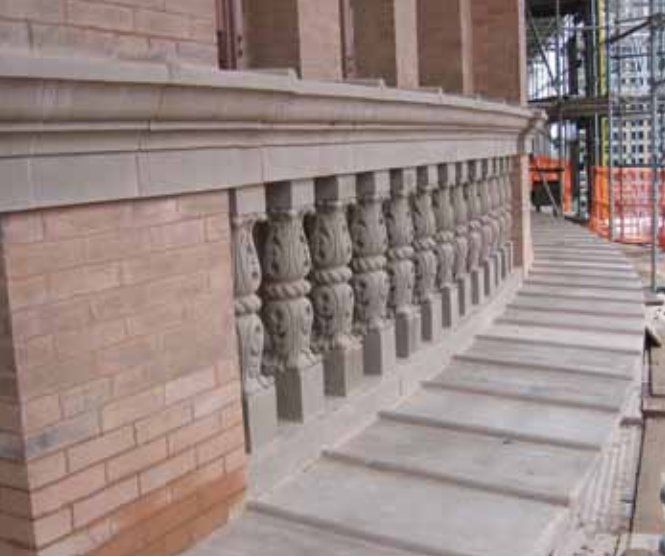
Figure 4: Typical terra cotta cladding with roll caps found throughout the structure.
