Solutions to Structural Distress in the South Tower of the Milwaukee City Hall

Part 2

By
Mark D. Webster,
LEED AP, P.E.,
Gunjeet Juneja, P.E.
and Donald O.
Dusenberry, P.E.

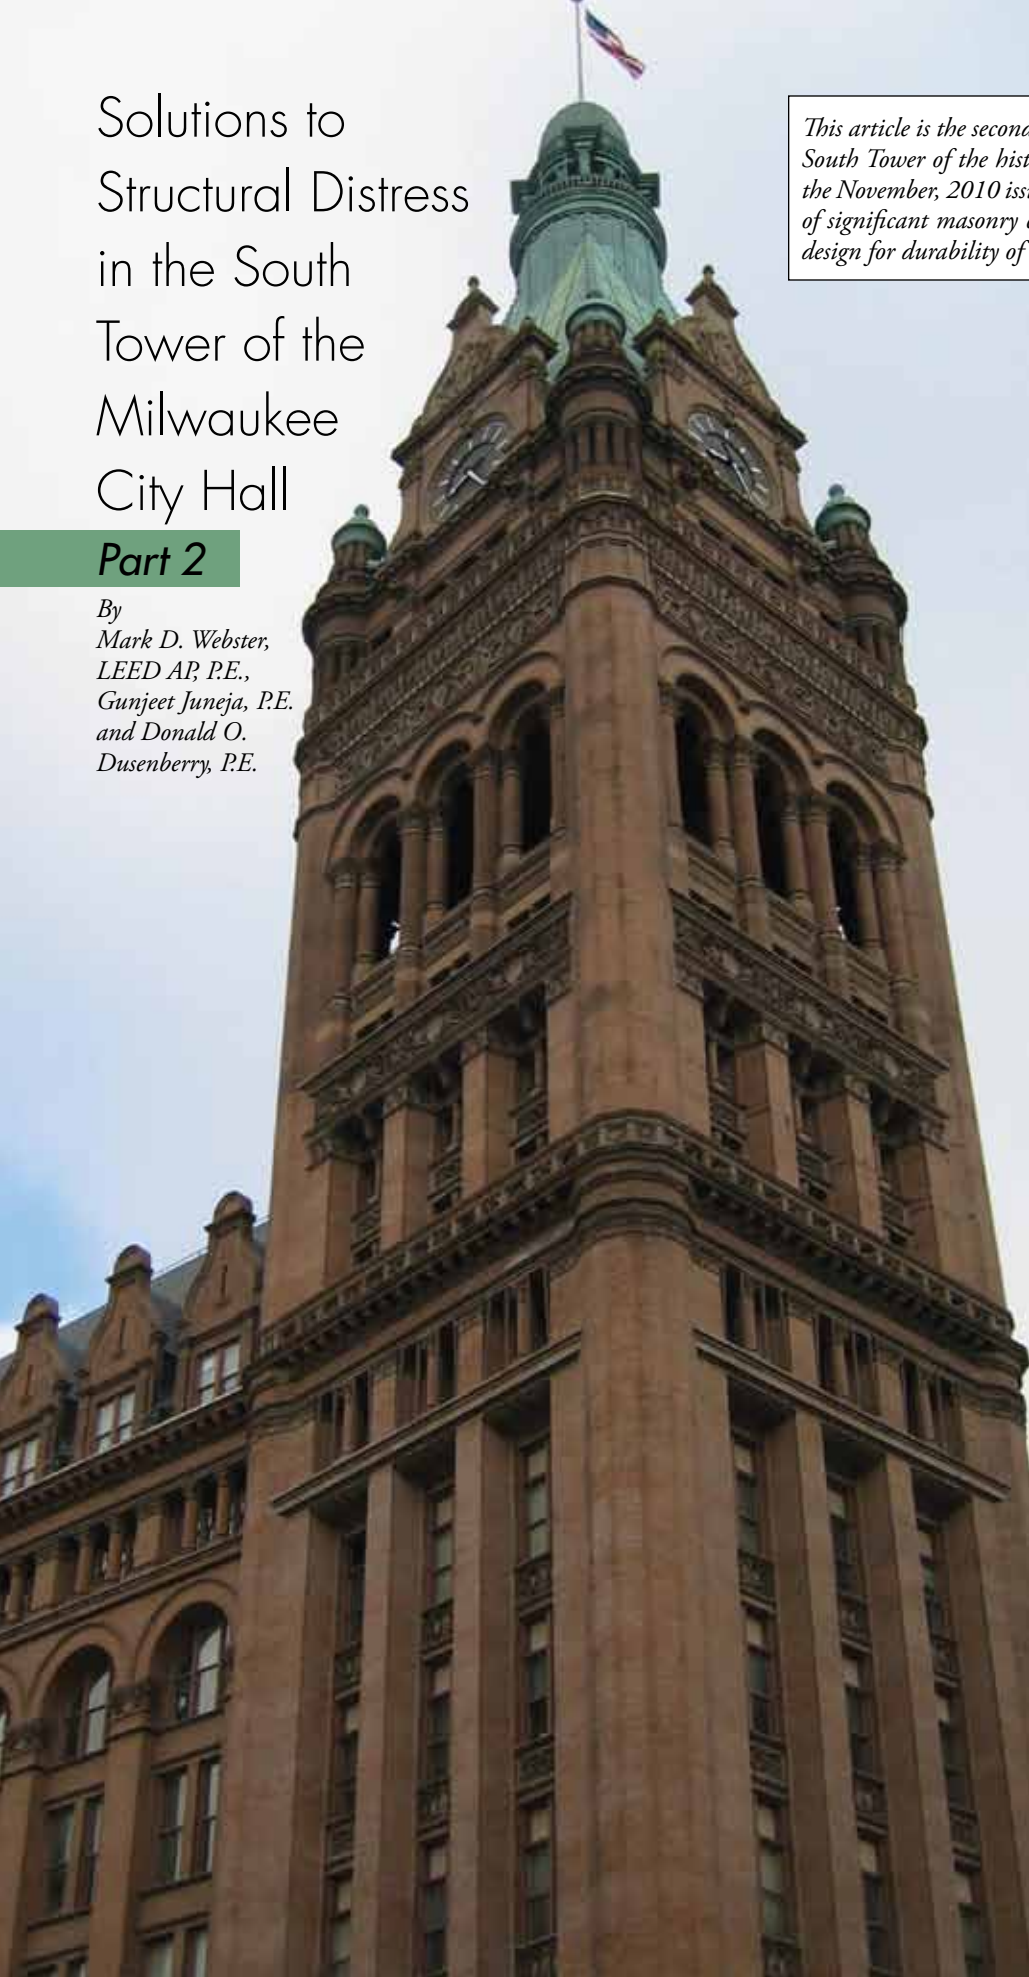
Figure 1: Milwaukee City Hall's South Tower.

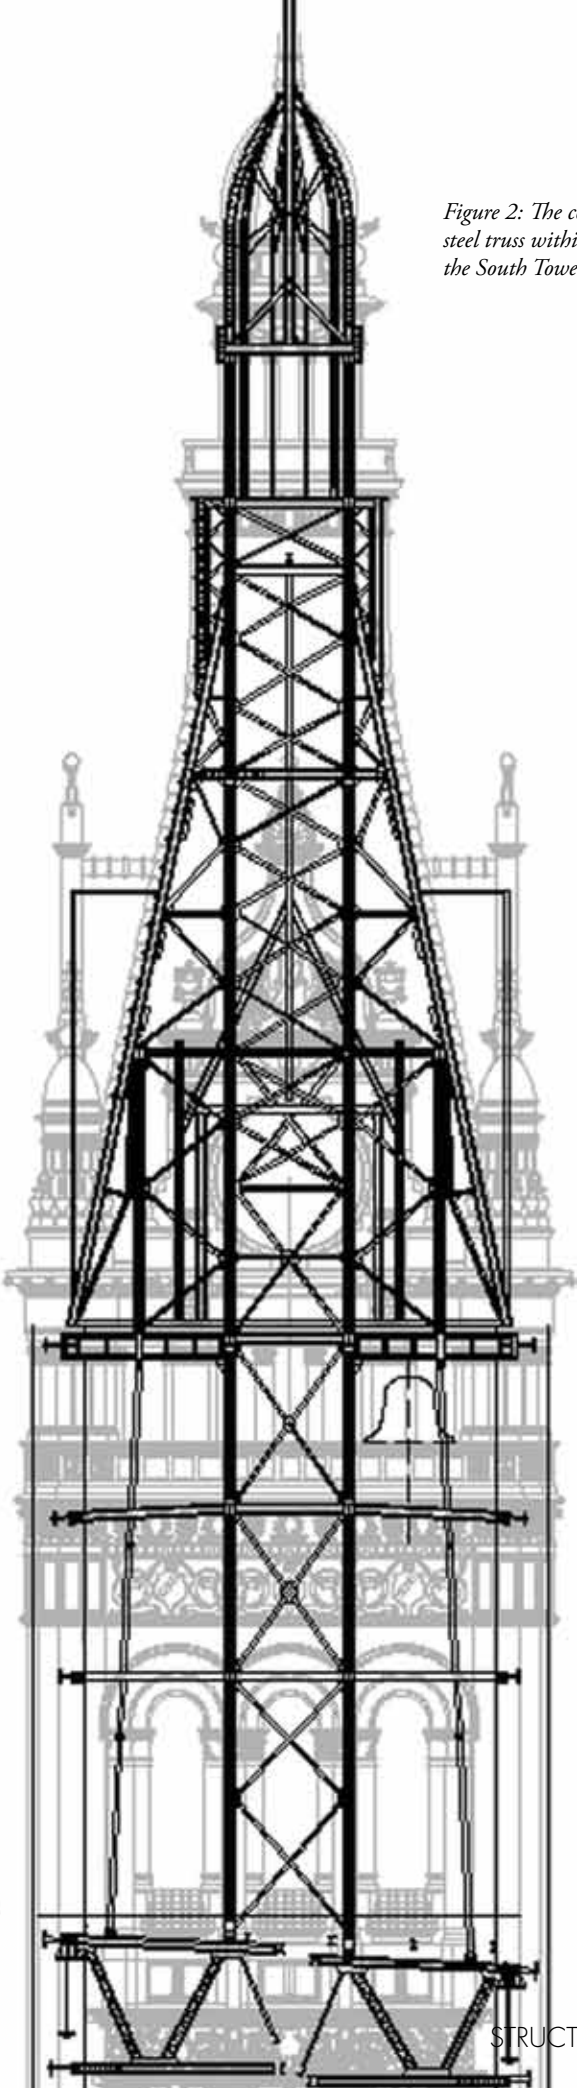
The interior steel structure (the core truss, Figure 2) of the tower extends from the 10th floor to the lantern at the apex of the roof, 86 feet above the 13th floor. The truss was analyzed using a two-dimensional model representing one plane of the three-dimensional trusswork. This model calculated the load distribution through the truss under the weight of the roof and wind loads acting on the roof, and provided the reactions of the steel structure on the masonry for the design of masonry rehabilitation.

Figure 2: The core steel truss within the South Tower.

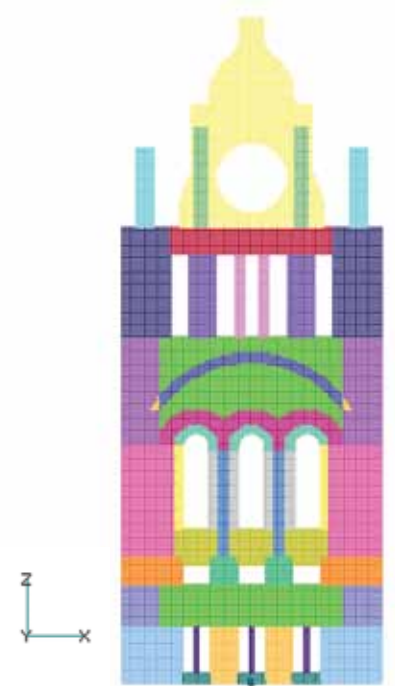
The reactions from the steel truss analysis were applied to a FE model of one side of the masonry tower from the 9th to 13th floors. The effect of the adjacent perpendicular walls at the tower corners was modeled by applying a symmetric boundary condition about a 45-degree plane through the center of the corner pier. *Figure 3* shows the FE mesh of the masonry tower model.

The cross-sectional properties of the wall and piers were computed, incorporating the offsets in the wall at different levels. The various colors in *Figure 3* represent the different section and material properties used in the model. SGH analyzed the wall for gravity loads including the reactions from the steel tower. The resulting stress values were used to design the repairs at and above the 11th floor.

Figure 3: FE mesh of the tower masonry.

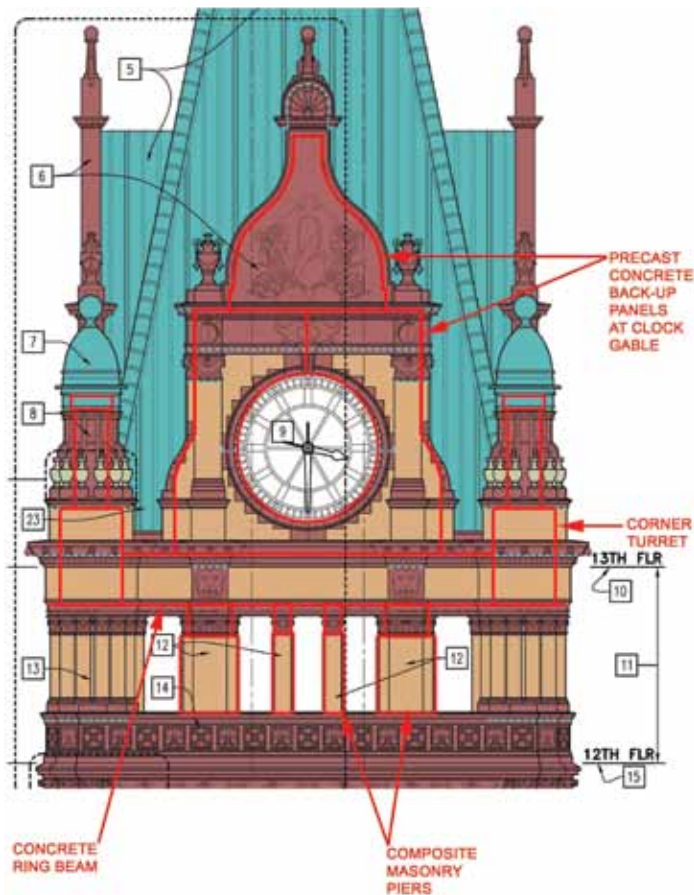
The structural analysis found excessive horizontal tension stresses in the perimeter masonry at the 13th level. These walls supported four solid masonry gables, incorporating 15-foot diameter clocks, and massive solid masonry corner turrets, as well as a portion of the load from the sloping steel-framed roof.

Figure 4: Schematic diagram showing location of major new structural elements.

To resist the stresses at the 13th level, we designed a reinforced concrete “ring beam” that is 1 foot 3 inches wide by 4 feet 6 inches deep. Because the gable walls and corner turrets were in poor condition, and constructing the ring beam required removing the masonry at this level, it was determined that the solution that best matched the economic and durability goals of the project was to remove and reconstruct the masonry from the 13th level up, incorporating modern materials and systems while maintaining the historical appearance of the tower.

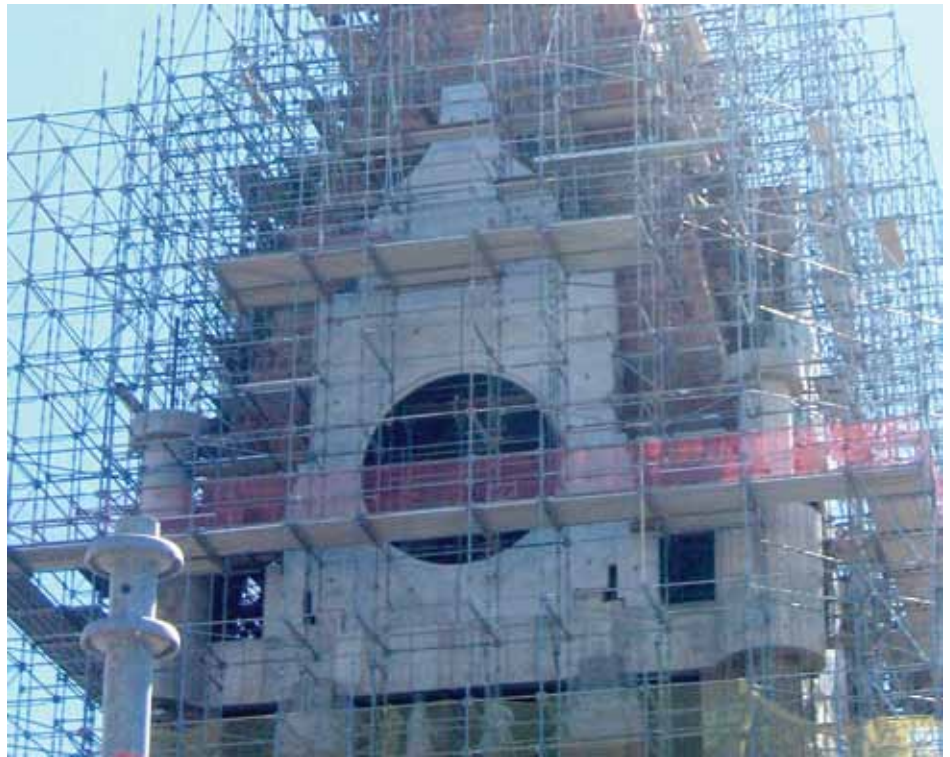
Figure 5: View of the ring beam, corner turrets, and clock gable precast backup during construction.

The clock gables were originally constructed using solid mass masonry with embedded structural steel framing. Precast concrete panels attached to new structural-steel framing were used to reconstruct the gables. This solution offered structural system continuity with the steel framing in the core truss, eliminated any embedded structural-steel framing that would be vulnerable to future hidden corrosion, and provided a stable backup surface for the brick veneer cavity wall system used to face the new gables.

Three 6-inch precast panels were specified to frame the face of each gable (Figure 5) and two panels for the cheek walls, nominally reinforced with #5 bars at 12 inches on center each way at panel mid-thickness. The panels were designed to resist their self-weight, out-of-plane wind, and seismic forces, providing connections with slotted and oversized holes between the precast and steel to isolate the panels from other loads that were intended to be supported by the steel framing.
