Investigation of Distress in the South Tower of the Milwaukee City Hall

By Steven DelloRusso, P.E.,
Brent Gabby, P.E. and
Donald Dusenberry, P.E.

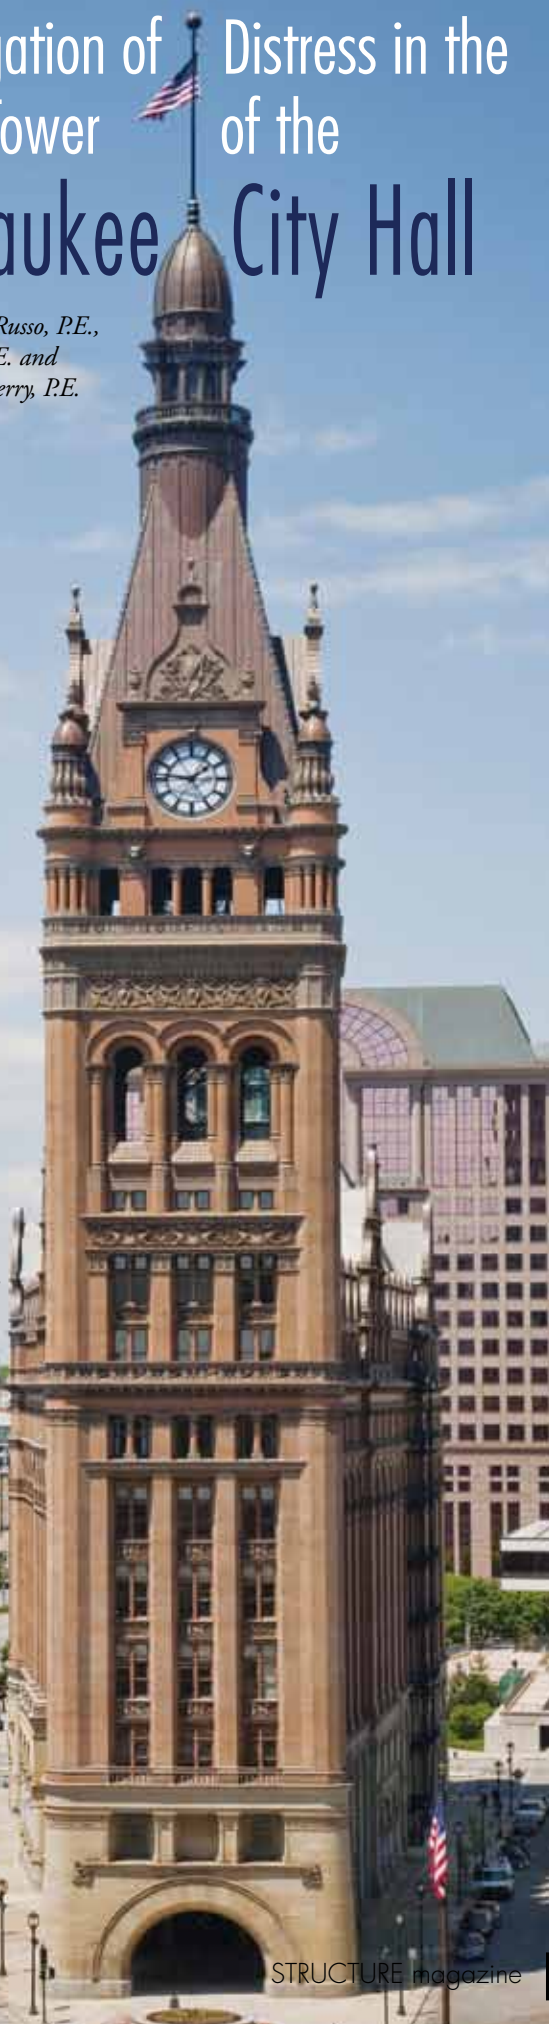
Figure 1:
Milwaukee City
Hall – South
Elevation. Courtesy
of Eric Oxendorf.

THE MILWAUKEE CITY HALL, a National Historic Landmark, was built between 1893 and 1896. Designed in the German Renaissance Revival style by Henry C. Koch & Co., the building is situated east of the Milwaukee River and has three distinctive features: the 390-foot South Tower with a copper spire and lantern, a 235-foot copper clad North Tower, and the mansard and hipped slate roofs on the nine-story main building connecting the two towers. The building, a perimeter-load-bearing masonry structure supported on wood piles, is trapezoidal in plan and approximately 300-feet long. The largely brick masonry exterior walls contain decorative terra cotta, sandstone, and granite elements with repetitive massing and detailing throughout (*Figure 1*).

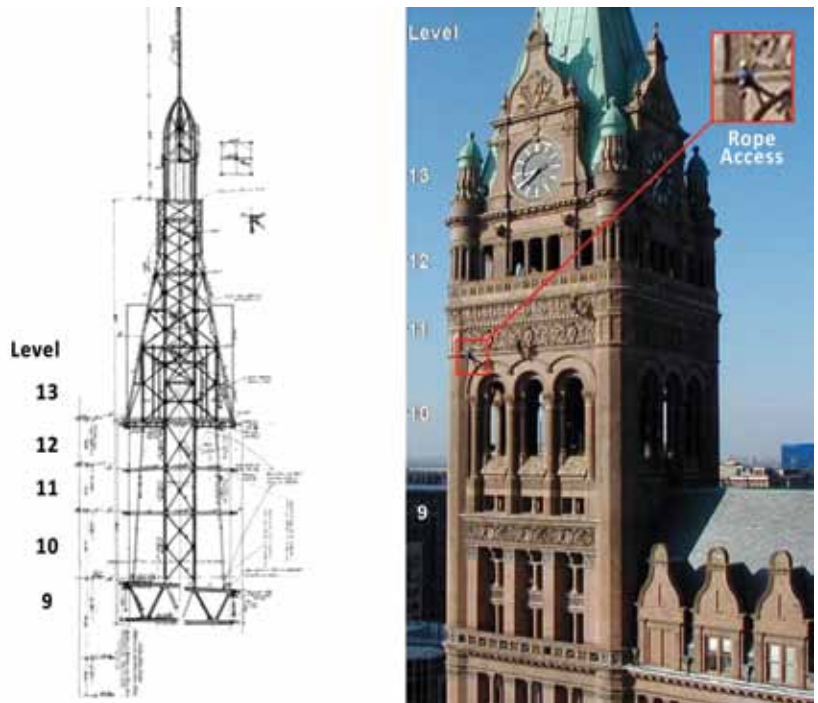
Figure 2: South Tower Structure.

The upper portion of the South Tower is a hybrid steel and masonry structure, approximately 56 feet square in plan, consisting of masonry perimeter walls up to 54-inch thick and a central four-sided steel truss (the core truss) that extends vertically from the ninth floor to the top of the roof spire (*Figure 2*). At the ninth floor, the core truss is supported on two built-up steel trusses that span diagonally between opposite tower corners.

Staging the structure for the investigation was impractical. Therefore, we used industrial rope access techniques to inspect the main façade, sloped roofs, and exterior ornamental features, including large turrets, finials, and arches (*Figure 2*). This inspection revealed extensive masonry cracking and deterioration that was not easily detected by ground or interior observation.

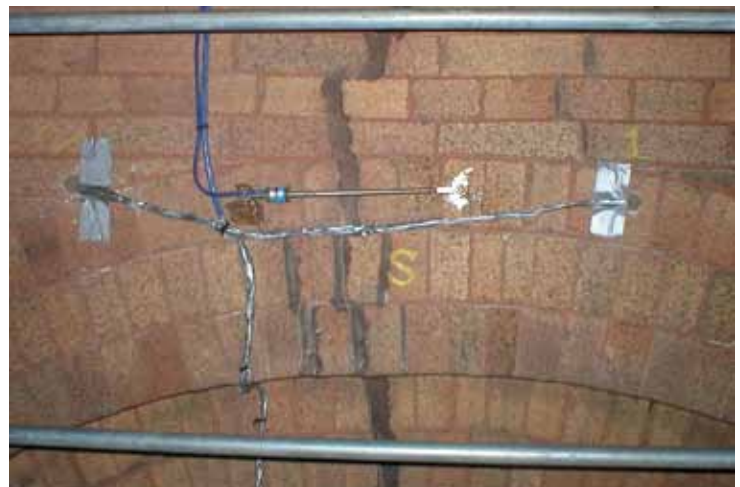
Figure 3: Crackmeter and Thermocouple Wiring Above Floor 10 Arch.

Some of the significant cracking extended from the masonry arches on floor ten upward into the brick walls of floor eleven (Figure 3). In addition, significant gaps were between the exterior masonry walls and the flooring systems on floors eleven and twelve. These gaps suggested that the tower was spreading in response to loads and environmental conditions. Circular columns at floor twelve had large vertical cracks, indicating that the columns were splitting.

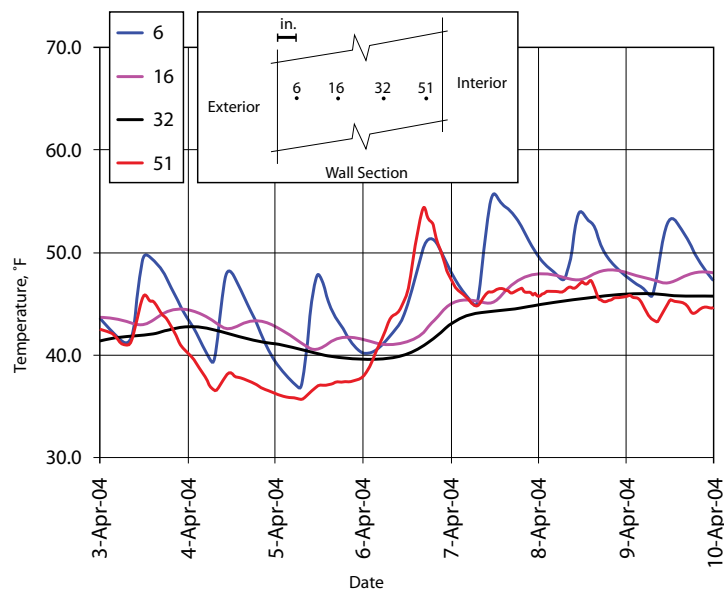
Figure 4: Daily Thermocouple Data Showing the Lag of the Central Temperatures. (East elevation – Floor 10)

Crackmeter measurements recorded daily cyclic movements as well as annual excursions, indicating that cracks were active and responded to temperature changes and thermal gradients through the wall thickness. Crackmeters on the exterior façade recorded greater movements than those on interior surfaces. Thermocouple data indicated thermal gradients within the thickness of the masonry, with temperature changes in the central portion of the wall lagging those near the faces. These transient gradients induce bending stresses in the stone (Figure 4, page 24).

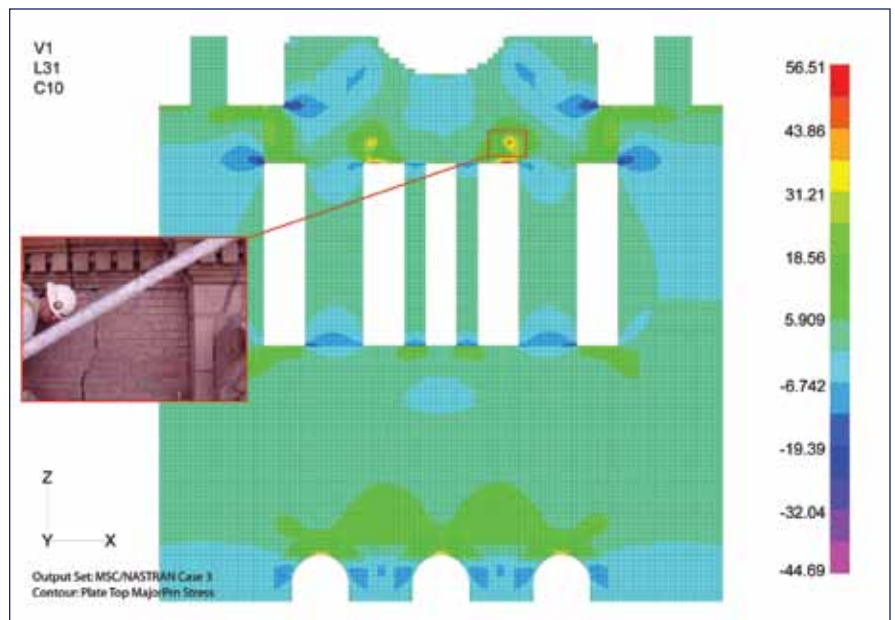
Figure 5: FEM results for Gravity Loads. Note Area of High Stress Corresponds to Location of Observed Crack on Structure.

We modeled the masonry wall from floor nine through floor thirteen under gravity and thermal loading conditions. Results for gravity loads alone showed stresses in some locations greater than the accepted values of tensile strength of the masonry, indicating that the cracks probably formed originally under gravity loads. The locations of high stress were at the tops of the floor ten and floor twelve arches, where we observed the most significant cracking in the field (Figure 5). We repeated our analysis, incorporating some discontinuities in the model to represent cracks at the locations of high stress. This analysis showed that the cracks were likely to propagate under gravity loads. Unrestrained uniform temperature changes produced little changes in resulting stresses for both models.
