A Gem in the Mountains

By Carol A. Stevens, P.E., SECB and Phillip A. Warnock, AIA, NCARB

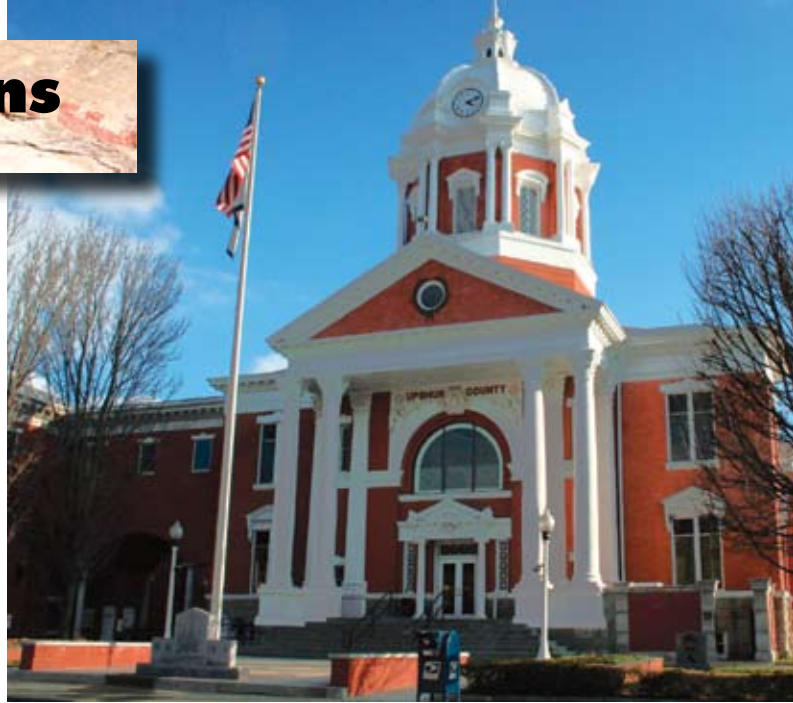
Restored dome and main entrance.

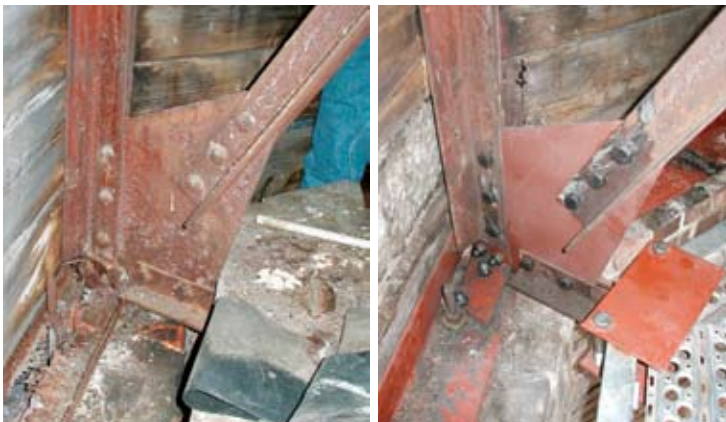
In the second phase of the project, the dome was repaired and restored. During the initial investigation, it was discovered that the dome had actually shifted because the legs of the inverted steel channel that it was resting on failed, causing the south side of the dome to be approximately 1½ inches lower than the north. The rusting was so advanced that the riveted connections between the truss rib and the bottom channel ring were completely deteriorated in some locations. The shifting also caused low slope areas above the cast iron ornamental columns to slope toward the building, essentially funneling water into the structure. Previous repairs, including EPDM roofing installed directly over leaking panels, increased the deterioration of the galvanized sheathing and the water

Left: Failed steel channel and riveted connection at truss. Right: Repaired connection at truss.

Brick fired at the same plant and from around the same time that the courthouse was built was salvaged from a local house, and used to replace those bricks that had lost their structural integrity. Bricks and anchors were reset, repointed, and when necessary, replaced to create a structurally stable base for the steel dome trusses. A jack truss was created to allow the replacement of the entire steel ring at the bottom of the trusses. A steel angle was used in place of the steel channel, as the previous channel caught and trapped water and pigeon droppings, leading to its disintegration. Slight corrections were made to counteract the dome shifting without stressing the roofing system. The wood windows and louvers were repaired to deter pigeons from roosting in the dome. The original roofing system on the dome consisted of painted galvanized steel sheets on wood decking. For galvanized steel that was over 100 years old, most of the original steel was in remarkable condition. However, as the processing of steel changed around WWII to speed its manufacturing, the replacement of damaged steel with in-kind materials was impossible. Terne-coated stainless steel was selected to replace damaged areas, and low slope areas were built up to provide positive drainage with no visual impact from the ground. Once all leaks were repaired, the roofing was coated with a high performance polyurethane industrial coating that provides the greatest protection for the roofing and provides a clean white gloss finish. The dome's cast iron columns and column bases were repaired and coated as well.

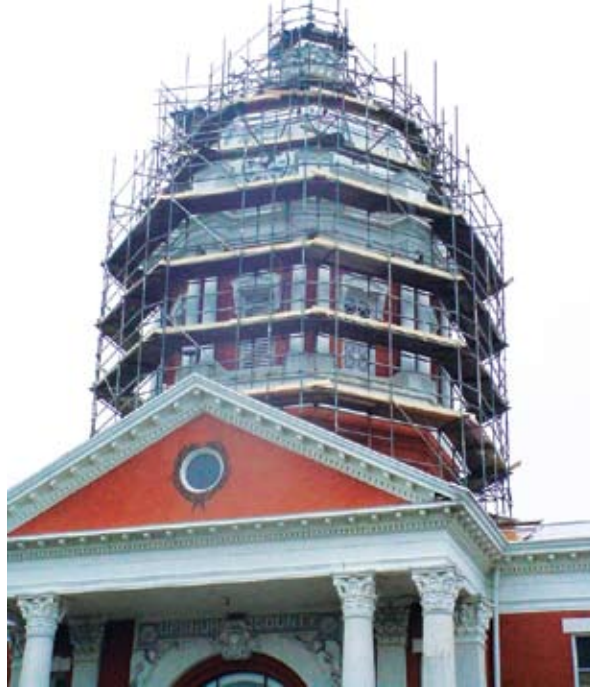
Scaffold around dome to facilitate repairs.

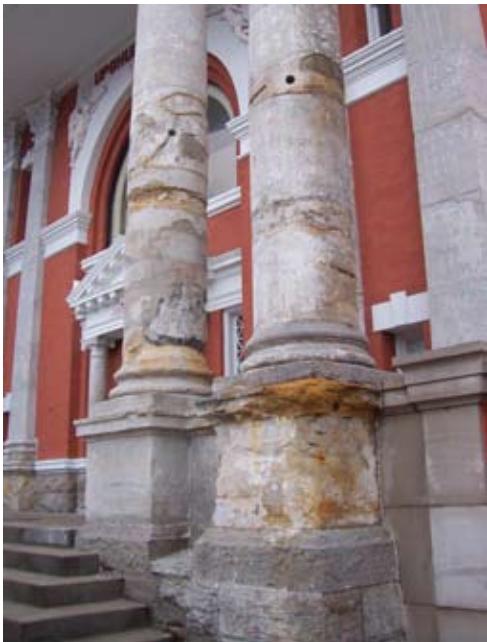
However, when hairline cracks appeared, water penetrated the system and could not escape. Freeze-thaw cycles and hot days combined to break down the underlying stone's properties, essentially rotting the stone because water could not escape the waterproofing. Areas of parging began to fall off, uncovering softened stone and sometimes pulling good stone with it, as the bonding strength of the parging was greater than that of the stone. The parging and waterproofing were removed from the columns and left exposed over the winter, allowing the stone to "breathe" and dry out. Many areas of stone were much stronger after drying out, no longer crumbling when rubbed with fingertips. The removal of the parging also exposed some beautiful detailing, that had been hidden for unknown years, at the stone capitols of the entry columns and at the column bases. Core samples were taken to determine the properties of the inner stone, including compressive strength, bond strength and color.

Left: Distressed sandstone columns discovered upon parging removal. Right: Restored sandstone columns and bases.

The repair of the stone elements at the main entrance (columns, railings, cheekwalls and foundations) turned into the third and final phase of the project. Matching the original stone properties, repair mortar was created to repair portions of the stone columns, railing and foundations. Other stones were too severely damaged to repair and were replaced in-kind with dutchmen. Steel bracing was installed before the deepest prior repair materials were removed due to concerns with the structural integrity and stability of the columns. Where cracking of the stone carried through an entire column, injection repairs complemented stainless steel cross-pinning to stitch the column together. All areas of grout and other cementitious repair materials were removed and repair mortar was installed. Shallow cracks were routed and repaired; deeper cracks were injected with repair materials. Column base and railing sections were repaired with the repair mortar and the original stone profile was restored.

Due to funding limitations and a conscious decision not to remove all traces of work, wear and weather from the columns, only the most egregious of the pits and ruts on the stone were repaired along with the structural issues discussed above. This created a structurally sound set of columns, railings and foundations while retaining a patina of the 100 plus years of use. The smooth-tooled areas of stone that had historically been coated were provided with a self-cleaning, mineral coating specifically formulated for stone and approved for historic preservation use. This coating has a very high rate of vapor permeability and allows the stone to breathe while preventing liquid water from penetrating the stone. At the rock-faced stone, color-matched mortar and dutchman were used to match the existing stone.
