Second Opinion Leads to Substantial Savings in Evaluation and Repair of Marble Façade

By William D. Bast, PE., S.E., SECB, Scott G. Nacheman, M.Sc.Eng, AIA, R.A., Rachel L. Michelin, EIT, LEED® AP and Dziugas Reneckis, Ph.D., PE.

Water Tower Place is a 74-story, 859-foot tall reinforced concrete building, constructed between the years of 1973 and 1976 (Figure 1).

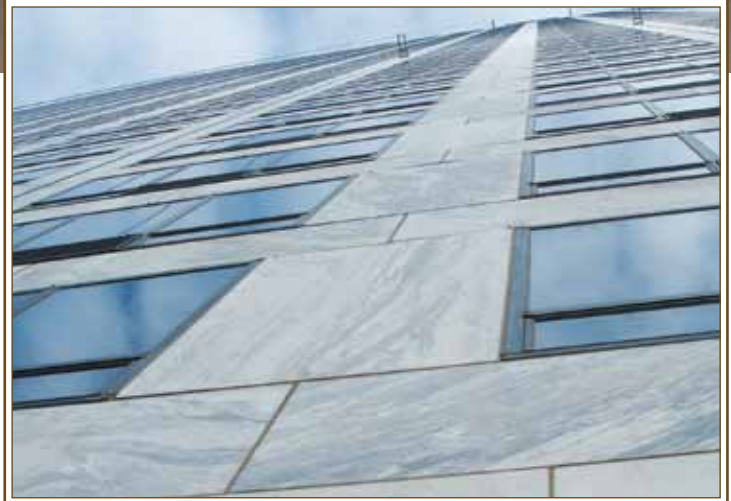
Georgia Cherokee Solar Gray marble panels (1½-inch thick) and flush aluminum-framed windows envelop the tower exterior (Figure 2). The veneer panels on this portion of the high-rise are anchored to the reinforced concrete structure spandrel beams and columns. Approximately 16,000 marble panels clad the building, and 6,240 of those (39%) cover the condominium portion of the building.

Figure 2: Overview of the metal-framed windows and marble panels.

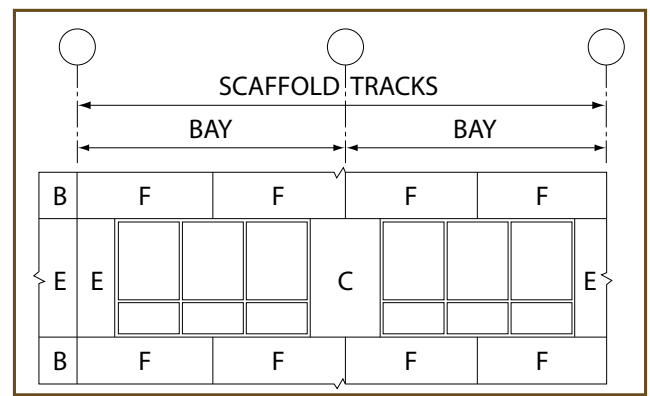
Four sizes, or types, of marble veneer panels clad the high-rise portion of the building (Figure 3). The structural frame here is comprised of upturned reinforced concrete spandrel beams, typically 12.5 inches wide by 32 inches deep, which are covered with four 33 inch tall panels per scaffold bay (Type F panels), as well as a smaller panel at the corners of the building (Type B panels). The columns are typically 10 inches or 14 inches deep by 48 inches wide, covered by 49-inch wide marble panels at the center of each bay (Type C panels). At each end of the bays, adjacent to where the building scaffold tracks are located, two vertical panels were utilized to cover the columns (Type E panels). All panels are typically separated from one another, and from the window framing, by 3/8-inch thick sealant joints.

Figure 3: Partial elevation indicating panel types.

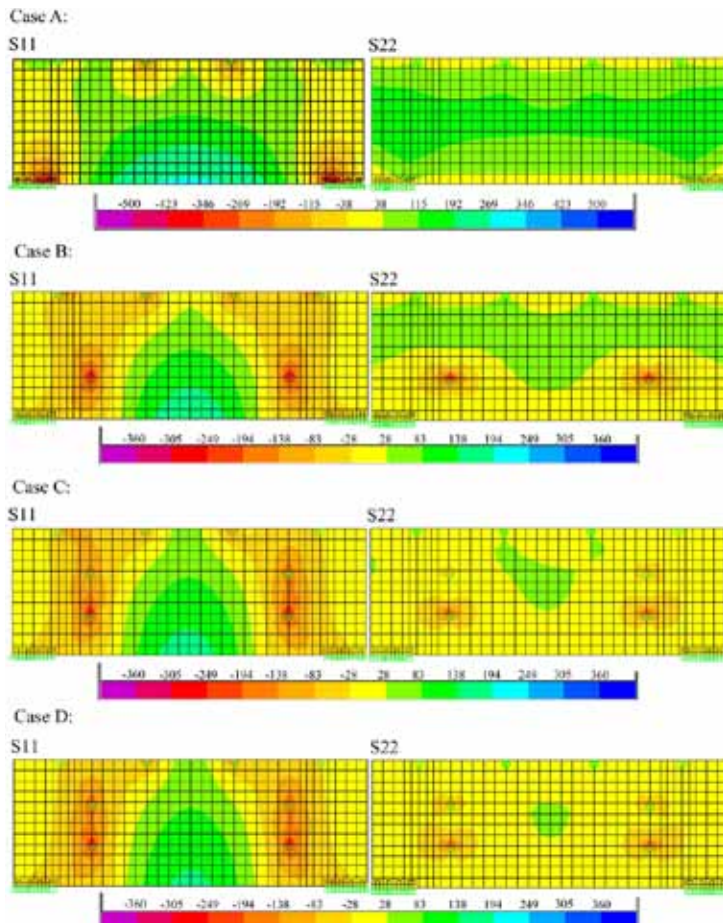
Some of the results of the June 2007 analysis are included in *Figure 4*, which displays results incorporating Dead, Thermal (+90°F), and Wind (55 psf) Loading. The following cases are compared:

- Case A: the original design and installation of the marble panels
- Case B: the marble panels with mechanical restoration anchors installed in the 1980s
- Case C: recommended repairs, with installation of 4 restoration anchors (missing one original pin)
- Case D: recommended repairs, with installation of 4 restoration anchors (missing two original pins)

The stress concentrations in the stone are visible at the kerfs, pins, and anchors. Based on these results, Thornton Tomasetti determined that the installation of repair anchors that have capacity to resist both wind suction and wind pressure loads would provide adequate support for the marble panels.

Figure 4: Analysis results for Panel Type F.

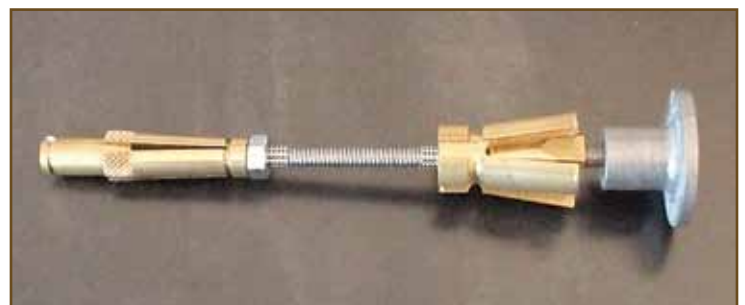
Figure 5: Expansion sleeve anchor designed by CTP and Thornton Tomasetti for panel support against wind pressure and suction.

would result in overstresses and further cracking at the panel mid-spans, as well as at the pin and kerf supports. Thornton Tomasetti proposed using a mechanical anchor with an expansion sleeve, which was co-developed with Construction Tie Products (CTP), for resisting inward and outward wind loading (Figure 5).

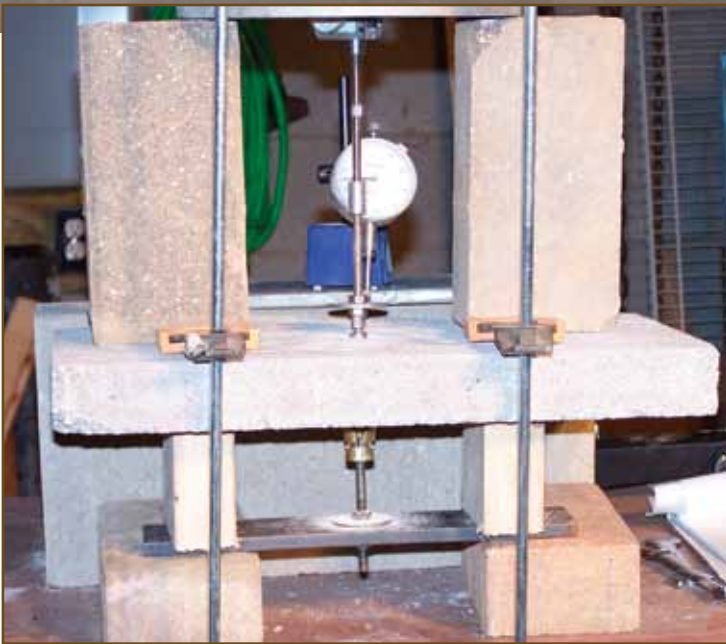
Figure 6: Anchor testing apparatus.

Thornton Tomasetti directed CTP to develop a testing assembly that would represent the interaction of the anchor and the stone (similar to ASTM C1354 testing). The anchor was tested in the stone with the reaction base spacing set at three times the anchorage depth (in this case it was 4½ inches from the test specimen), which generated an “anchorage load” value (Figure 6).

The anchors were loaded up to approximately 1,100 pounds without failure, and they exhibited an average axial stiffness of approximately 37 kips/inch.
