# Bill Williams River Concrete Bridge Fire Damage Assessment

By Martha Davis, P.E., Paul Tremel, P.E., and Alex Pedrego

The purpose of this Arizona Department of Transportation (ADOT) project was to assess the damage to the Bill Williams River Bridge from a July 2006 tanker accident and fire. The Bill Williams River Bridge, Structure #1272, is located on SR 95 at milepost 161.73 between Parker and Lake Havasu City in Arizona.

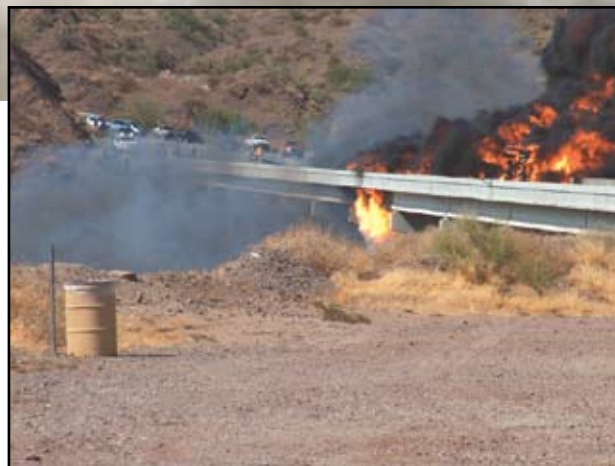
July 28, 2006 Fire – Looking North at West Side of Concrete Bridge. Courtesy of Bill Williams National Wildlife Refuge, U.S. Fish and Wildlife Service.

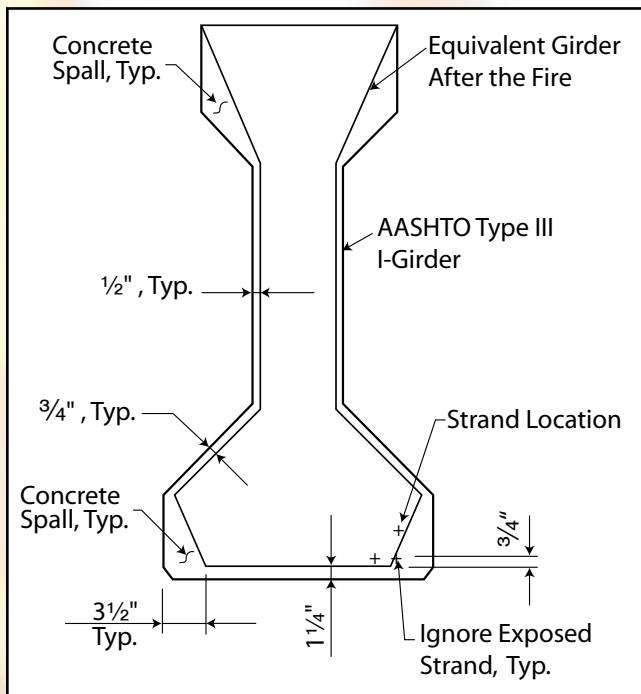
Figure 3: Reduced Girder Section.

The girder cross section that was analyzed combined all the damage that was observed during inspection and materials testing. The reduced section was applied to the entire length of the girder in the fire damaged area. The concrete neglected from the top and bottom flanges was based on spalls and apparent delamination. The thickness of the web was reduced by 1/2 inch on each side, based on observations in the field and the depth of microcracks listed in the materials testing report. One prestressing strand on each end of the bottom row was ignored since it was exposed in several locations on multiple girders. See Figure 3 for a sketch of the reduced girder cross section used in the load rating calculations. The girders were rated for flexure and shear. Due to the deck geometry and girder spacing, the distribution factor for the exterior girder was higher for dead load but not for live load. The girder ratings are based on loading to an interior girder with HS20-44 live load with an allowable tension of  $3\sqrt{f'_c}$  in accordance with ADOT requirements.
