# FULL METAL JACKET

## Part 3: Foundation Revisions

By D. Matthew Stuart, P.E., S.E., F. ASCE, F. SEI, SECB, MgtEng and Richard H. Antoine III, P.E., S.E.

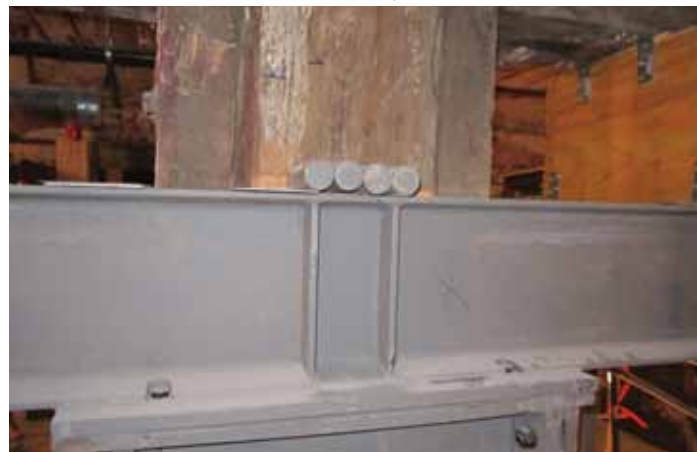
Figure 2.

In addition, at the locations where the temporary shoring could not be installed due to the obstruction of a kiln, four of the eight steel “underpinning” rods had to be installed at the top of the

jacket (Figure 2). The purpose of this last precautionary measure was to provide some redundancy via partial support of the column by the rods and steel grillage support on top of the existing slab on grade. There were no unexpected problems encountered during the installation of the steel jackets or piles, even though epoxy injection repairs were required at several columns (Figure 3). However, at a few locations, the top of rock was encountered at a shallow depth, which did not allow for the installation of the piles to the required minimum soil depth. As a result, the piles were installed to refusal, then encased in a subgrade concrete pier of a diameter that provided adequate contact area at the top of rock to support the imposed column load.

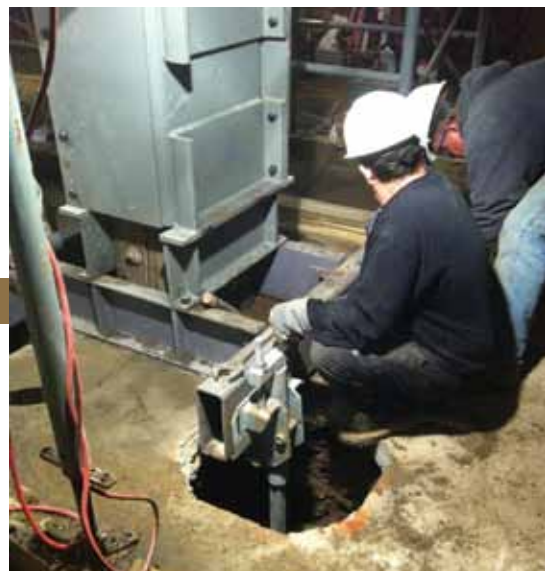
Figure 1.

The use of compaction grouting was also deemed impractical because of the expense and difficulty of ensuring that all of the slab voids had been properly filled and the required depth of grout penetration into the upper layer of soft soil had been achieved. Ultimately, helical piles (Figure 1) were chosen as the preferred foundation option for four reasons:

- 1) The rig used to install the piles could fit within the confines of the basement.
- 2) The capacity of the piles could be easily determined on site, based on the torque achieved during drilling.
- 3) The original steel grillage design only needed to be modified slightly to accept the piles, which in turn did not alter the fabrication of the previously approved steel jacket and channel base assembly.
- 4) The cost of the helical piles was less than the other foundation options.

In order to modify the original steel channel grillage design to accommodate four symmetrically placed piles at each column, HSS steel members were introduced to transfer the reaction of the steel jacket channel bases. The only concern with the pile foundations was the possibility of adverse effects from the vibrations that might be induced from the installation process on the deteriorated columns. In order to mitigate these concerns, the following precautions were employed prior to installing the piles. First, temporary shoring of the columns from the underside of the second floor pillow beams to the basement slab on grade took a portion of the load off the main columns during the construction phase. Second, the steel column jackets, channel bases and HSS grillage had to be erected and in place at each column prior to the installation of the helical piles. The purpose of this precautionary measure was to provide some means of mitigating the unexpected failure of a column by arresting a collapse via the installed steel jacket and grillage sitting on top of the existing slab on grade.

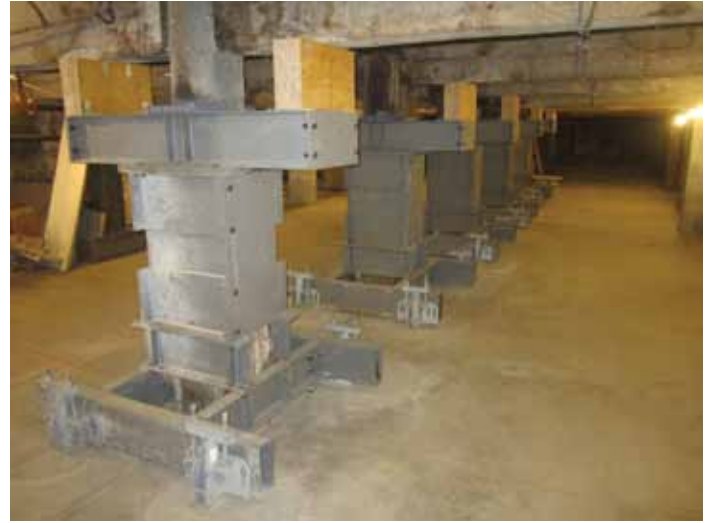
Figure 4.

The purpose of the steel column jacket solution was simply to stabilize the building in place, and not attempt to jack the structure back up to its original floor and roof elevations that existed before the column deterioration and settlement began (Figure 4). A similar approach was also taken for the repair of the horizontally distorted column, corbel and beam connection at the second floor. The fix used at the second-floor connection involved installing a stiffened steel side plate on each face of the joint that straddled the timber beam, pillow beam and top of the first-floor column. The side plates were attached to the wood framing via lag bolts, rather than through bolts. Although there may have been hidden mortise and tenon joints connecting each of the three individual timber members together at the joint, the steel side plates effectively stiffened and stabilized the connection.

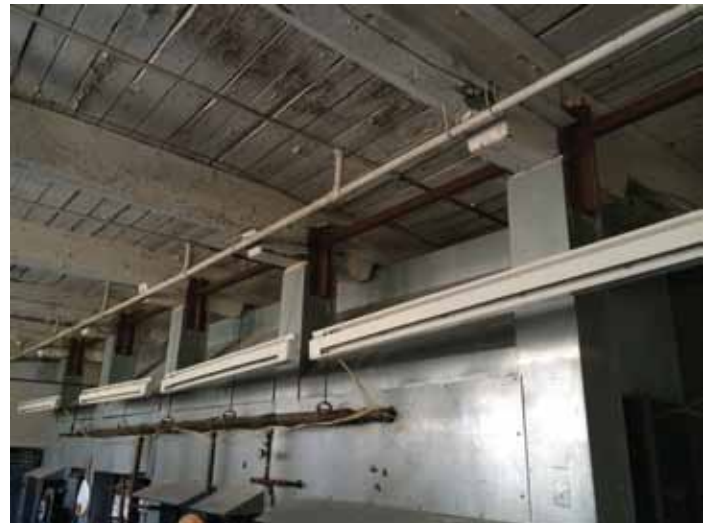
Figure 5.

Spanning between the steel side plates, HSS steel members were installed to brace each beam/corbel/column connection and prevent any additional out-of-plane rotation or movement of the joint (Figure 5). The HSS bracing was installed between all of the affected column/beam connections, and extended to an adjacent masonry wall at one end of the glass-blowing room and to a steel column and beam at an adjoining room next to the kiln room. Where the HSS brace was attached to the steel column and beam, the second-floor diaphragm, which was positively attached to the top of the steel framing, was available to resist lateral loads imposed on the line of HSS bracing due to any additional horizontal movement that might occur at the existing distorted column/beam connection. As a result, the existing connections were secured in place, and therefore capable of providing continued structural support of the second-floor framing and bracing of the top of the first-floor column.
