When Foundations Settle

Jacking of a Column in a 5-Story Concrete Building

By Dominic A. Webber, P.E., S.E.

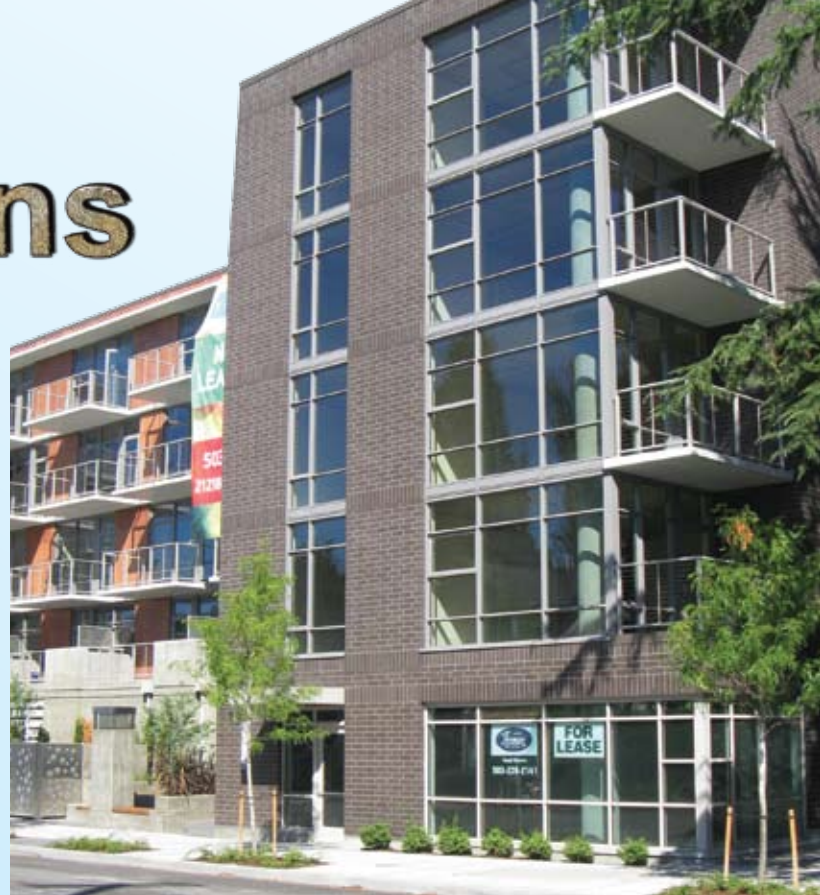
Upon being alerted by the contractor, the geotechnical and structural engineers arrived on site to assess safety concerns and to determine a course of action. One speculation on the cause of the problem was that heavy rains had created soil erosion of a utility trench adjacent to the

Figure 1: Finished building corner and exposed column that experienced soil settlement.

footing, allowing soil below the footing to spread laterally. It was early winter in the Pacific Northwest, typically being the rainy season. It was therefore decided that, before any design solution was considered, soil stabilization was necessary to prevent further column settlement and hopefully mitigate continued damage to the building.

The geotechnical engineer recommended that the apparent loose soil below the footing be pressure grouted with non-shrink or cement-bentonite grout as soon as possible. URETEK ICR, a deep injection process to control soil settlement was identified as the most suitable method. This process can inject polymer more than 30 feet into the soil where the polymer will expand to fill voids in the substrate, thereby minimizing future foundation settlement. To mitigate further settlement for the building, soil strengthening began within three days after soil remediation was recommended. Holes were drilled through the slab-on-grade and the exterior of the structure at an angle to access the soil below the foundation. The expanding polymer was pressure injected into the soil using six probes on each side of the foundation, approximately nine feet deep. Injections were applied at greater depths in the area of ground most affected by weak or unconsolidated soils. This application appeared to arrest settlement of the column, preventing further potential damage to the building and providing the time needed to correct the column settlement issue for the building.

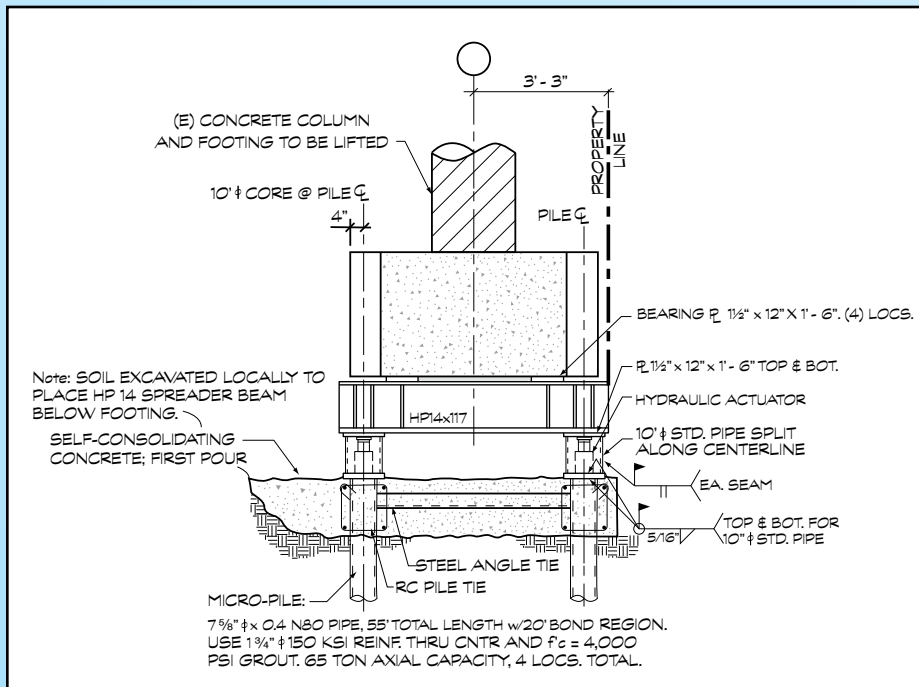
Figure 2: Schematic showing the overall concept of column jacking at the base of the footing. Sacrificial hydraulic actuators, supported by pin piles, raise the footing back into position and will ultimately be encased in steel pipe.

Ultimately, the final solution was likely achieved only by meeting with the foundation contractor to work out a solution that was constructible, could allow the column to be lifted as needed, and eventually provide the permanent support needed for the column to be structurally competent. Since the footing had to be supported permanently by piles, the primary structural consideration was to place the footing in direct bearing on the piles. This would require placing girders below the footing, lifting the footing using hydraulic actuators to jack against the girders below the footing and tying it off for permanent use. One obstacle to the final solution was how to use the piles to lift the footing, presumably placing the hydraulic actuators directly on the piles, and to have the steel girder framework below the footing also bear directly on the piles for the permanent support. Eventually, it was concluded the only way to achieve this was to sacrifice the hydraulic actuator. Compression-only hydraulic actuators with sufficient capacity to lift approximately twice the estimated gravity loads were found. These actuators could jack the column footing to the needed elevation, and were small enough to be enclosed in a steel pipe for permanent support between the steel framework below the footing and the top of the pile.

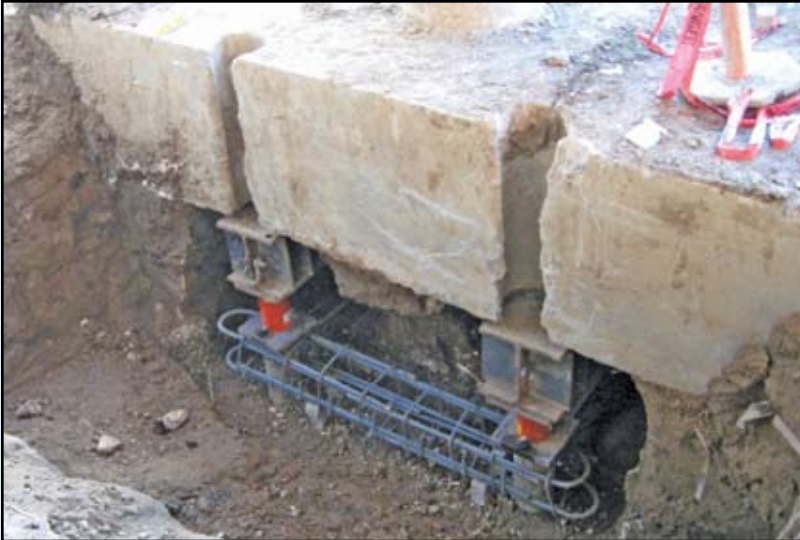
Figure 3: Reinforced concrete ties for the top of piles.

With large forces expected at the pile top, it was felt the pile needed to be stabilized in each direction. Deformed bar reinforcement was used to create a grade beam along the length of the footing, and steel angle was used to tie transversely below the footing. Then, self-consolidating concrete was cast to the bearing plate level mitigating any slight out-of-alignment of the piles.

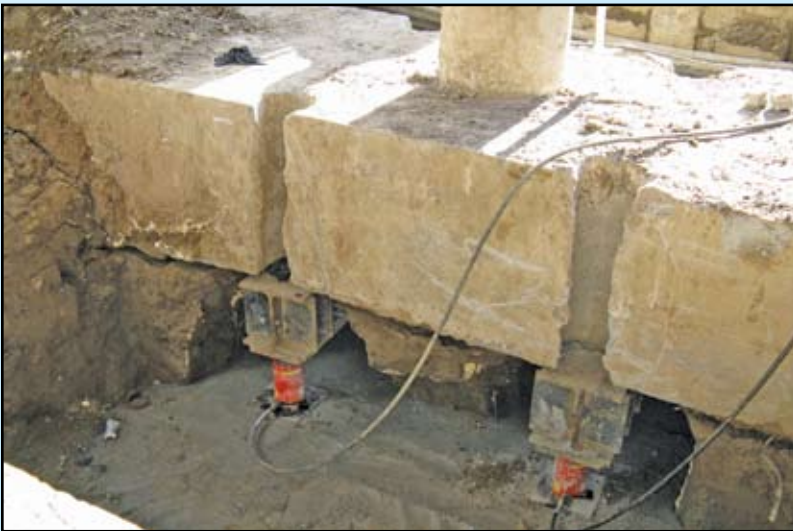
Figure 4: Concrete placed to top of pile cap. Actuators are connected to the same hydraulic pump to ensure the lifting load is distributed to the footing equally.

Four 100-ton compression-only hydraulic actuators were placed between each pile cap and the HP14 girder ends. Hoses for each hydraulic

actuator were linked to the same electric pump and fitted with quick release couplers. Linking the hoses to one pump was needed to ensure that all hydraulic actuators shared the column load equally. Quick releases were needed to remove the hoses from each hydraulic actuator while still pressurized, thereby maintaining their continued resistance of the gravity loads.

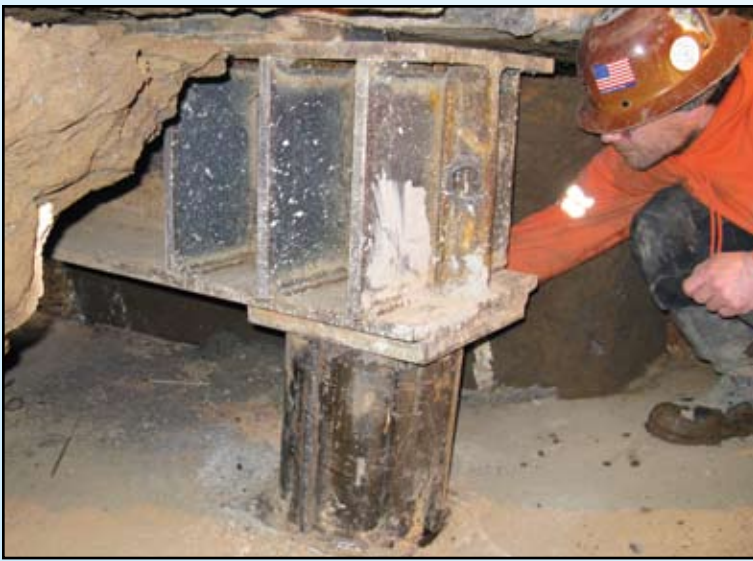
Figure 5: Hydraulic actuators encased in structural steel pipe. Pipe is permanent support for the HP 14 spreader beam and footing.

Once the footing was back in position, the hoses were removed from the actuators while pressure was maintained to sustain the column load, and each hydraulic actuator was encapsulated with steel pipe. Structural steel pipe had been delivered to the site in lengths longer than was needed. The final length of each hydraulic actuator was measured and the structural steel tube was cut to length. Each tube was split in two and a notch was provided at the base to accommodate the coupler for the hydraulic actuator. While each actuator sustained the needed pressure, the tubes were welded to the pile cap plate, the bottom of the HP14, and along each vertical tube seam. The entire assembly was then encased in concrete.

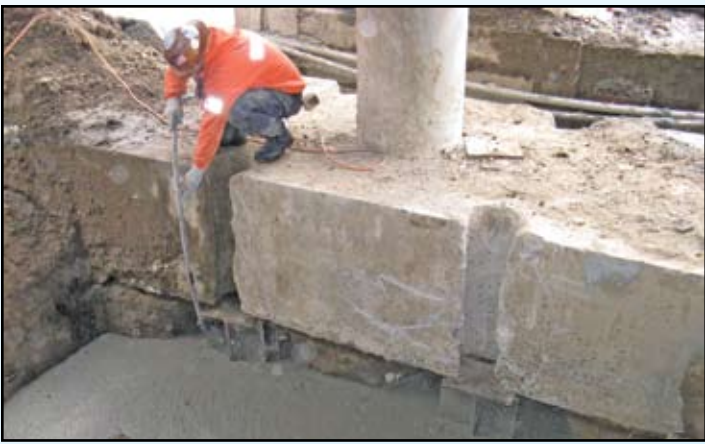
Figure 6: Self-consolidating concrete cast throughout the excavation to top of footing. Slab-on-grade cast back with reinforcement to resist a lateral load of 10% of the expected maximum column load.

The final step was to finish the concrete slab-on-grade that was disrupted for construction. Since the new footing was effectively supported on a pile foundation, the footing was tied to the slab-on-grade sufficiently to resist laterally 10% of the expected column load in either direction.
