# 150 Tremont Street

By Craig Barnes, P.E., S.E. and Steve McDermott

*CBI Consulting Inc. was engaged by KBA Architects to evaluate the cause of masonry displacement at the eighth story of an exterior corner of an office building recently converted to a university dormitory. This article reflects an engineer's perspective during the repairs.*

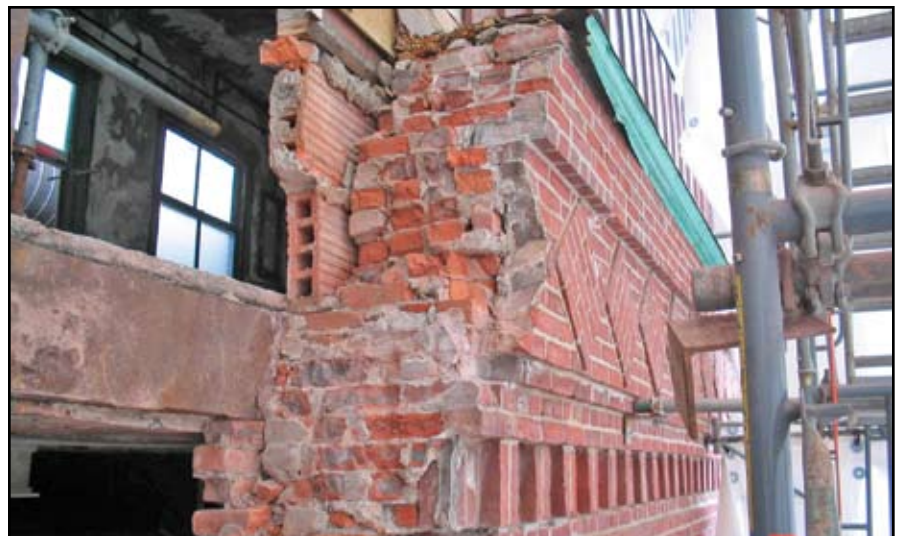
*View of flat masonry arch and parapet*

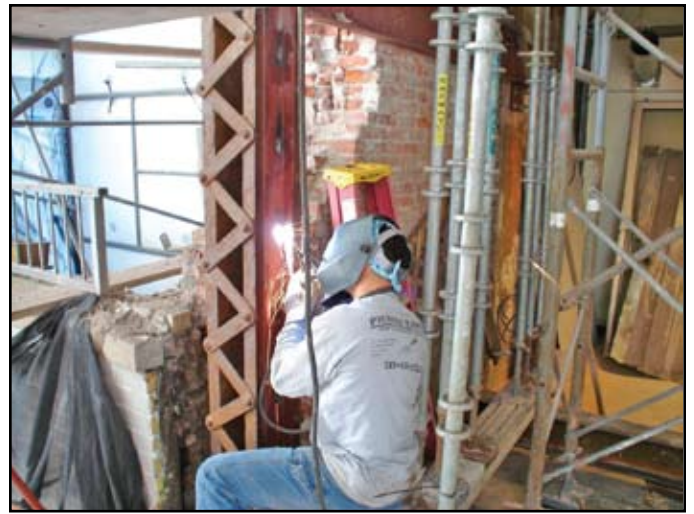
View of the column cutting during column removal

The three-story column replacement required a special procedure prior to removal. Even though the shoring was in place, loads were still being transmitted through the remaining column section. Simply cutting the column free in one operation was not advisable. The shoring was not jacked to receive the induced 100% load, and slack between floor to floor shoring distribution needed to be accounted for.

To cut the column free, systematic torch cutting was performed in increments, slowly reducing the column cross section. As more steel was removed, column vertical distortion was measured, and compared with elastic shoring deformation calculations. The torch cutting, column distortion, and measurements continued for two hours until the column distortion halted, which demonstrated that the shoring had fully supported the load and that the column was free. The total vertical deflection recorded was ⅜ inches, which compared well with a ⅝-inch deformation calculation.

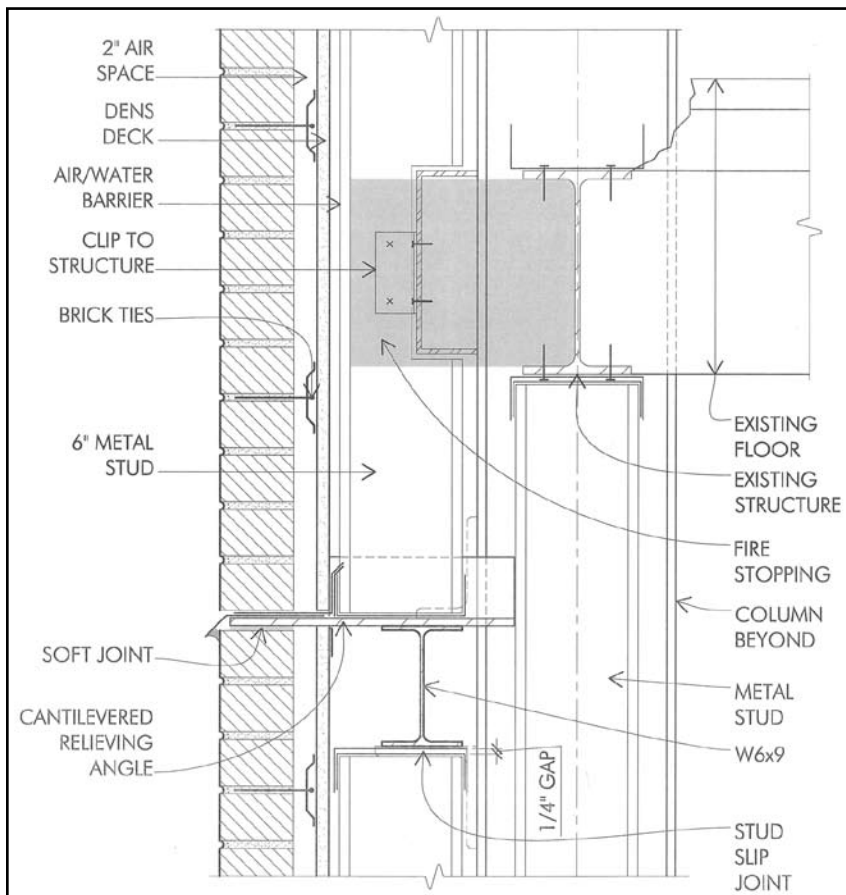
Section view of replacement veneer construction

Re-engineering began immediately, with the design of a curtain wall system that included a brick veneer, air space, and vertical cold form construction with slip connections to accommodate thermodynamic volume changes. The curtain wall system, which incorporated appropriate waterproofing and flashing details, contained a brick veneer to replicate the original building appearance. Supporting the masonry veneer, which was approximately 16 inches off the column face, required the design and fabrication of steel support brackets which cantilevered off the face of the column at every floor line. The curtain wall system became very complex at the 11<sup>th</sup> and 12<sup>th</sup> story. The original construction of the 11<sup>th</sup> and 12<sup>th</sup> stories consisted of mass masonry window arch headers supporting a large corbelled masonry parapet.
