## Historic Timber Bridges

### Design and Rehabilitation of Three Structures in Massachusetts

By S. D. Daniel Lee, P.E. and Matthew Anderson, M.S.

The Massachusetts Highway Department (MassHighway) is in the process of rehabilitating three historic timber covered bridges and has engaged the services of Fay, Spofford & Thorndike, LLC and Wood Advisory Services, Inc. to perform the evaluation and engineering. The three bridges are the Burkeville Covered Bridge in Conway; the Arthur A. Smith Covered Bridge in Colrain; and the Bissell Covered Bridge in Charlemont.

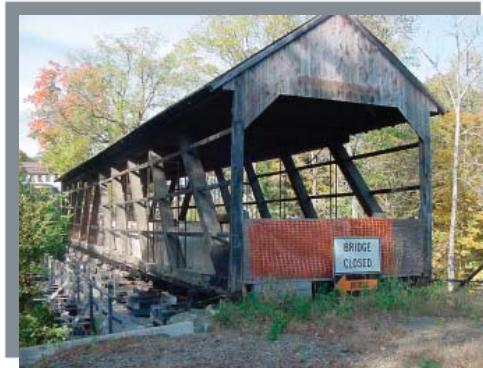
Figure 1: Burkeville Covered Bridge

steel hanger rods for verticals. See *Figure 1* for condition of the existing structure.

The load carrying capacity of the existing timber structure was found to be lacking. The most difficult design issue for this bridge structure was providing the means to resist the lateral design wind load. Even at a wind pressure of 12 psf for the region, the existing structural system could not transmit this lateral load into the abutments. The increased live loads also overstressed many members of the Howe trusses. A secondary steel framing system was introduced to sister the top chords, cross beams on the top chords, diagonals, and verticals in order to resolve the capacity issues. A rigid moment connection was made between the sistering elements of the cross beams and verticals to effectively transmit the lateral wind load into the abutments. This secondary framing system was placed on the outside face of the Howe trusses and covered by the replacement timber siding, pretty much obscuring it from casual observers.

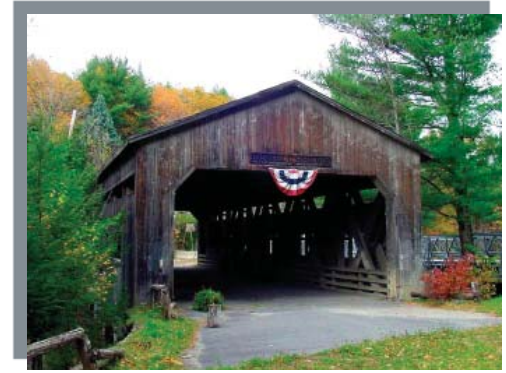
Figure 3: Bissell Covered Bridge

The historic Bissell Covered Bridge carries Route 8A over the Mill Brook in the Town of Charlemont. The existing bridge structure, built in 1950, has a span length of 92 feet. The curb-to-curb width is 24 feet with a total width of approximately 32 feet. The bridge is designed for two-way traffic on two travel lanes. See *Figure 3* for a portal view of the existing bridge.

The structural timber members in this bridge are all Douglas Fir and are in excellent condition. The chemical preservative has been successfully protecting all of the timber members from a very moisture laden environment for the past 50 plus years. The bridge is located adjacent to a waterfall over a small dam. Two major structural problems contributed to closing of the bridge to all traffic. The first one is the severe deterioration of the unprotected steel bolts in all of the connections in the floor trusses. Some connections have completely missing bolt heads or nuts. Some floor truss diagonals have splits that run through multiple bolt holes. The second most critical condition is with the pair of main trusses. The problem at these main trusses is also the steel bolted connections.

The unprotected steel bolts are all rusted to varying degrees of severity. The condition of these steel bolts is better than the steel bolts in the floor trusses.

A 3-dimensional computer model evaluation indicated that many existing timber members can carry the proposed upgraded live loads, but the steel bolted connections could not. All of the structural bolted connections are made with unprotected steel bolts with split rings. Even if the entire truss is taken apart and replaced with galvanized split rings and slightly larger diameter bolts, the size and configuration of the connection is simply not adequate to satisfy the new load demands. To overcome this deficiency in the panel point connections of the main trusses, a secondary structural system of steel tension rods is designed to share

and relieve a significant portion of the design loads from the connections at each of the truss panel points. Due to the specific details of this pair of parallel chord main trusses, we are able to place the system of steel tension rods at the centroid of each truss by way of steel saddles to apply and transfer a pretensioned force into the tension vertical and tension diagonal members of the main trusses. A pair of steel tension rods is also pretensioned to relieve axial tension loads in the two bottom chords of the main trusses.
