Preservation of Historic Gilbertville Covered Bridge

By S. D. Daniel Lee, P.E. and Matthew Anderson, M.S.

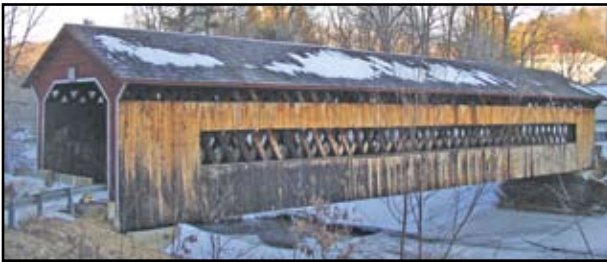
Figure 1: Winter setting of the covered bridge.

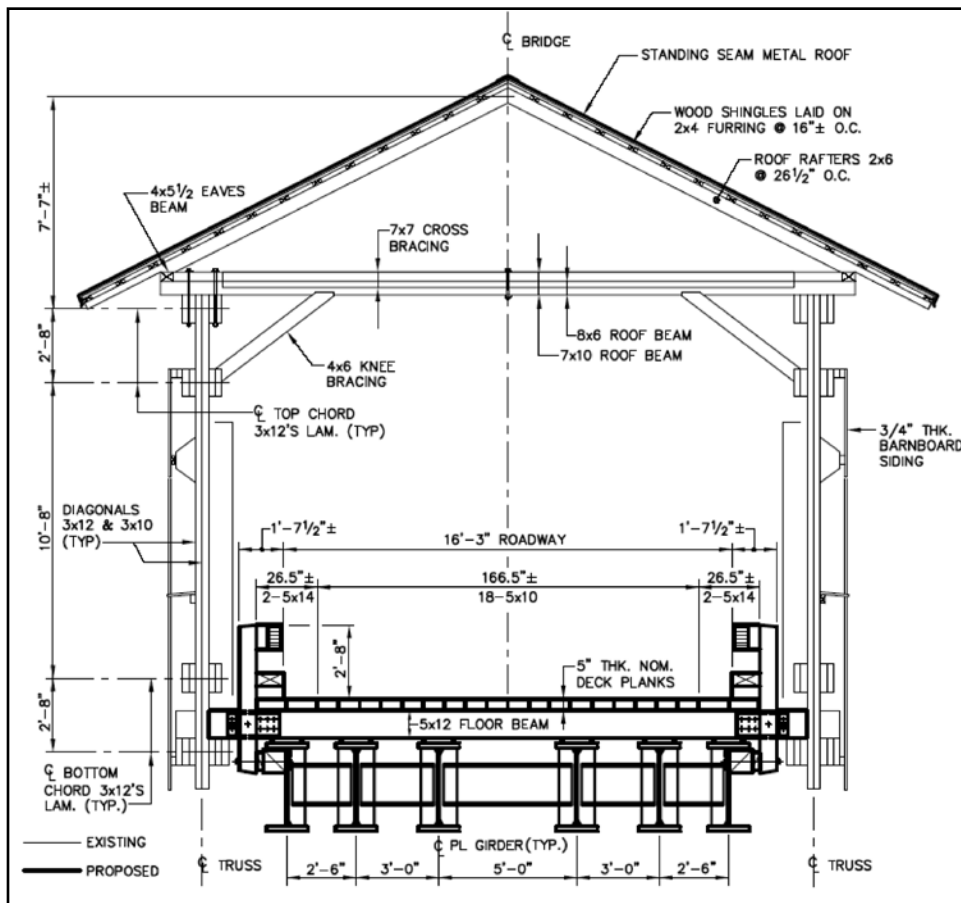
Figure 2: Proposed rehabilitation. Typical Cross Section.

Given the need for upgrading the bridge structure for heavier vehicular loading and the desire to preserve as much of the historic members of the structure as possible, a compromise was achieved with the addition of a secondary sub-framing system to carry the entire superstructure load. Six steel girders will be installed directly underneath the floor beams and floor joists. Four interior steel girders are designed to carry AASHTO H15 truck or uniform pedestrian live loads, and the two exterior steel girders are designed

to primarily carry the weight of the timber superstructure, the entire snow load, and the effects of wind load plus a tributary amount of the live load. These girders will mostly be hidden by the siding of the covered bridge, as viewed from the roadway level. (Figure 2)

No significant repair of the superstructure will be needed at this time. Minor repairs of floor beams will be done by using sistering elements. The 3x12 floor joists will be replaced with new 5x12 floor beams, maintaining the spacing of 18 inches on center for the support beams. The 3-inch thick deck planks will be removed and replaced with 5-inch thick deck planks. Crash-tested timber bridge rails will be installed. The present structure does not have any protective railing.
