# Common Threads

Structural Issues in Historic Buildings

By Craig M. Bennett, Jr., P.E.

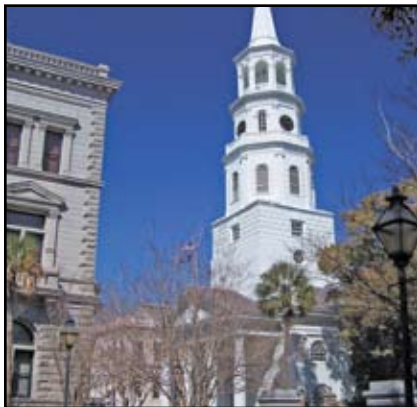
The lateral loads caused by swinging bells were more critical in 1993 than they had been in the 1764 installation. In the earthquake of 1886, the steeple

St. Michael's Church, Charleston, SC - 1751.

had settled several inches and had been severely fractured. After 1989's Hurricane Hugo, we had had to straighten the top 50 feet, the timber spire. We were also aware that we had potential lateral loads of up to 20,000 lbs imposed on the tower with every swing of the bells. Although concerned about mixing old and new materials, we took a lesson from the English preservation engineers and tied the tower together with an internal reinforced concrete ring beam at the level of the bell frame. Today the eight bells, the largest of which weighs almost a ton, and their eight human ringers, announce services on Sunday morning, and ring for weddings, Independence Day and June 28, Carolina Day, commemorating the first decisive victory of the American Revolution. Most gratifying is that the local ringers are regularly joined in the celebration with ringers from the United Kingdom.

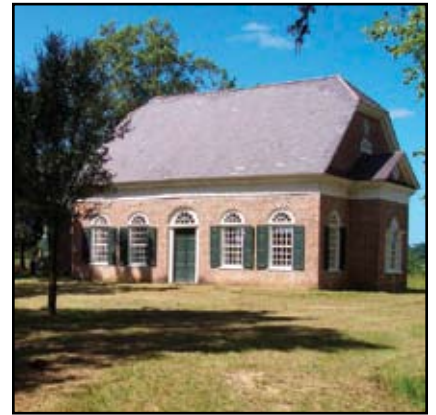
Between 1998 and 2002, a drought left the expansive clays under Pompion Hill Chapel unusually dry. Differential settlement, perhaps exacerbated by several campaigns of foundation repairs, caused severe cracking of the plaster and some masonry damage in this stunning structure. To make matters worse, several roof trusses, supported on severely overstressed extended top chords over a coved ceiling, had failed, transferring their loads into the roof sheathing, then into the end walls, by diaphragm action.

Pompion Hill Chapel, Huger, SC - 1763

Replacement of the failed trusses in kind would have been appropriate from a preservation standpoint, but exact replacement timber members would have, in time, failed under load like the original. Fortunately, there was room between the roof framing and the structure of the coved ceiling for contractor Tommy Graham to install deep timber sister members on each side of each truss, carrying the bending moment at the top chord extensions and preserving the original construction for future generations.

Because ground modification would have been far more expensive than the church could have afforded, on the recommendation of geotechnical engineer Jim Hussin of Hayward Baker, it was elected to try an underground irrigation system as a means of keeping the soils beneath the walls moist. Time will tell whether or not this approach will work long term, but initial monitoring of 46 survey bolts hidden around the perimeter of the building shows a slow movement upward of the portions of the structure which had settled the most.

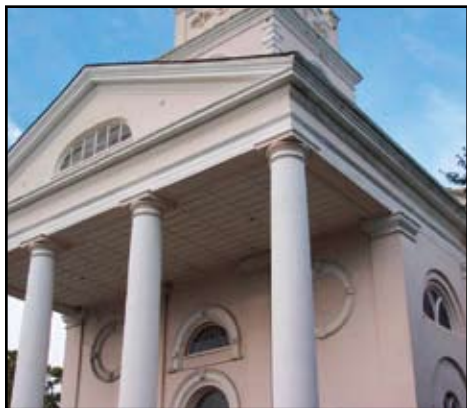
In the late summer of 2001, a church member at the Cathedral Church of St. Luke and St. Paul noticed that one of the timber columns in the balcony appeared to have pushed its way into a hollow millwork box supporting it, damaging the plinth block and torus at the column base. Investigation revealed that, over

time, there had been a total of 12 inches of differential settlement under the tower, and that there was a five inch differential settlement between the exterior walls of the church and the balcony columns only 12 feet away. The roof trusses had transferred their loads from the outside walls to the interior columns, pushing them through the hollow boxes. Only the lateral support of the balcony rail had kept the columns from falling and dropping a 38,000 lb plaster vault 44 feet into the nave of the church.

*Cathedral Church of St. Luke and St. Paul, Charleston, SC - 1814.*

While there is little doubt that the six timber roof trusses originally spanned the 61 feet from exterior wall to exterior wall, analysis showed that they did it with stresses of around 3000 psi, much higher than the 1200 psi which we might use in design today. High stresses and load redistribution had taken their toll on the trusses, and strengthening was necessary before putting the truss loads back on the outside walls. Unfortunately, the cost of improving the foundations or the soils under the church was prohibitive. But dealing with the secondary effects was not entirely unreasonable. Work now underway with Palmetto Craftsmen has, like Pompion Hill, sistered the trusses to preserve original historic fabric and taken the loads off of the balcony columns. But just in case the walls move several more inches and drop the trusses onto the balcony columns again, the balcony column load path has been strengthened to provide the appropriate redundant load path.

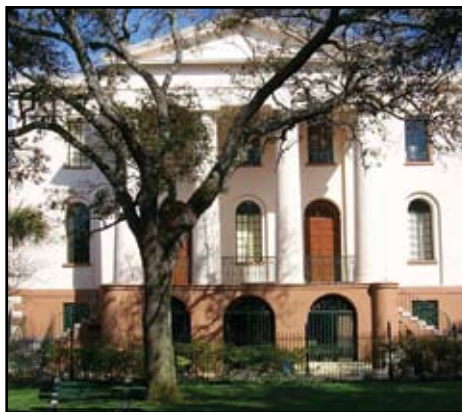
Robert Mills' Fireproof Building was built as a government record storage building and continues to be used for archival storage, now for the South Carolina Historical Society. Mills had designed the building with masonry walls and floors, supported on masonry vaults. Unfortunately, installation of modern tall storage shelves and the removal of a wall

in the basement had caused extraordinary thrusts in several masonry vaults, resulting in a small bulge in an exterior wall on the west side and some exterior wall cracking.

*The Fireproof Building, Charleston, SC - 1826.*

Any sort of structural intervention in a building of this age must be undertaken very carefully, and only after considerable study. Rather than undertake any remedial construction work, we recommended relocating the heaviest loads to rooms whose walls could handle the thrusts and recommended keeping offices in the rooms with less masonry to resist the thrust of the vaults. Sometimes the best structural intervention involves no construction at all!

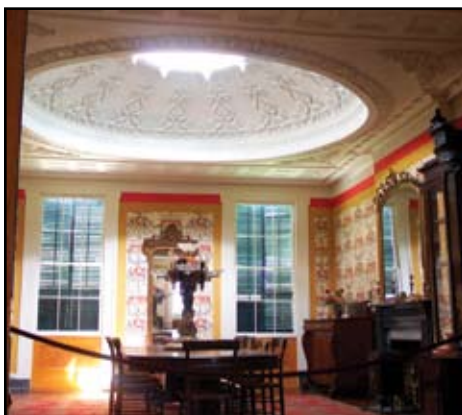
Creep in the very highly stressed pine ceiling joists which support two 13-foot diameter

*One of the twin domes at Gaineswood, this one over the dining room.*

plaster domes had allowed one dome to drop about three inches, and the other to drop five. Two previous efforts to reinforce the joists had been largely unsuccessful. By installing small timber and steel rod trusses over the domes and lifting them very slightly (about an inch, each) with threaded rods placed around the dome perimeters, it was possible to take the load off of the existing structure to arrest further creep and allow repair of the fractured plaster. Fortunately, it did not require removing either the original structural system or the two attempted repairs.

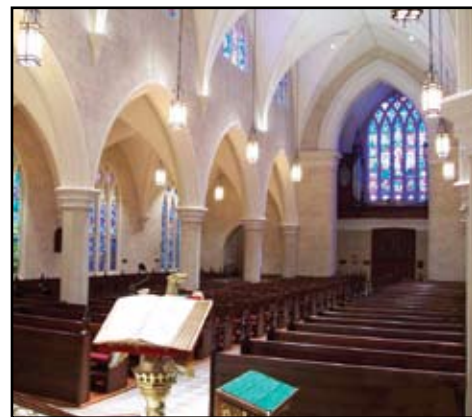
Grace Church was only 40 years old when the earthquake of 1886 nearly destroyed it. The two legs of the tower closest to the nave sank about eight inches, severely damaging the attached clerestory walls and breaking the tie rod which spanned the grand arch between those legs. Courageous repairs undertaken immediately afterward included rebuilding the grand arch, installation of inverted arches under two of the tower legs and extensive repairs to the clerestory walls.

*The tower arch at Grace continues to spread and the members bracing the clerestory walls are moving.*

The iron rods installed after the earthquake are now corroded; the fractures in the masonry open and close with temperature and humidity, but trend towards opening; and the tower continues to settle, with an easily noticed lean toward the nave. Work now starting will tie the walls of the tower together with embedded stainless steel rods. Once the tower is stabilized, the options are to either improve the soils under the tower or underpin it with micropiles. The process will be guided with a non-linear structural model that accounts for the largest of the existing cracks and, most importantly, for the inability of the masonry to carry any significant tension stress.

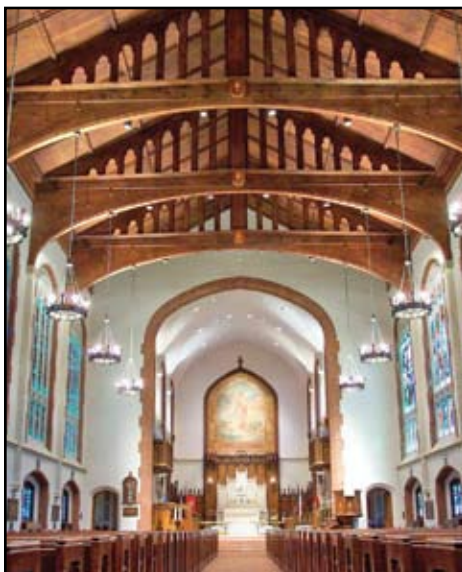
It seems that many 20<sup>th</sup> century designers had lost track of the need for stiff buttressing to resist the thrust of large arches. The chancel arch of St. Luke's is a good example. Even a simple linear elastic finite element analysis shows the problems with the behavior of the arch, a reality made more apparent by a large crack found during the 1998-2000 renovation. Deep flat plates on each face of the wall over the arch successfully tied the buttresses together. Interestingly enough, the church warden chose to have us leave the interior plate slightly exposed. The plate was left flush with the plaster, with exposed bolt heads, "so that the members of the church could see where at least a little of their money went."

*The chancel arch at St. Luke's Church, Atlanta, GA - 1906.*

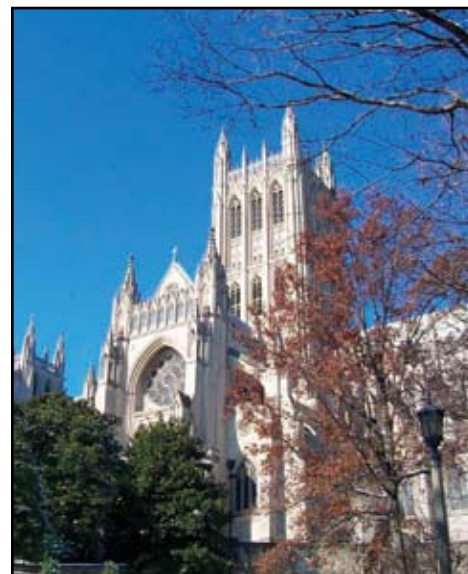
not do the same with the tower foundations. So one finds today in the Cathedral the same issues that one finds in many other Gothic churches... settlement of both west towers and of the crossing tower. This movement of the tall portions of the building relative to the lighter clerestory walls of the nave has caused cracking in the walls and vaults. Structural distress, like that in many masonry buildings with tall elements, shows up invariably in the last bays of the nave walls, adjoining the towers.

*Washington National Cathedral, Washington, DC - 1907.*
