Robert Purcell Community Commons

Saving a Building from Alkali Silica Reaction

By Peter Paradise, P.E.

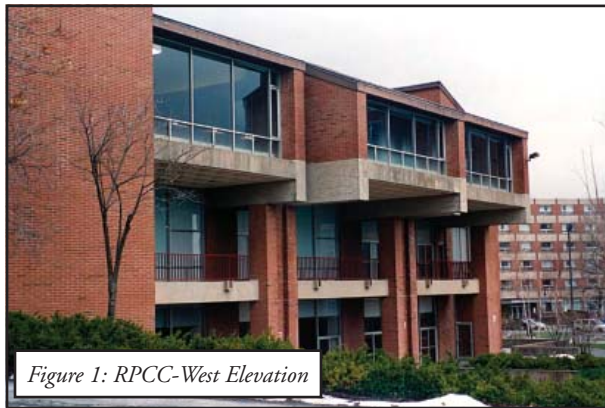
Figure 1: RPCC-West Elevation

The Robert Purcell Community Commons (RPCC) is a student center on the Cornell University campus constructed in 1970. It contains dining, conference, and student recreation facilities. RPCC is a three floor structure built around a concrete frame. The exterior walls are a brick veneer backed by 8-inch thick load bearing brick walls. The third floor features projecting bays supported by cantilever beams. The beams support masonry sidewalls, projecting floor bays, and the sloping roofs above (Figure 1). The cantilever beams are exposed concrete on the exterior. The concrete was exhibiting significant cracking.

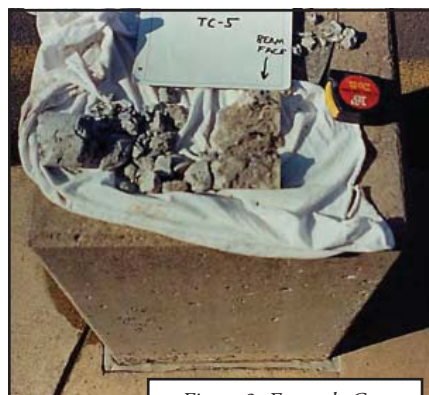
Figure 3: Example Core

Core samples were analyzed by petrographic examination (ASTM C856). The examinations determined that the concrete had minimal air entrainment and contained four types of alkali-silica gel. These findings are consistent with the “map” cracking patterns in the concrete. The examination also identified secondary gel deposits which are typical for concrete with long term moisture exposures.

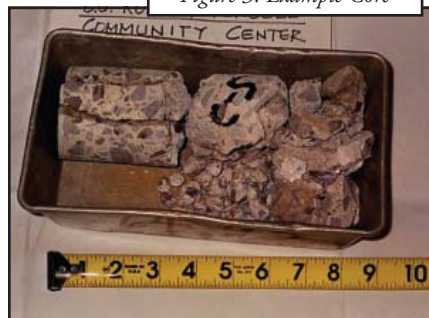
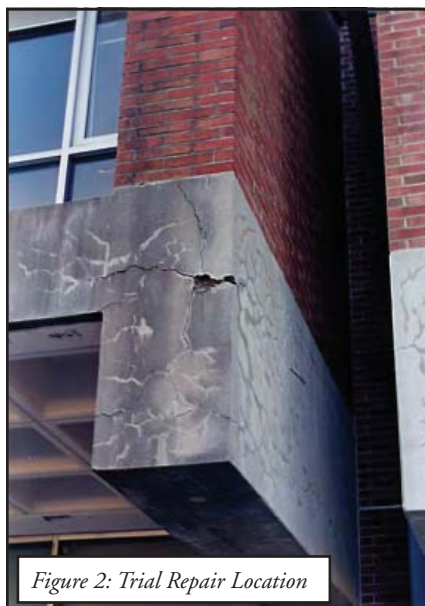
Figure 2: Trial Repair Location

In order to further assess the efficacy of the vacuum injection/impregnation process, a trial repair project was undertaken. Repairs were conducted on two bays of severely impacted concrete (Figure 2). The repair methodology consisted of removing and shoring bricks bearing on the top of the beams, sandblasting previously applied coatings, surface sealing cracks, setting a network of ports to draw vacuum (Figure 4), drying the internal cracks via vacuum, injection of epoxy resin, test coring, application of finish coating, adding flashing and weeps, and brick replacement.

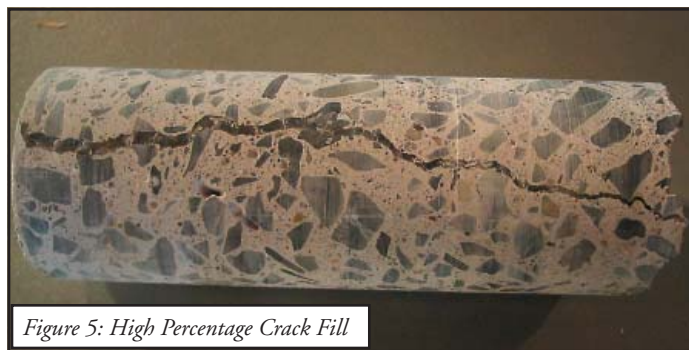
Figure 5: High Percentage Crack Fill

Coring results for the building varied significantly between 100% fill (Figure 5) and 0% fill. Because cores were taken from the most severe crack areas, poor fill results served as the trigger for a second round of injection. Prior to reinjection, a much more intensive impact echo testing program was implemented that enabled a comparison between pre and post injection results. Although the difficulties of

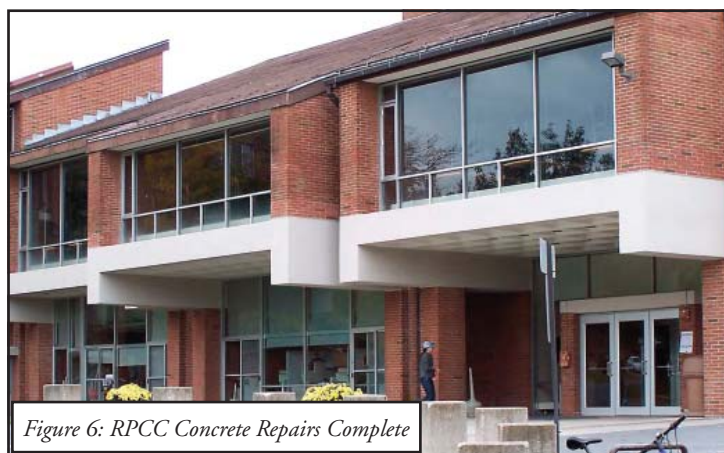
Figure 6: RPCC Concrete Repairs Complete

The repaired concrete has been in place for 12 to 18 months and has experienced winter and summer weather extremes (Figure 6). To date, the performance is good and no mirror cracking is occurring through the elastomeric coating. Ongoing monitoring of the structure will continue.
