# Double Tee Flange Failures

Study of an Existing Parking Garage

By Frank Lagodimos, P.E., SECB

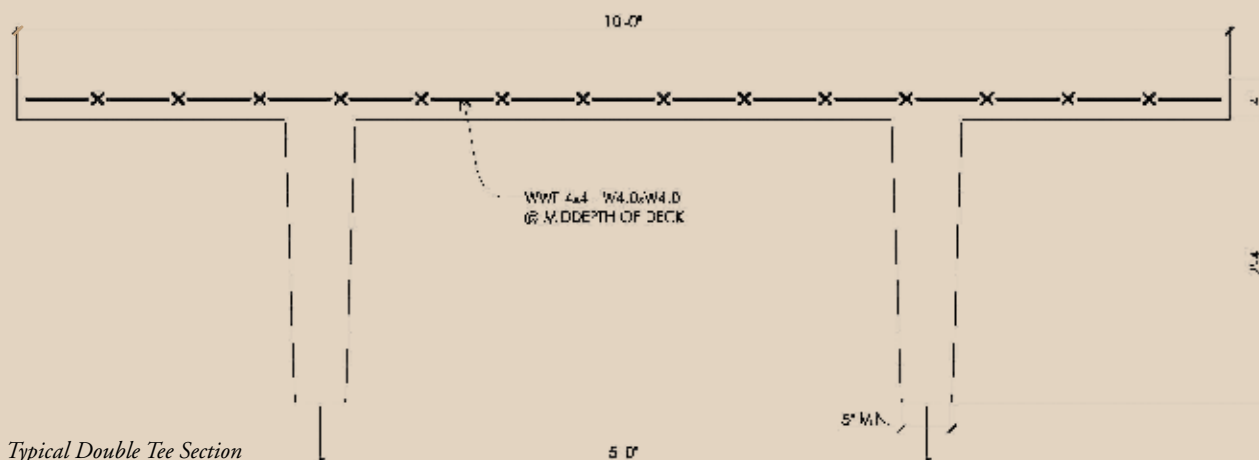
Typical Double Tee Section

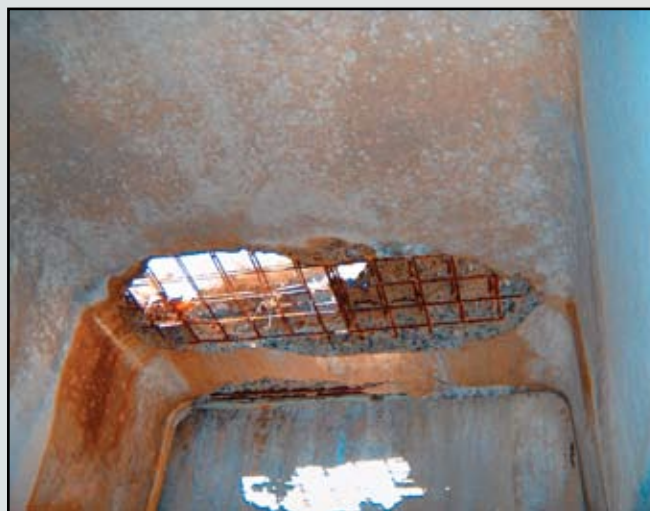
Areas of the deck were swept clean by a small sidewalk sweeper and the deck was found to be in fair condition. Due to safety concerns, town employees had knocked the damaged area of the upper deck down prior to the field investigation. This resulted in a single two foot wide by fourteen foot long hole in the middle portion of a northern span. The failed deck lay below the hole on the lower level of the garage. Other areas of the deck contained smaller holes and spalls scattered

Existing hole in deck

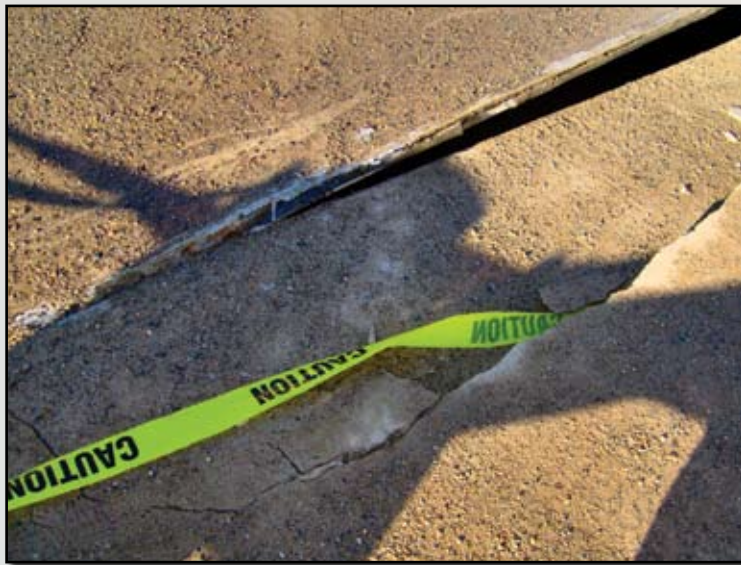
Water staining and efflorescence was also present throughout the underside of the deck. Upon excavating around several of the wet areas, the existing reinforcing was found to be generally in good condition. Further excavations around spalls and deck blow-throughs found the reinforcing mesh to be intact within one inch of concrete embedment. Observations regarding the mesh contained within the fallen 14 foot section of deck revealed corrosion along the outside edge of the mesh in several areas.

*Failed area of deck*

The loaded vehicles could have created the hairline cracks in the deck, thereby exposing the reinforcing mesh to moisture and road salts washing off parked vehicles. The water and salt would result in corrosion of the reinforcing and spalling. This conclusion is reinforced by two facts. First, chloride testing that was conducted as part of the garage study. Six core samples were recovered from the deck and tested for compression and chloride content. The water soluble chlorides (% by weight of cement) were found to be as high as 2.29%. Research indicates that the threshold at which the electrochemical process begins to corrode the reinforcing is 0.15%. This is the com-

monly accepted level at which the passivity of the concrete is no longer protecting the reinforcement from corrosion. Secondly, the majority of the spalls and deck blow throughs were concentrated along the cantilevered flange sections of the tees.

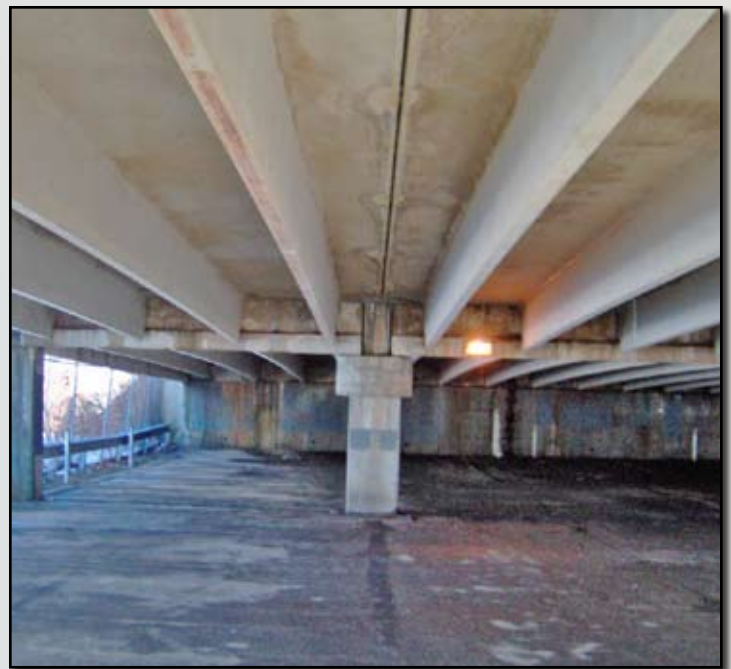
The rain during the investigation revealed many wet areas on the underside of the parking deck, indicating the presence of cracks.

*Underside of parking deck*
