Unique and Effective Sampling Method Saves Money and Time

Bridge Post-Tensioning Inspection, Assessment and Evaluation Project

By Jerry Frost, P.E., MS, MBA, Troy Madlem, P.E., Don Kline, P.E. and John Crigler, P.E.

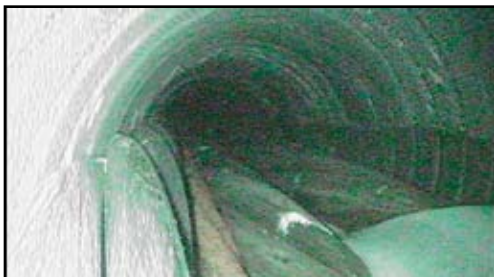
Figure 4a: Example of corrosion – Duct Void

Table 1 summarizes the findings of the inspection. Ramps A, B, and C failed the statistical sampling test performed in accordance with ANSI. For these sample lots, 100 percent of the tendons were inspected. The table indicates the total number of voids found inside the PT ducts at high points to be 33. Most of the voids had no exposed strands. Figure 4 shows a tendon void where the strands are completely covered by grout. Of the total number of voids, 8 were large enough to have exposed strands.

After review of each inspection, VSL placed epoxy in the borescope hole to protect the tendons from air and moisture intrusion. Whenever the field team found a void in the tendon inside the duct, action steps for repairs were taken but only after full inspection, documentation and assessment of the tendon condition was completed. VSL used the vacuum grouting technique to fill the void. In this technique, a vacuum pump extracted air from the void. Then grout was added to the void.

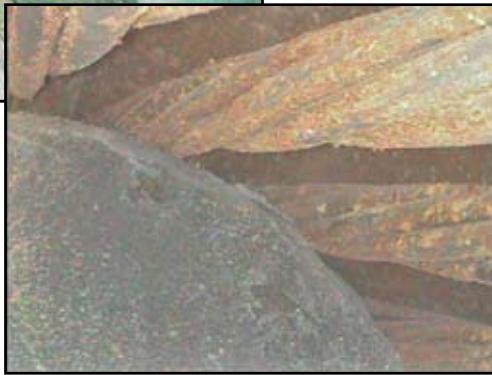
Figure 4b: Example of Level 1–2 Corrosion

The exposed strands exhibited various levels of corrosion (Figure 4). The observed level of corrosion was classified according to the corrosion chart in the PCI Journal article, *Evaluation of Degree of Rusting on Prestressed Concrete Strand*. A classification of level 4 or less was considered mild corrosion with no loss of cross-sectional area. Areas with exposed strands and corrosion levels greater than 4 were noted and itemized as areas for future monitoring and inspection efforts.

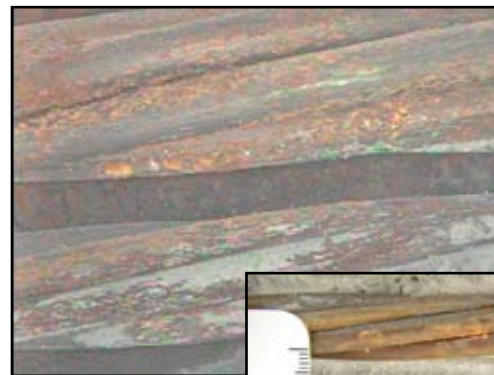
Figure 4c: Example of Level 4–5 Corrosion

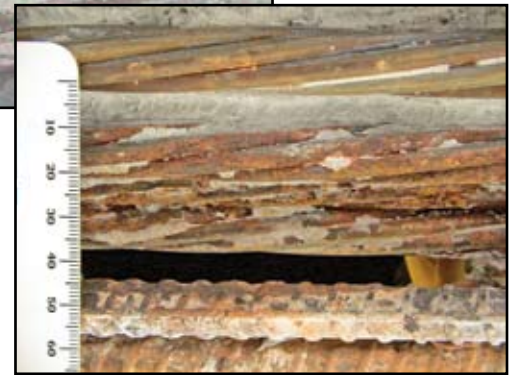
Figure 4d: Example of Level 5–6 Corrosion at Coupler

In addition to the findings represented in Table 1, the team found significant incidence of exposed strand with corrosion level of 5 or higher at the PT couplers in the Mainline and in Ramp C. These areas were also noted and itemized as areas for future monitoring and inspection efforts.
