Structural Repairs Stabilize a Modernist Church

By John F. Vincent, P.E.

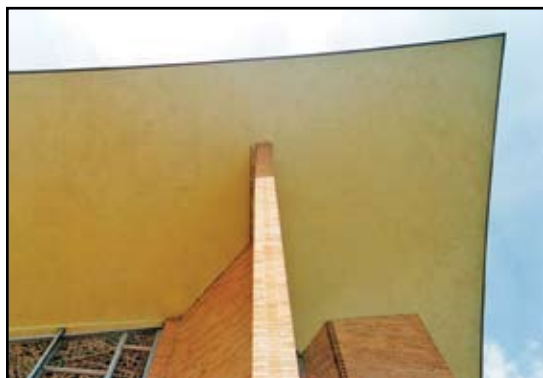
After 36 years of service, the upper portions of the fin walls showed visible bowing. Concerned for the safety of parishioners and the stability of the structure, the parish engaged CTLGroup to perform a structural evaluation. Investigations revealed masonry cracks (approximately $\frac{1}{8}$ to $\frac{1}{2}$ inches wide) that were associated with the wall bowing. Furthermore, the tops of the fin walls had displaced laterally about 6 inches from their original locations at the canopy soffit (Figure 2). The tip of the canopy is the high point of the roof. The walls were sliding “up” the soffit surface as the roof was displacing downward. Because the fin walls were displacing relative to the canopy, the structural integrity of both the walls and roof shell were in question.

modeled by modifying the modulus of elasticity of the elements. Analyses results indicated that frictional restraining forces between the tops of the fin walls and sloping shell soffit were insufficient to accommodate applied interfacial shear forces. Based on this finding, it appeared that some displacement of the walls relative to the shell had occurred at the time of original construction, when shoring for the shell concrete was removed. These initial wall displacements were aggravated over time by seasonal temperature changes, which displaced the walls further in small increments each year. The accumulation of wall displacements over the life of the structure led to the distress observed in the walls.

Figure 2: Top of original fin wall shows bowing of wall and displacement at canopy soffit.

The finite element model was used to predict the strength and ductility needed to properly design new fin walls and their connection to the canopy and edge beams. The new walls were designed as reinforced masonry elements, with matching brick from the manufacturer of the original brick. The new fin walls were tied to the roof with a new reinforced concrete diaphragm at the canopy soffit, and have sufficient ductility to move with roof volume changes without damage.

At the tops of the fin walls, the masonry terminates a few inches beneath the canopy soffit in a stair-step configuration. The new diaphragm, located at and between the fin walls, transfers shear force between the walls and the canopy soffit

through shear friction. With the new detail, the masonry only resists shear force through application of lateral loads or lateral displacement of the roof. This detail eliminated the shear force from gravity-load transfer that the original sloping concrete/masonry interface detail had applied to the wall.

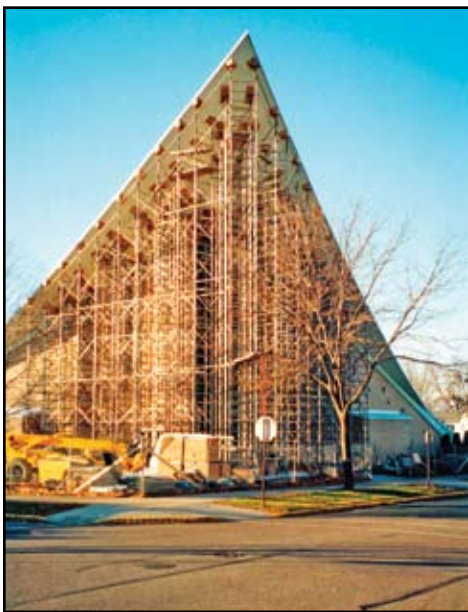
Figure 3: Shoring supporting the concrete shell roof during fin wall reconstruction.

The finite element model also was used to analyze various methods of shoring the roof shell during reconstruction of the fin walls. Shoring was required to support the canopy and interior regions of the roof structure tributary to the fin walls. It was important to minimize axial strains and settlement in the shoring to avoid imposing large stresses on the canopy. Minimizing the shoring plan area to avoid encroaching on space within the church, and thus allow services to continue throughout construction, was an important criteria. Shoring design was the responsibility of the repair contractor. The shoring system that was developed to meet these requirements involved:

1. Closely spaced tower shores supported by concrete foundations (Figure 3);
2. Custom-fabricated oak blocks (cut from 12- x 12-inch timbers) set atop the shore posts to accommodate the compound and variable slope of the roof soffit (Figure 4); and
3. Regular monitoring of shore footing elevations to ensure that footings were not settling. An emergency plan was prepared that would have been implemented had foundation settlement been discovered.

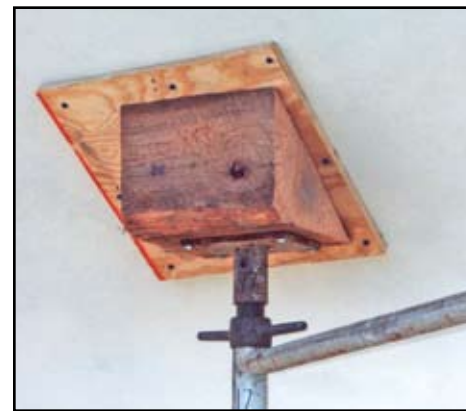
Figure 4: Custom-cut oak block fits canopy profile at top of shoring post.

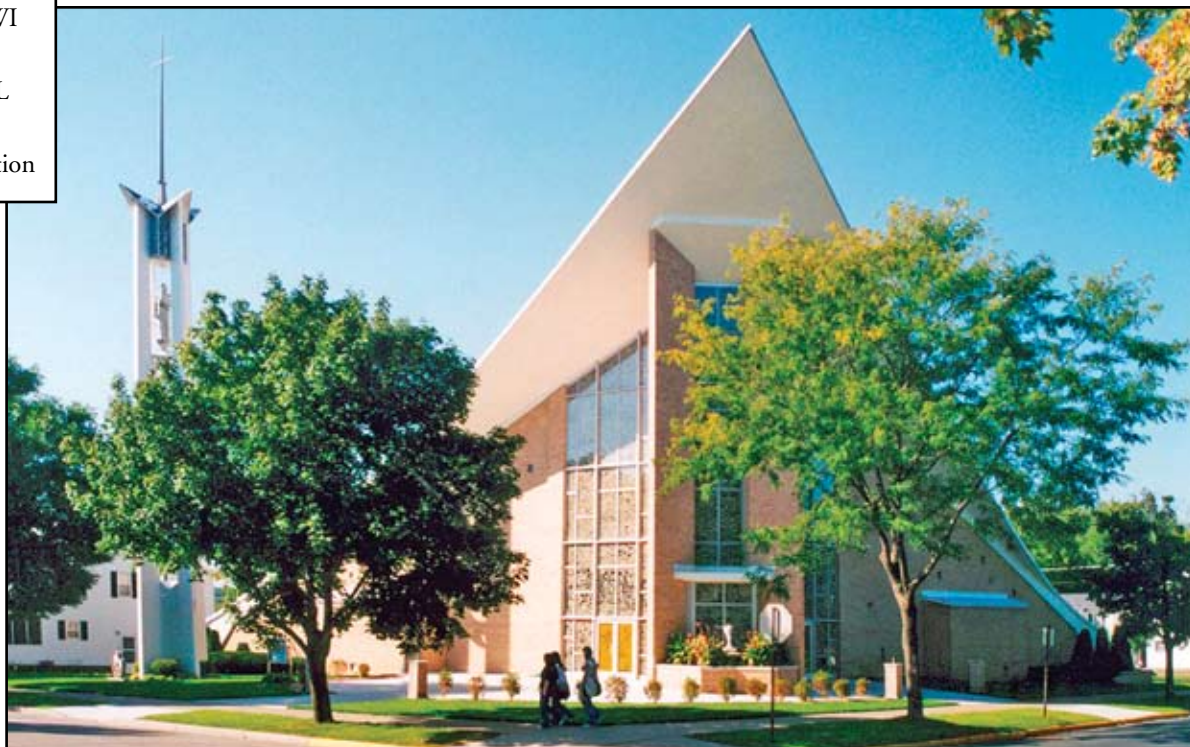
Figure 5: The Catholic Church of St. Joseph after completion of repairs.

The design preserved the building's architectural character, and allowed the church to remain in use through the entire course of the repairs. Matching brick from the original supplier were used to construct new reinforced masonry fin walls. Original stained-glass windows were carefully removed, stored, and reinstalled in the strengthened structure. A view of the repaired structure is shown in Figure 5. The investigation and repairs saved this landmark church, and will extend its useful life for many years to come. ■
