# Solving the Puzzle

A Case Study of Building Distresses Due to Foundation Movement

By Xing Shi, Ph.D., and Mark Holland, P.E.

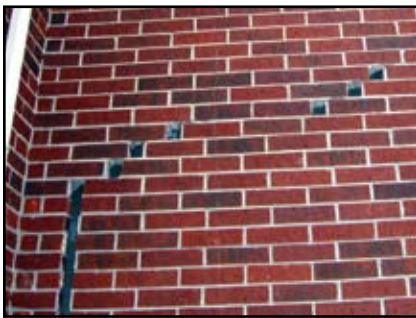
Figure 1: The major crack in the corner of the south wing brick wall.

This building is a three-story apartment facility with post-tensioned slab-on-grade, wood stud frame and wood roof truss, and screen-type brick veneer. At a protruding portion in the south wing of the building, there was a major crack that widened as it extended from the 1<sup>st</sup> floor to the 3<sup>rd</sup> floor (Figure 1). On the 3<sup>rd</sup> floor, the crack was almost 2 inches wide, clearly indicating significant building movement. Figure 2 shows a floor plan of the south wing and the location of this major crack. During the review, many other cracks, both exterior and interior, were found throughout the south wing. A person standing on the inside could feel the floor sloping down towards the end wall. Based on these preliminary findings, it was determined that these distresses were caused by foundation movement.

As shown in Figure 1, the major crack extended from the 1<sup>st</sup> floor to the 3<sup>rd</sup> floor and turned 45 degrees at the wall corner to continue until it reached the fascia board of the roof. The movement was such that the side brick wall to the right of the crack rotated away from its original position. It was then quite logical to ask the question, "How did the adjacent end wall move?" Upon further inspection, using a long ladder, the top of the end brick wall was found pushed outwards by the movement of the side wall, exactly as expected. So far, the physical movement of the exterior brick walls was fully understood.

A conceptual design strategy was also recommended. It involved installing precast segmented concrete piers around the perimeter of the post-tensioned slab-on-grade, using these piers to jack up the building back to its original position. The void created underneath the slab-on-grade would be filled with expansive foam material.

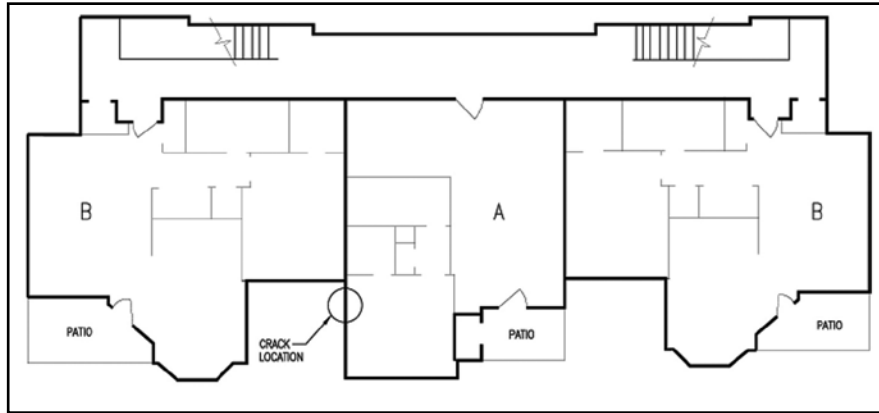
Figure 2: Floor plan of the south wing. The major crack was located in the brick wall along the left-hand side of the protruding room of module "A".

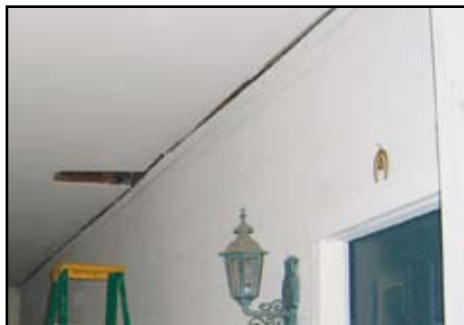
Figure 3: Gap between the ceiling and the siding wall on the 3<sup>rd</sup> floor.

A discovery in the 3<sup>rd</sup> floor breezeway led to the last piece of the puzzle. As shown in *Figure 3*, a gap of about 1 to 2 inches wide between the ceiling and the siding wall was discovered. By cutting out a piece of sheet rock from the ceiling, the gap and the bearing of the wood roof truss could be observed. *Figure 4* shows a picture of the condition of the bearing of the roof truss. It is clear that the roof truss also “rotated” away from its original position. As a result, nails had partially pulled out, and there was a gap of approximately 2 inches between the end of the truss and the wood stud. This was exactly the “hinge” location of the main structure.

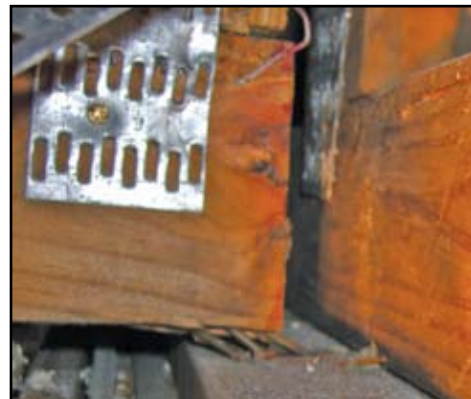
Figure 4: Bearing of the wood roof truss. Note the pulled-out nails.
