Evaluation of Structural Damage

Reinforced Concrete Arch Culvert

By Steven J. Smith, Ph.D., P.E., Terry M. Sullivan, P.E., Jeremiah R. Nichols, P.E., Honggang Cao, P.E., Michael G. Carfagno, P.E. and Larry P. DeRoo, P.E.

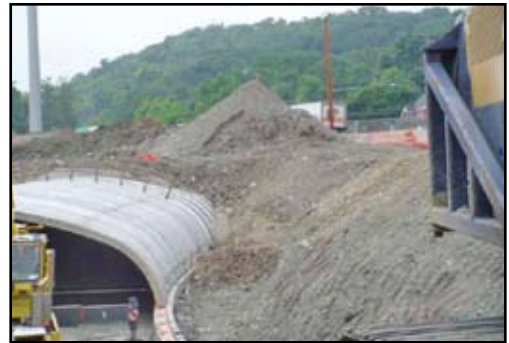
Figure 3: One of several distinct overburden stockpiles placed over the Duck Creek Culvert.

In late July of 2004, Ahern's quality control manager noted some spall damage on the inside of the culvert. A preliminary check showed that a large overburden stockpile had inadvertently been placed over the top of the culvert in an area that had been completed and backfilled several months prior (Figure 3). The Corps and Ahern reviewed their archives for site photographs from the previous year, to see if any other stockpiles had been placed over the culvert. The photos showed several distinct stockpiles that covered about 400 linear feet of the

1150 foot long culvert. It was inferred by the Corps that the stockpile had simply been moved as required so the contractor could continue to proceed with other work on site. Aerial photos of the stockpile were taken and a field survey was completed. The maximum stockpile height was approximately 15 feet, with the maximum height over the culvert of about 12 feet. The culvert had been designed for a maximum dead load of four feet of earth.

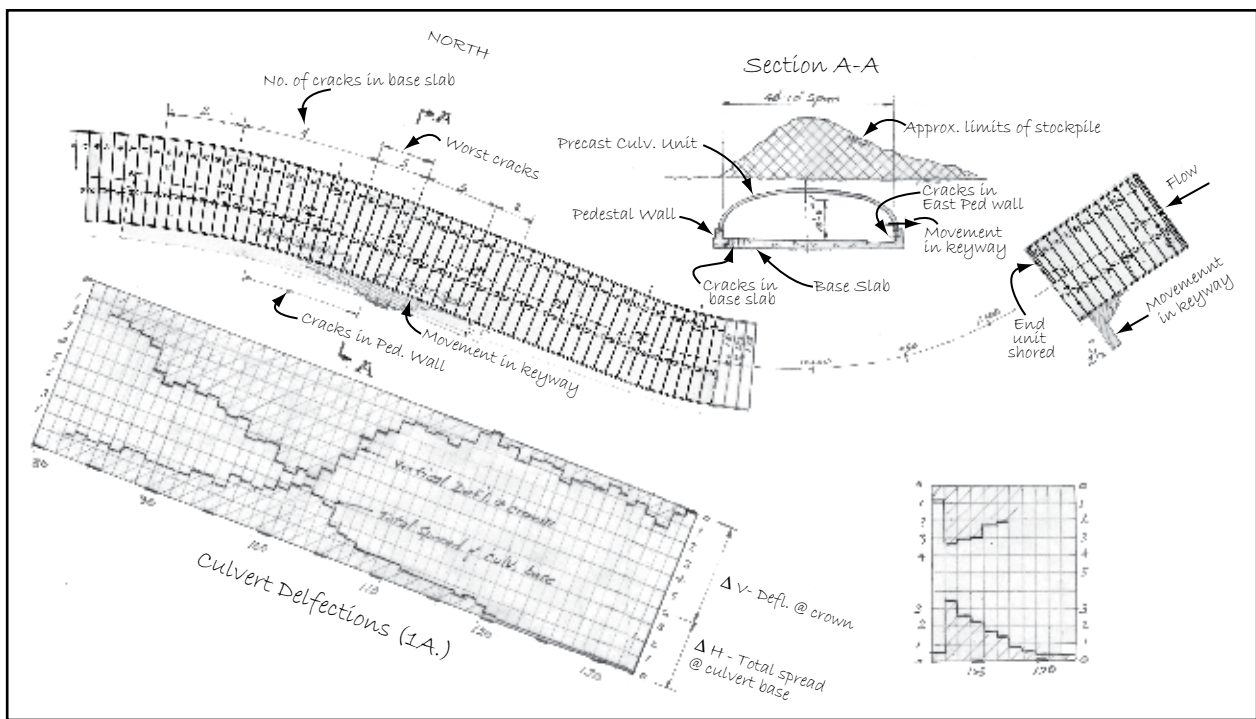
Figure 4: Field notes prepared by CON/SPAN® summarizing visually observable and measurable damage to culvert precast elements, base slab and knee walls.

A preliminary damage survey provided a summary of the type and extent of visible damage (Figure 4). A detailed site investigation followed and considered five potential types of structural distress, as listed in the Condition Assessment that follows.

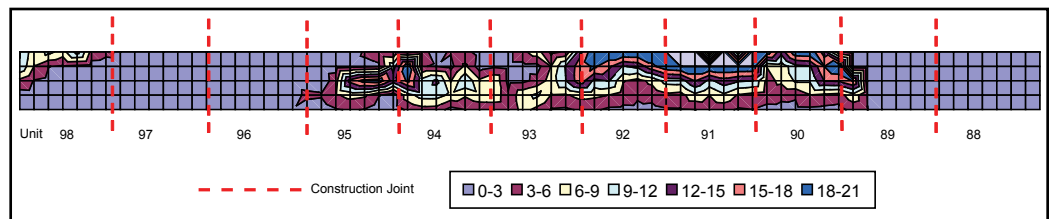
Figure 5: Graphical representation of typical Impulse Response (IR) data, showing region of elevated mobility (and associated potential damage) in the knee wall.

For a continuous section of knee wall with sound concrete, average mobility values were less than 2. Values greater than 4 indicated concrete anomalies within the knee wall. The IR testing was not capable of detecting the relatively superficial effect of failure of the knee wall key way, and was also sensitive to variability in the stiffness provided by the backfill material. The IR testing proved effective at identifying significant cracking in the knee wall. Results corresponded well with visual observations and coring. The test results were ultimately confirmed after the knee wall was exposed during the demolition operations (which were guided by the IR results). Figure 5 shows sample IR data.

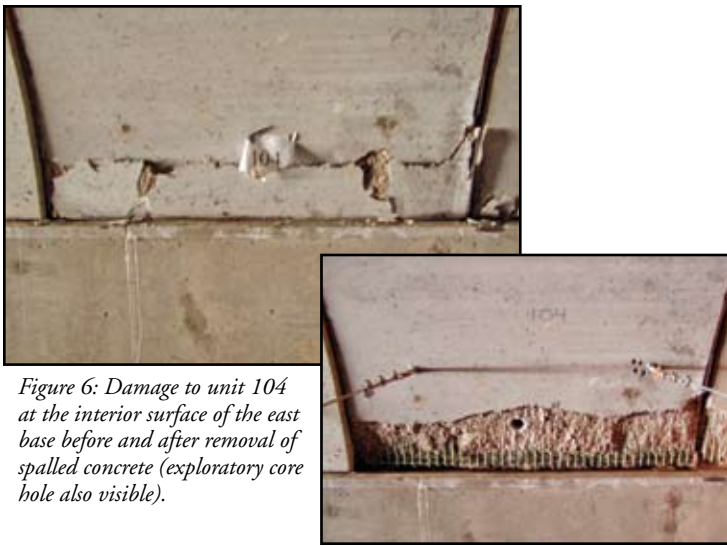
Analysis of the IE test results on the arch elements showed significant internal delamination only at those units with visible damage on the interior surface. Surprisingly, even with the severe overload of approximately 50 precast arch units, only four were significantly damaged.

Figure 6: Damage to unit 104 at the interior surface of the east base before and after removal of spalled concrete (exploratory core hole also visible).

3. Shear failure at the base of the arch in the form of delamination of the precast concrete from the steel reinforcement: Damage of this type was limited to units that were subjected to the highest loading. *Figure 6* shows a damaged unit before and after the spalled concrete had been removed, revealing the damage to be limited to the outer layer of concrete. The interior layer of rebar on one unit had been plastically deformed along the failure plane in the concrete.

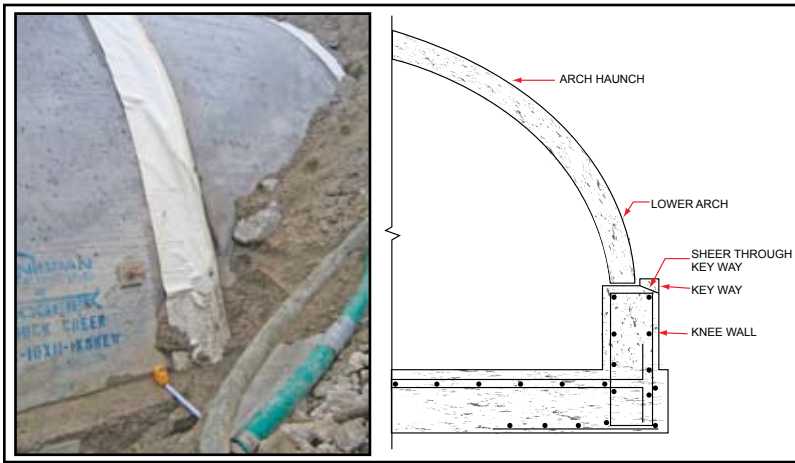
Figure 7: Key way failure

4. Knee Wall: Separation between the arch units and the interior grout pack of the knee wall was documented at a majority of the overloaded units. This implied a failure of the key way (*Figure 7*). Complete failure of the knee wall was identified in regions that were highly loaded (*Figure 8*). The balance of the knee wall in the affected area had damage that transitioned from the relatively minor key way failure to the full section failure.

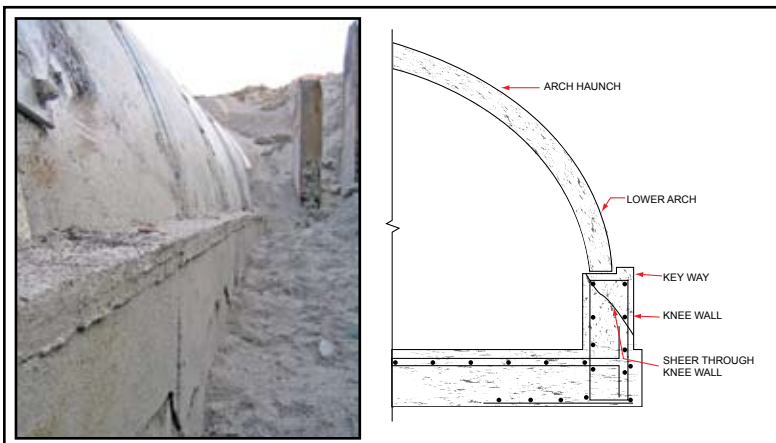
Figure 8: Knee wall shear failure.
