## 170 Tremont Street

### Thin Brick Seated Pre-Cast Failures

By Craig E. Barnes, P.E., SECB

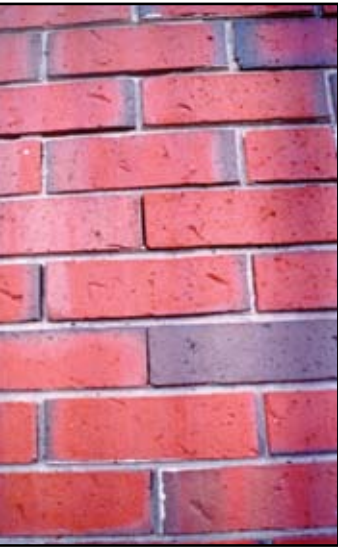
Figure 1: Raked mortar joints at brick veneer

In early 2000, CBI Consulting Inc. was engaged to undertake the façade inspection of 170 Tremont Street, an 18 story condominium building in the heart of Downtown Boston. In the case of 170 Tremont Street, a binocular survey revealed minor masonry cracking on the brick façade. The existing construction plans were not helpful in determining the cause of the cracking. The record plans showed a precast concrete façade. The actual façade was a combination of brick and precast. This conflict between as-built plans and existing conditions reveals a possible pitfall if too much reliance is placed on as-built documents. Prior to the high rise survey on 170 Tremont Street, the owners planned a full sealant replacement at the existing windows to address leak issues. Knowing there was a potential need to address distressed brick, the property manager allowed for a limited allotment of brick replacement during the sealant replacement project.

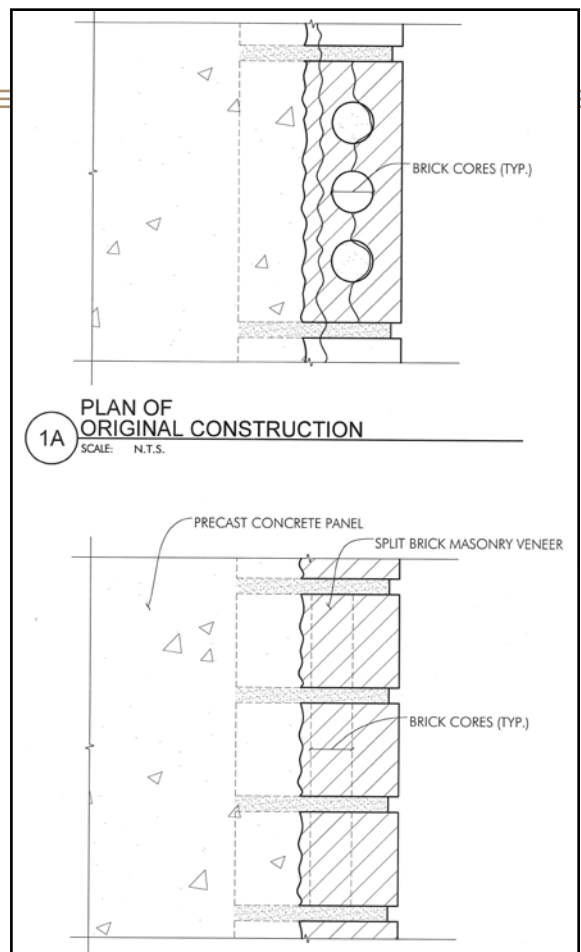
Figure 2: Illustrates bricks cast into concrete panels and the extent of veneer separation

surface. This, we believe, was followed immediately by the placement of reinforcement followed in turn by concrete placed to the desired depth. The bond between brick, mortar back-up, and precast concrete was critical. When the panels were righted, the plastic joint strips were removed and the final product was the raked joint seeded brick panel. (Figure 2)

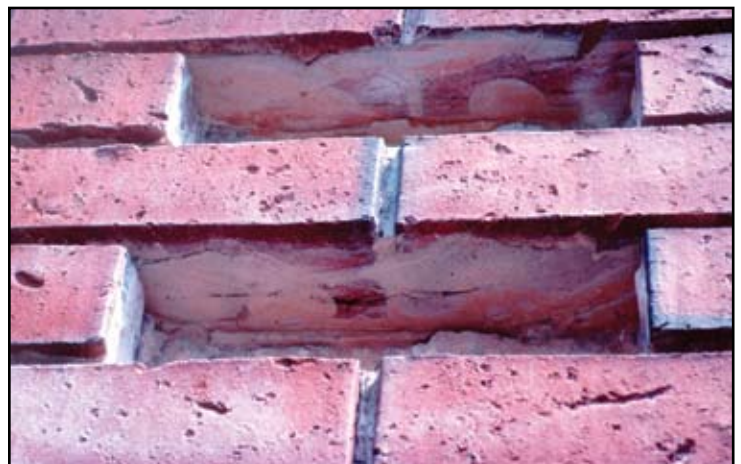
The phenomenon of deterioration of a raked joint mortar by water, combined with acid rain, is well documented. In the case of 170 Tremont Street, the deterioration of the mortar joint and thin shell between the brick core and the brick surface allowed moisture into the cores of the brick. Existing conditions revealed that there was no guarantee in the casting process that the brick cores would be solidly filled with mortar. Our review found solid filled cores and other cores

Figure 3: Brick excavation seen from the underside of the brick. Note the ragged horizontal crack through the cores of the brick

partially filled. Water setting in the raked joint and finding its way to the brick cores during freeze thaw cycles will expand when frozen, causing the brick face to fracture from the parent concrete panel (Figure 3). That was the problem that had been observed with the binoculars. Over time, one could imagine the entire brick seeded façade breaking loose (unzipping) from the concrete substrate.

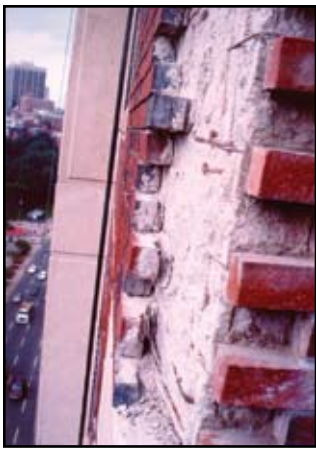
Figure 4: Panel with brick removed showing reinforcement in the concrete and the ragged freeze thaw fracture at veneerface

as well as the back-up portion of the brick still embedded in the concrete was removed. Once the brick and mortar was removed, the resulting panel surface was fairly smooth. Some areas contained exposed reinforcing rods (Figure 4). The reinforcing rods were in good condition and did not need to be replaced or supplemented, although slight corrosion was observed. The fact that there was rust on the reinforcement pointed out yet another problem that would occur down stream unless corrected. Due to moisture oxidizing the reinforcing within the panel, the reinforcing would expand and begin to push the brick off, creating another mechanism that would endanger the integrity of the system. Replacement or repair of these elements was accomplished in a traditional way. Exposed reinforcement of the concrete was cleaned and coated with epoxy. The concrete surface was cleaned, and an application of an epoxy mortar thin set was applied to the concrete surface. Mechanical ties were drilled into the concrete back-up and left exposed to be incorporated in the mortar joints of the replacement brick. A hot dipped galvanized steel relieving angle was placed at the bottom course of brick at a joint between the panel being repaired and the panel below (Figure 5). The relieving angle supported the brick, which was then placed in traditional fashion, with the addition of a solid collar joint of epoxy mortar. The concept of the rake joint was abandoned and the joints were pointed to be flush with brick surfaces.

The conditions presented several problems that a series of repairs were designed to correct. First, brick that had totally separated and was in danger of falling was removed. Full panel sized removals were conducted. The cored brick which was in the process of falling, or had peeled off,

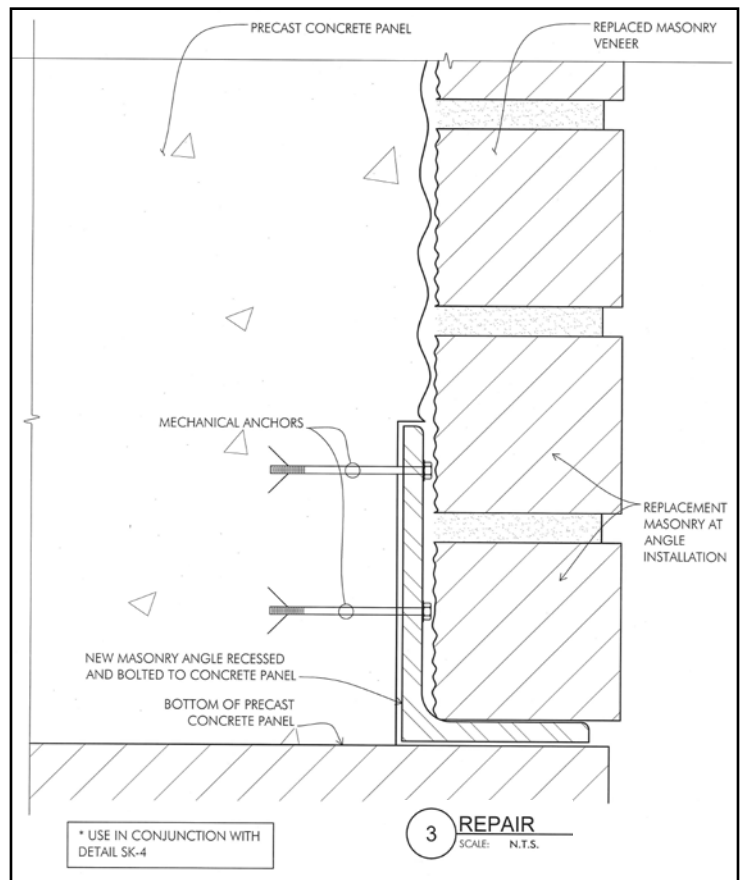
Figure 5: Section at new support angle

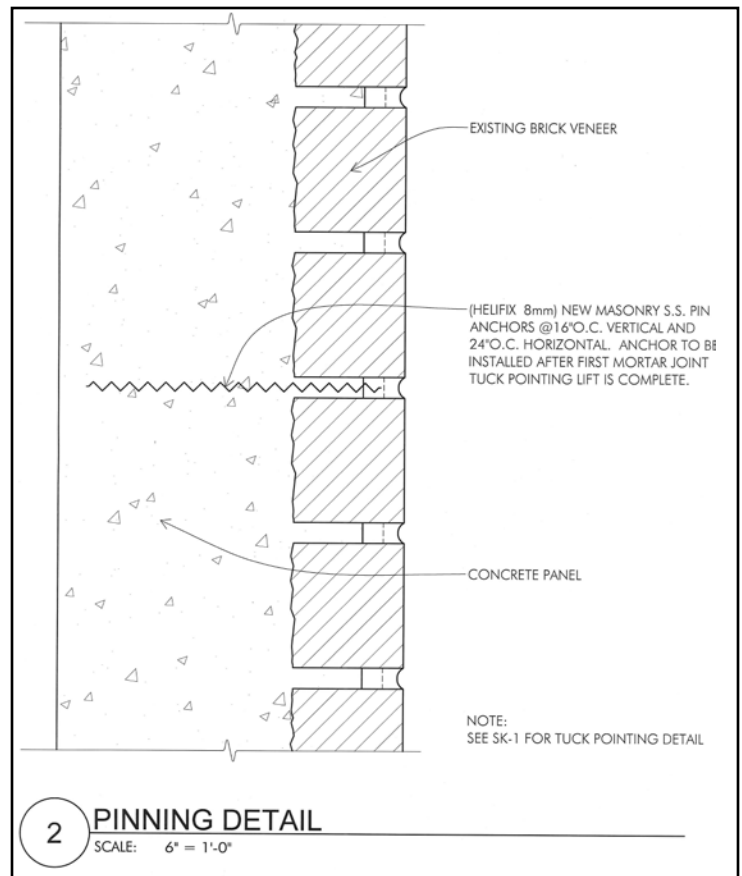
Figure 6: Wall section showing installation of helical anchors used to pin the veneer

The second condition addressed veneer brick, which was debonded but not dislodged over small areas. The repair implemented here was derived by viewing a number of the existing conditions which revealed, in all cases, that the original setting grout was very strong, bonded to the brick at mortar joints, and often remained intact even as a crack on the core line was initiated. Taking advantage of the strong well bonded mortar and abandoning the rake joint, which was a minimum of 3/8-inch deep, allowed for the re-securing of the veneer with stainless steel helical anchors. Once the anchors were set, the mortar joints were flush pointed. This process was used over the entire surface, both at the cracked areas and those areas that may not have been cracked. Figure 6 shows the final condition.

At the conclusion of the pointing, the entire surface was clear sealed to add one more level of security against water intrusion. ■
